Side Curtain Air Bag Investigation  
Dynamic Science, Inc. (DSI), Case Number DS08033  
2006 Toyota Highlander  
Oregon  
June 2008

1. Report No. DS08033		2. Government Accession No.		3. Recipient Catalog No.	
4. Title and Subtitle On-Site Rollover Investigation				5. Report Date May 29, 2009

**Dynamic Science, Inc.**  
**Crash Investigation**  
**Case Number: DS08033**

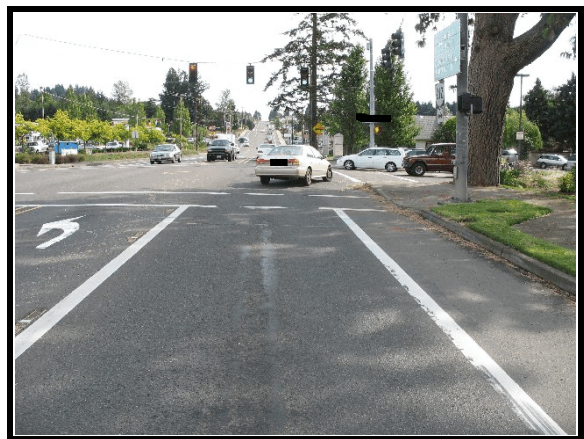
**Figure 2.** Eastbound approach for Freightliner

The two-vehicle crash occurred within a four-leg intersection controlled by traffic signals for each direction of travel. At the time of the crash, there were no adverse weather conditions and the roadway surface was dry. The south leg of the intersection provided access to a parking lot. The roadway was comprised of a northbound combination through lane and right turn lane, a left turn lane, and a southbound through lane (**Figure 2**). The roadway was of asphalt construction and there was a 2% positive grade. The speed limit was 32 km/h (20 mph). The west leg of the intersection was a state highway that was comprised of an eastbound through lane, a left turn lane, and a westbound through lane (**Figure 3**).

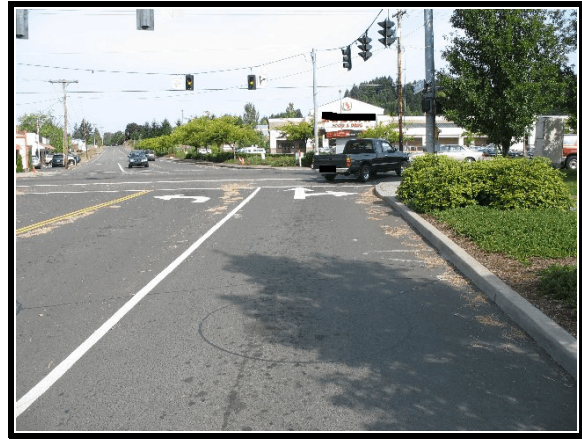
**Figure 3.** Northbound approach for Toyota

The Toyota Highlander was being driven northbound at an unknown speed by an 80-year-old male. There was one additional adult female passenger seated in the vehicle's front row right position. The Freightliner was being driven eastbound at an unknown speed by a 32-year-old male.
