**NOT-IN-TRAFFIC SURVEILLANCE  
CALSPAN REMOTE BACK OVER INCIDENT INVESTIGATION**

**SCI CASE NO.: CA08035**

**VEHICLE: 1999 HONDA ODYSSEY MINIVAN**

**INCIDENT DATE: JUNE 2008**

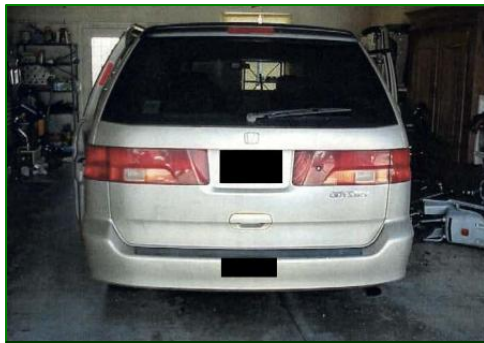
The back view of the involved Honda Odyssey is provided in **Figure 3**. **Figure 4** is an undercarriage view of the exemplar vehicle.

**Figure 3. Back view of the involved Honda Odyssey.**

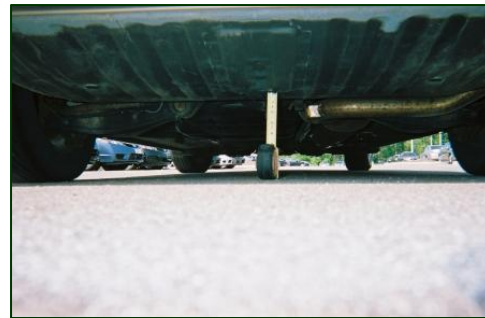
<b>Component</b>	<b>Measurement Above Pavement</b>
Beltline	118 cm (46.5")
Base of Tailgate Glazing	117 cm (46")
Top of Tailgate Glazing	163 cm (64")
Bottom of Bumper	35 cm (13.75")
Top of Bumper	53 cm (21")
Tailpipe	25 cm (10")
Exhaust Pipe	18 cm (7")
Muffler	18 cm (7")
Forward Edge of Undercarriage Floor	21 cm (8.25")
Rear Edge of Undercarriage Floor	28 cm (11")
Lower Control Arm	15 cm (6")
Lower Shock Mount	12 cm (4.75")
Sway Bar Link	17 cm (6.75")
Sway bar Mount	20 cm (8")

**Figure 4. Undercarriage of the exemplar Honda Odyssey.**

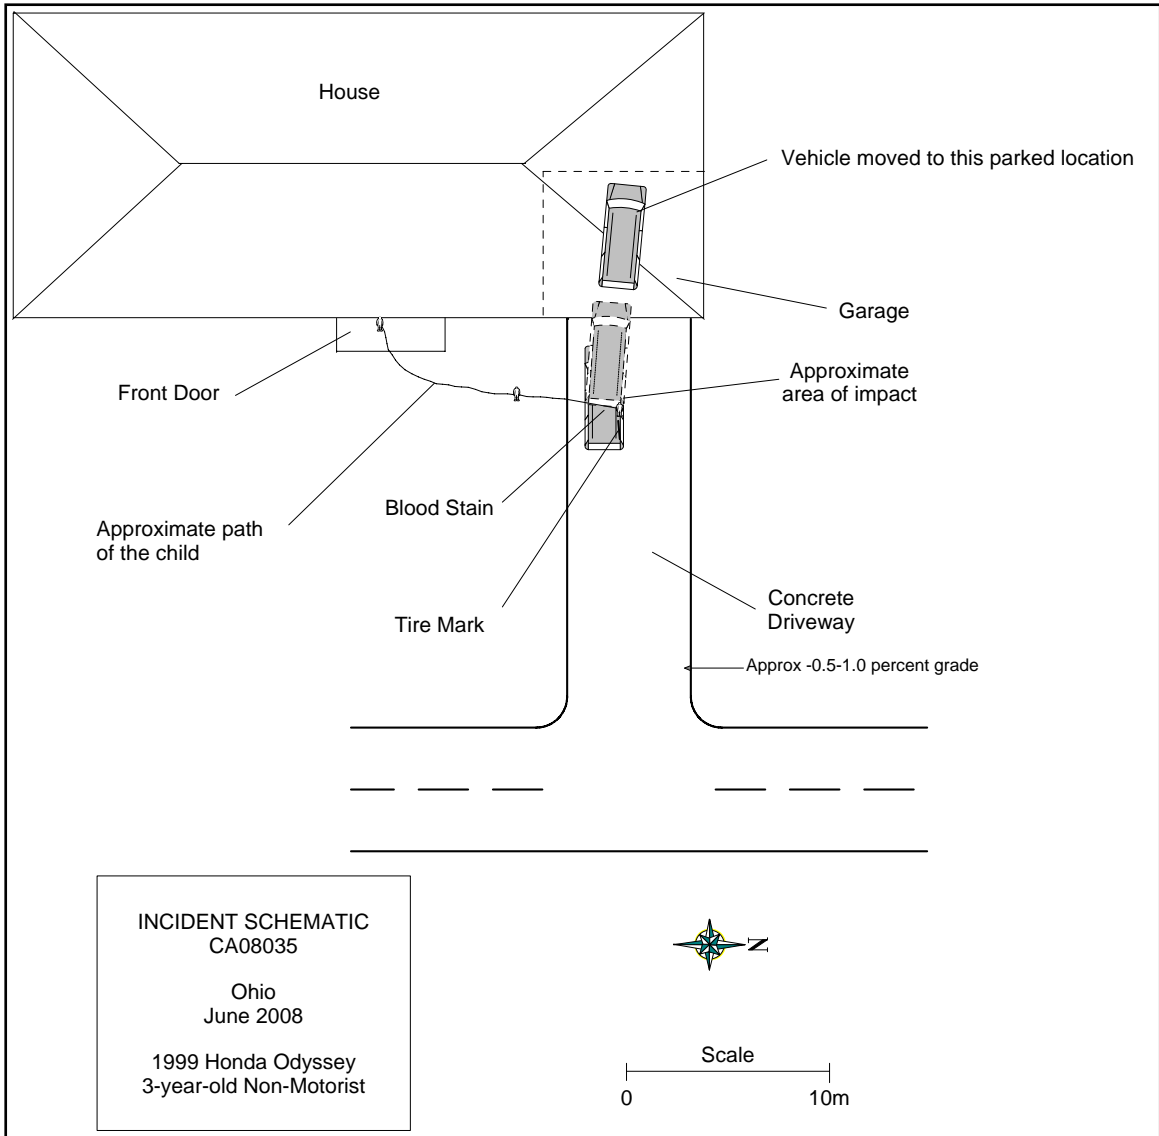
estimated at 0.5-1 percent. There were no visual obstructions along the edges of the driveway or adjacent to the garage. **Figure 2** is an overall view of the incident site. A schematic of the incident scene is attached as **Figure 13**.

**Figure 13: Scene Schematic**
