ON-SITE ROLLOVER INVESTIGATION

CASE NUMBER - IN08036

VEHICLE - 2007 SATURN VUE

CRASH DATE - August 2008

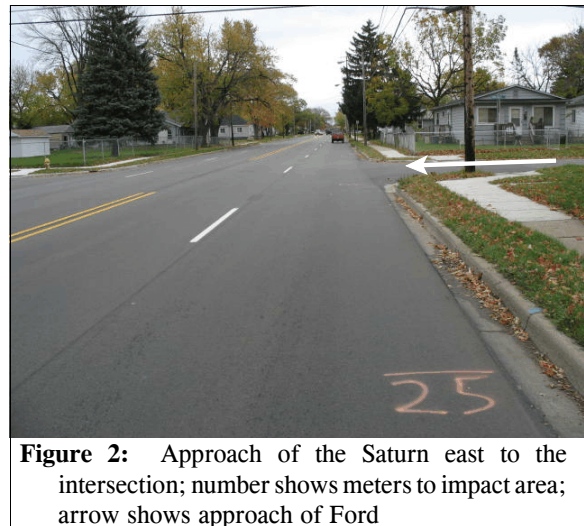
Figure 2: Approach of the Saturn east to the intersection; number shows meters to impact area; arrow shows approach of Ford

Pre-Crash: The Saturn was traveling east in the outside lane (**Figure 2**) and was occupied by a restrained 68-year-old female driver. She stated in the interview that she was traveling between 40-48 km/h (25-30 mph) and intended to continue east through the intersection. The vehicle's Event Data Recorder (EDR) report indicated that the vehicle was traveling 48 km/h (30 mph) 2.5 to 0.5 seconds prior to Algorithm Enable (AE), and no braking was recorded during this time. The Ford was occupied by a male driver and one passenger and was traveling north approaching the stop sign (**Figure 3**). The Saturn's driver initiated a left steering maneuver in an attempt to avoid the crash, but did not apply the brakes. The crash occurred in the intersection of the two roadways.

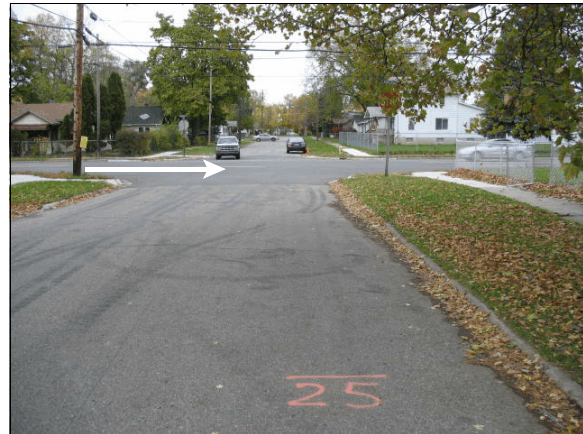
Figure 3: Approach of the Ford north to the intersection; arrow shows approach of the Saturn

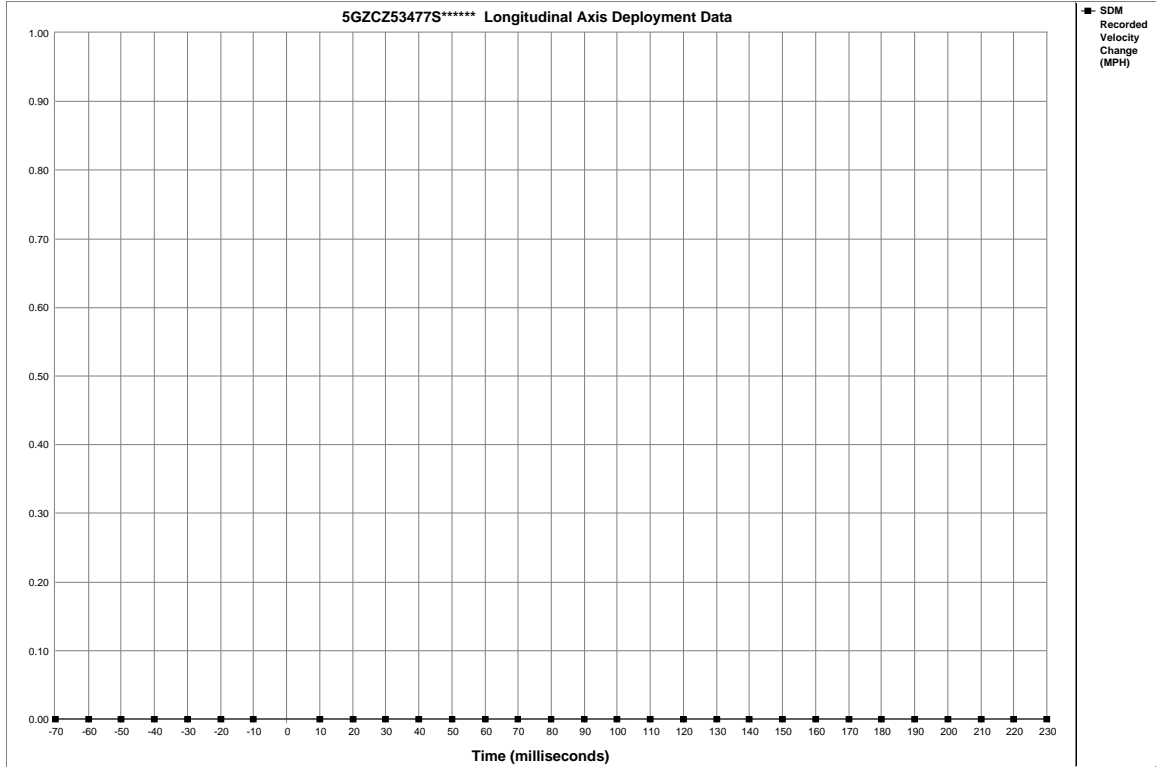
Time (milliseconds)	-70	-60	-50	-40	-30	-20	-10	10	20	30	40	50	60	70	80
SDM Longitudinal Axis Recorded Velocity Change (MPH)	0.00	0.00	0.00	0.00	0.00	0.00	0.00	0.00	0.00	0.00	0.00	0.00	0.00	0.00	0.00
Time (milliseconds)	90	100	110	120	130	140	150	160	170	180	190	200	210	220	230
SDM Longitudinal Axis Recorded Velocity Change (MPH)	0.00	0.00	0.00	0.00	0.00	0.00	0.00	0.00	0.00	0.00	0.00	0.00	0.00	0.00	0.00

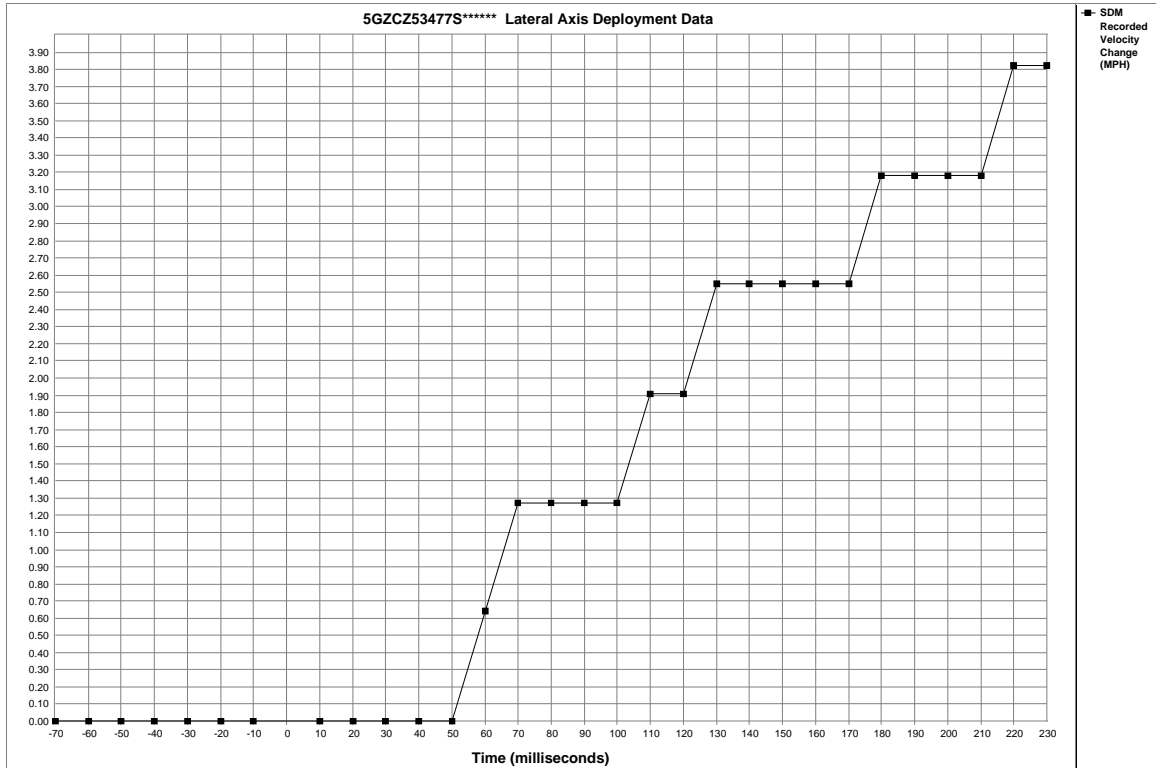
Time (milliseconds)	-70	-60	-50	-40	-30	-20	-10	10	20	30	40	50	60	70	80
SDM Lateral Axis Recorded Velocity Change (MPH)	0.00	0.00	0.00	0.00	0.00	0.00	0.00	0.00	0.00	0.00	0.00	0.00	0.64	1.27	1.27
Time (milliseconds)	90	100	110	120	130	140	150	160	170	180	190	200	210	220	230
SDM Lateral Axis Recorded Velocity Change (MPH)	1.27	1.27	1.91	1.91	2.55	2.55	2.55	2.55	2.55	3.18	3.18	3.18	3.18	3.82	3.82

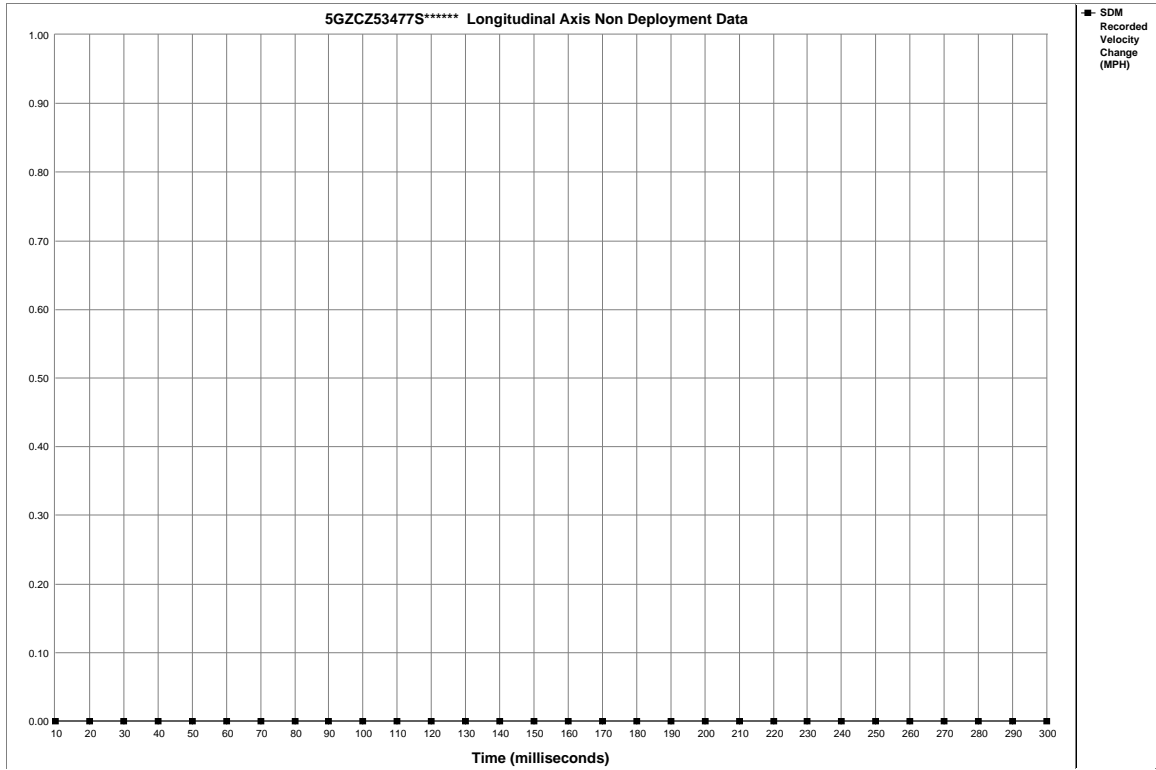
Time (milliseconds)	10	20	30	40	50	60	70	80	90	100	110	120	130	140	150
SDM Longitudinal Axis Recorded Velocity Change (MPH)	0.00	0.00	0.00	0.00	0.00	0.00	0.00	0.00	0.00	0.00	0.00	0.00	0.00	0.00	0.00
Time (milliseconds)	160	170	180	190	200	210	220	230	240	250	260	270	280	290	300
SDM Longitudinal Axis Recorded Velocity Change (MPH)	0.00	0.00	0.00	0.00	0.00	0.00	0.00	0.00	0.00	0.00	0.00	0.00	0.00	0.00	0.00

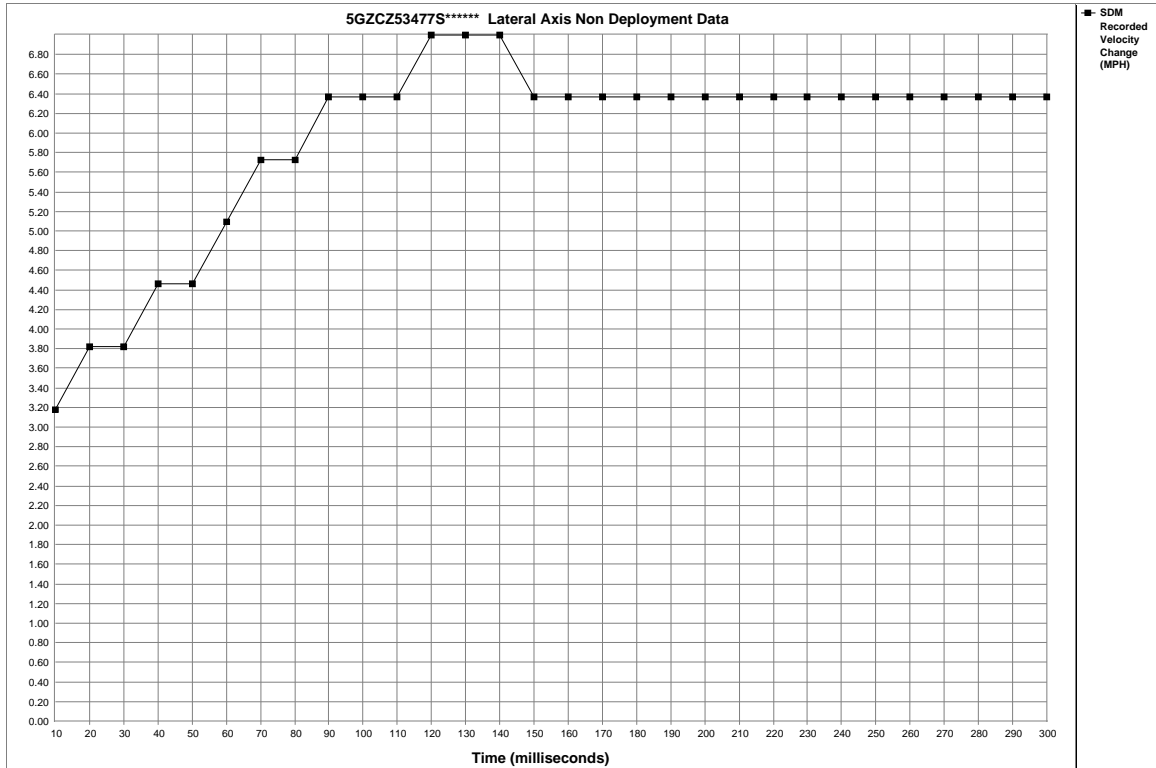
Time (milliseconds)	10	20	30	40	50	60	70	80	90	100	110	120	130	140	150
SDM Lateral Axis Recorded Velocity Change (MPH)	3.18	3.82	3.82	4.46	4.46	5.09	5.73	5.73	6.37	6.37	6.37	7.00	7.00	7.00	6.37
Time (milliseconds)	160	170	180	190	200	210	220	230	240	250	260	270	280	290	300
SDM Lateral Axis Recorded Velocity Change (MPH)	6.37	6.37	6.37	6.37	6.37	6.37	6.37	6.37	6.37	6.37	6.37	6.37	6.37	6.37	6.37
