ON-SITE SIDE IMPACT INFLATABLE OCCUPANT PROTECTION INVESTIGATION

CASE NUMBER - IN08043
LOCATION - TEXAS
VEHICLE - 2003 HONDA ACCORD EX
CRASH DATE - September 2008

Technical Report Documentation Page

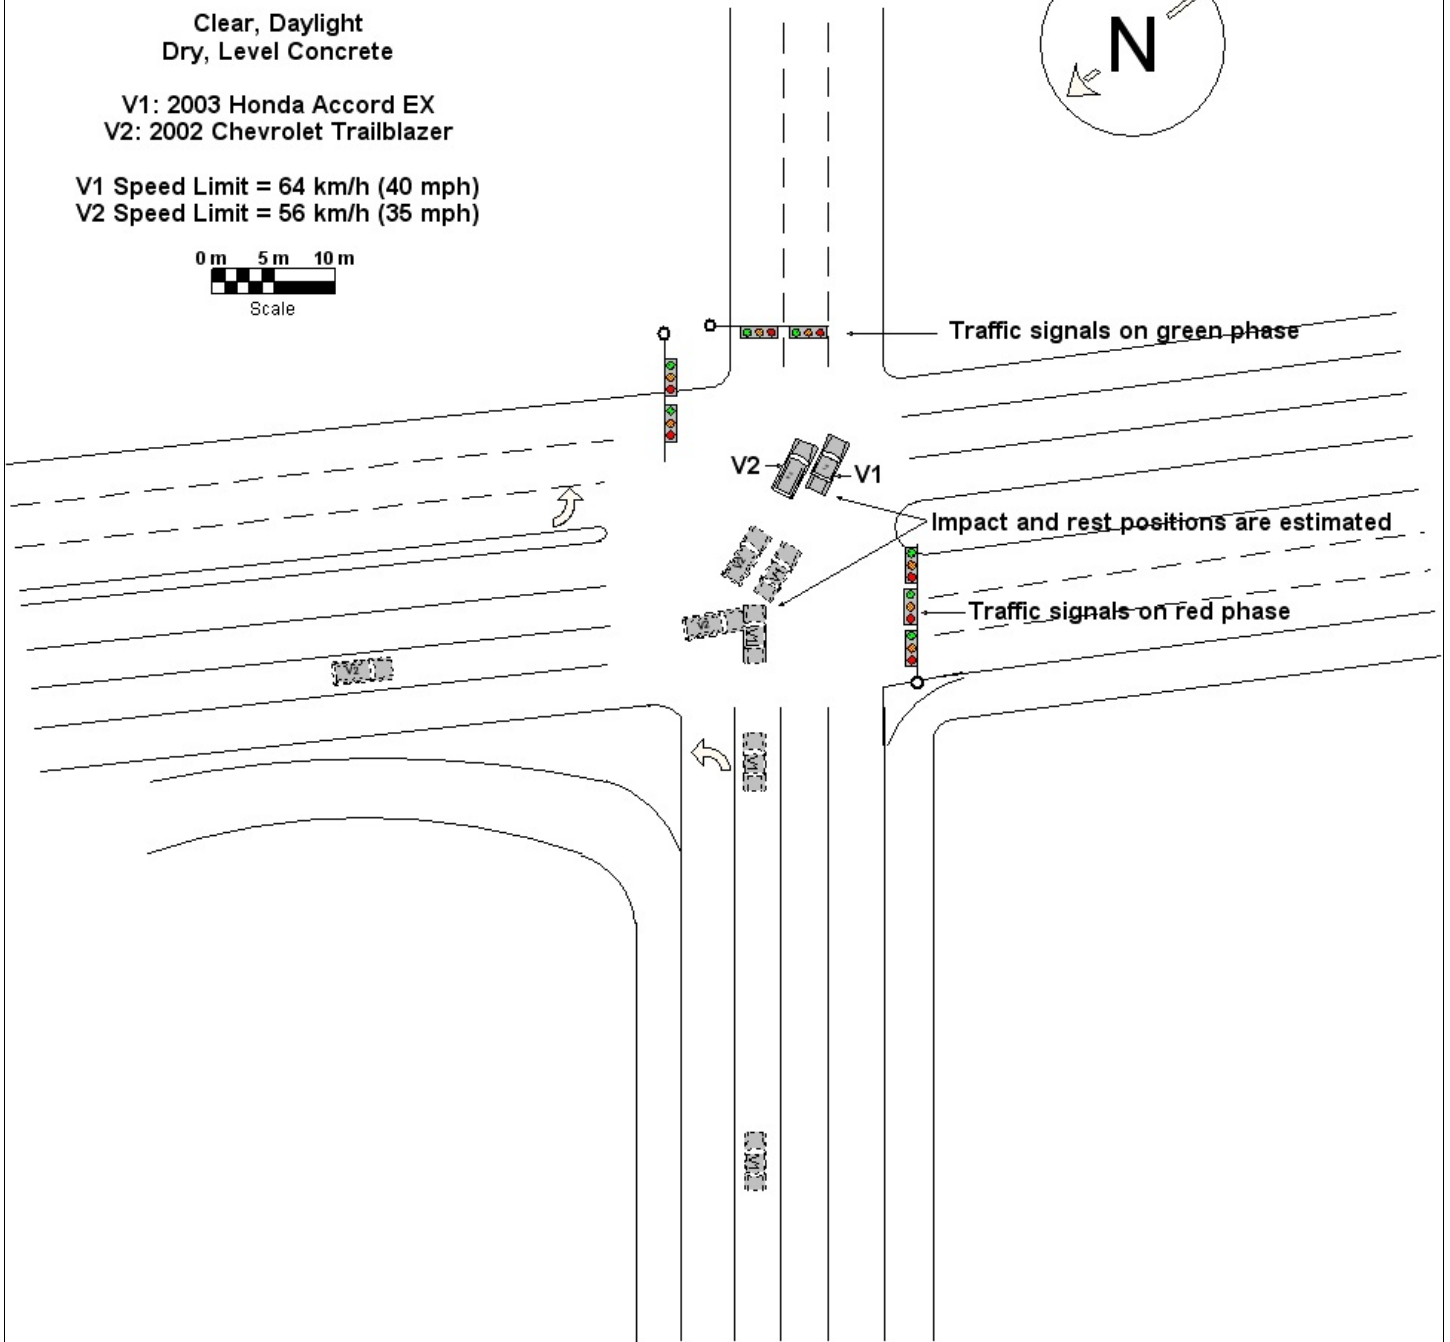
V1: 2003 Honda Accord EX
V2: 2002 Chevrolet Trailblazer

V1 Speed Limit = 64 km/h (40 mph)
V2 Speed Limit = 56 km/h (35 mph)
