ON-SITE SIDE IMPACT INFLATABLE OCCUPANT PROTECTION INVESTIGATION

CASE NUMBER - IN08049

VEHICLE - 2004 HYUNDAI TIBURON GL

CRASH DATE - November 2008

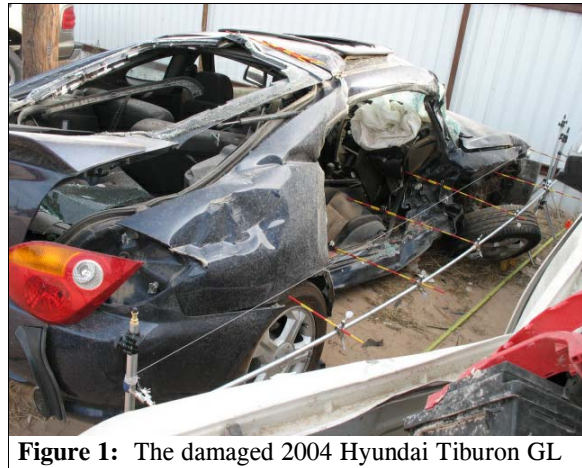
This on-site investigation focused on a 2004 Hyundai Tiburon GL (**Figure 1**), which was equipped with seat back-mounted side impact air bags that deployed as a result of the crash. The front right passenger sustained a fatal injury. The crash was brought to the National Highway Traffic Safety Administration's attention on December 9, 2008 by this contractor. This investigation was assigned on December 12, 2008. The crash involved the Hyundai, a 2008 Chevrolet Tahoe LTZ, a parked not-in-transport 1998 Ford Taurus LS, and a parked not-in-transport 1997 Ford Explorer XLT. The crash occurred in November 2008, at 0231 hours, in Texas and was investigated by the city police department. This contractor inspected the crash scene, Hyundai, and Chevrolet on December 16-17, 2008. This report is based on the police crash report, police photographs, scene and vehicle inspections, occupant kinematic principles, occupant medical records, and this contractor's evaluation of the evidence.

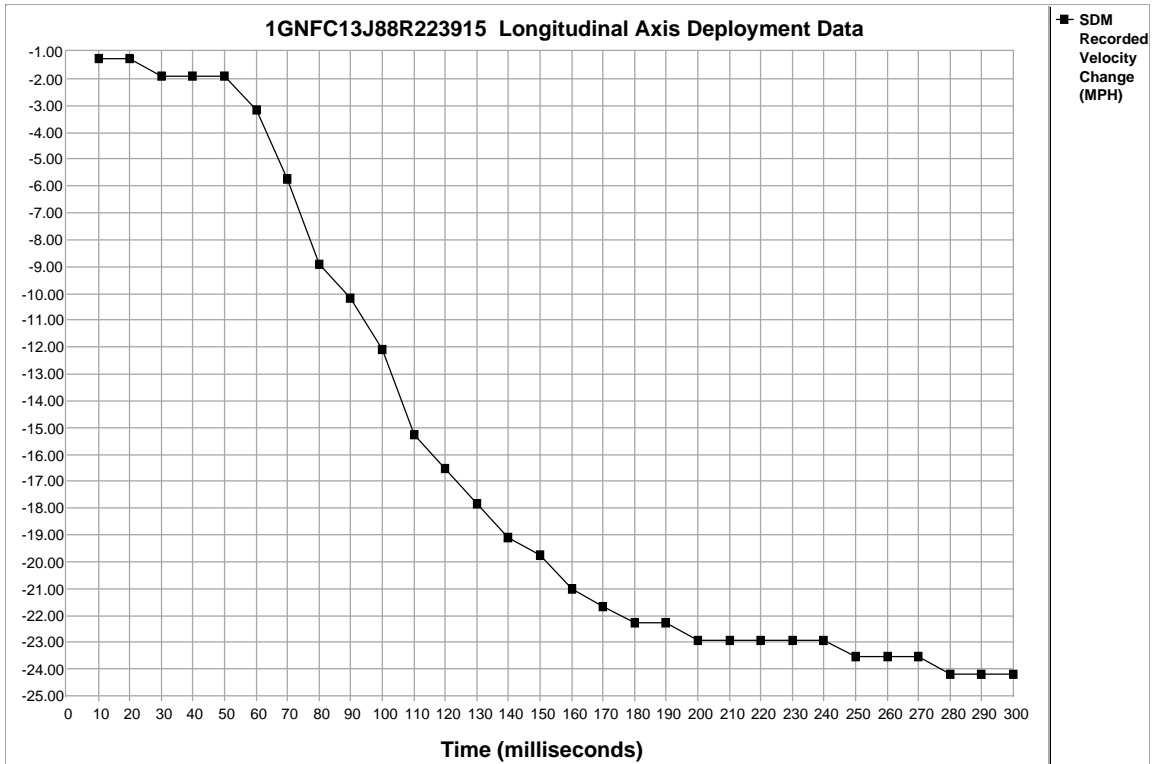
Time (milliseconds)	10	20	30	40	50	60	70	80	90	100	110	120	130	140	150
Longitudinal Axis Recorded Velocity	-1.27	-1.27	-1.91	-1.91	-1.91	-3.18	-5.73	-8.91	-10.19	-12.10	-15.28	-16.55	-17.83	-19.10	-19.74
Time (milliseconds)	160	170	180	190	200	210	220	230	240	250	260	270	280	290	300
Longitudinal Axis Recorded Velocity	-21.01	-21.65	-22.29	-22.29	-22.92	-22.92	-22.92	-22.92	-22.92	-23.56	-23.56	-23.56	-24.20	-24.20	-24.20

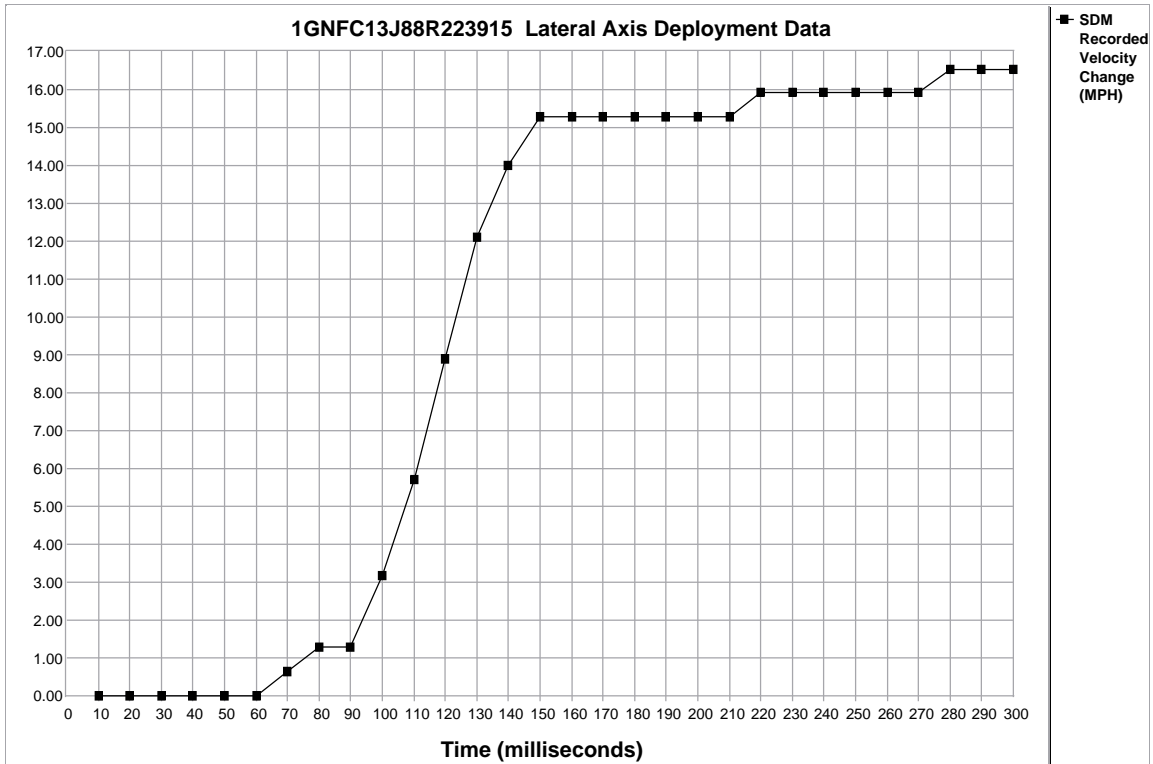
Time (milliseconds)	10	20	30	40	50	60	70	80	90	100	110	120	130	140	150
Lateral Axis Recorded Velocity Change (MPH)	0.00	0.00	0.00	0.00	0.00	0.00	0.64	1.27	1.27	3.18	5.73	8.91	12.10	14.01	15.28
Time (milliseconds)	160	170	180	190	200	210	220	230	240	250	260	270	280	290	300
Lateral Axis Recorded Velocity Change (MPH)	15.28	15.28	15.28	15.28	15.28	15.28	15.92	15.92	15.92	15.92	15.92	15.92	16.55	16.55	16.55
