CALSPAN ON-SITE CHILD RESTRAINT SYSTEM CRASH INVESTIGATION

SCI CASE NO: CA08051

VEHICLE: 2000 CHEVROLET MALIBU

CRASH DATE: OCTOBER 2008

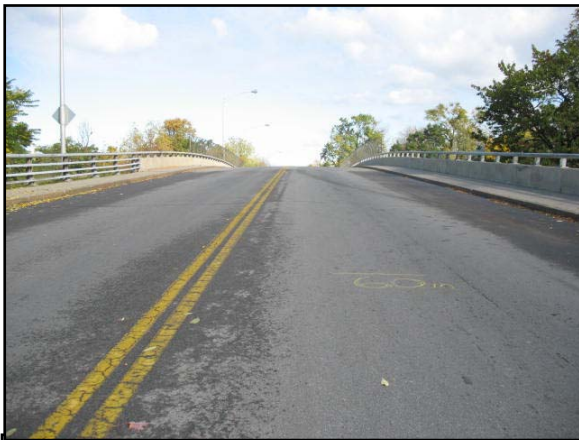
Figure 2. Northbound trajectory view 60 m (197 ft) from the point of impact.

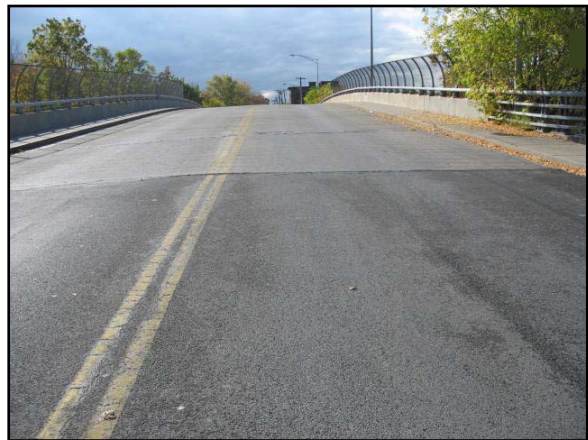
Figure 3. Southbound trajectory view 40 m (130 ft) from the point of impact.

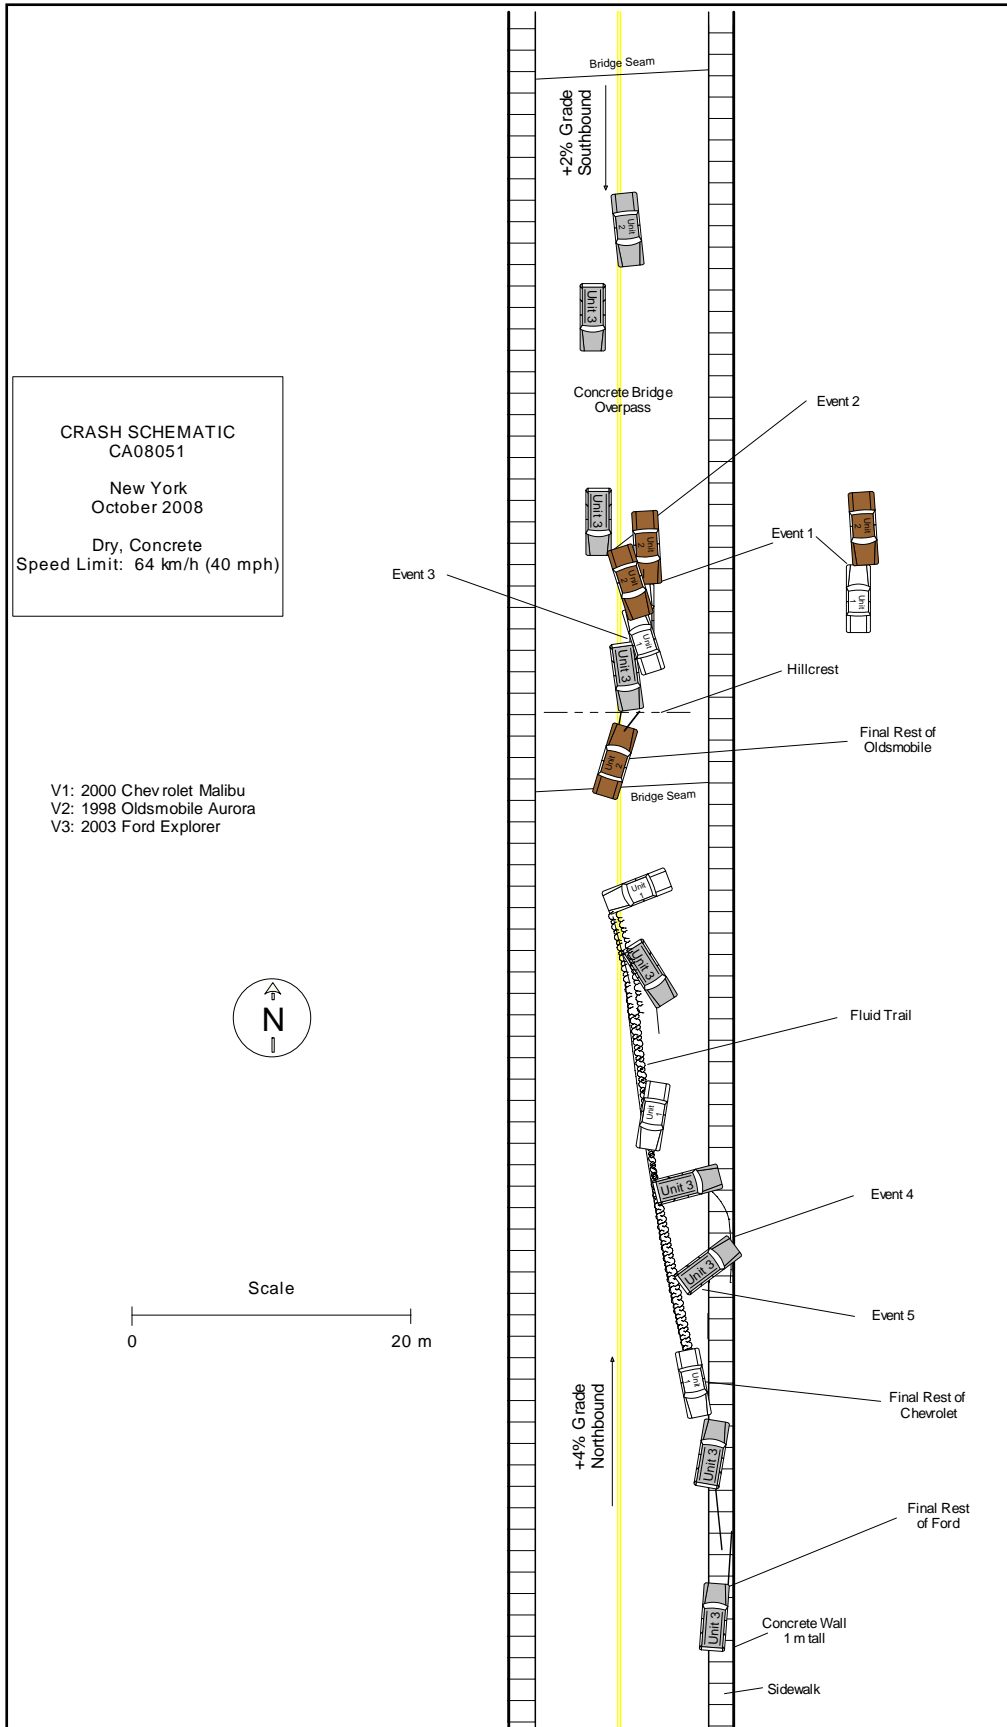
Figure 15: Scene Schematic

This three-vehicle crash occurred during the nighttime hours of October 2008. At the time of the crash, it was dark with artificial overhead street lighting. The weather was clear and the road surface was dry at the time of the crash. The crash occurred on a two-lane north/south roadway in an urban residential setting. The traffic lanes were separated by a double yellow centerline. At the crash site, the road continued over a bridge overpass that carried traffic over a series of railroad tracks. The grade of the northbound approach lanes measured positive 4 percent. The southbound approach grade measured positive 2 percent. The point of impact was located 9 meters (29.5 feet) south of the hillcrest within the northbound lane. The respective traffic lanes were bordered by 15 cm (6 in) concrete curbs and concrete sidewalks. A 1 meter (3 feet) tall concrete wall was located immediately outboard of the sidewalks. The speed limit in the area of the crash was 64 km/h (40 mph). **Figures 2 and 3** are northbound and southbound trajectory views along the roadway. The Scene Schematic is included as **Figure 15**.
