Child Restraint System Investigation
Dynamic Science, Inc. (DSI), Case Number DS09003
2002 Mitsubishi Montero
California
January 2009

14. Sponsoring Agency Code	
15. Supplemental Notes				
16. Abstract <p>This on-site investigation focused on the child restraint systems that were installed in the second row of a 2002 Mitsubishi Montero. The Mitsubishi was occupied by a 32-year-old male driver, a 27-year-old female front row right occupant, a 3-year-old female second row left occupant who was restrained in a backless booster seat, an 8-year-old second row middle occupant, and a 4-year-old male second row right occupant who was restrained in a backless booster seat. This two-vehicle crash occurred in January 2009 at 0255 hours. The Mitsubishi was traveling southbound on an interstate highway. The other vehicle was a 2004 Mazda RX8 that was being driven by a 25-year-old male. The Mazda was traveling southbound, and initiated a lane change prior to the impact. The front end of the Mazda impacted the rear end of the Mitsubishi. After the initial impact, the Mitsubishi initiated a rollover, struck a guardrail, and then impacted a utility pole. The driver of the Mitsubishi sustained mult

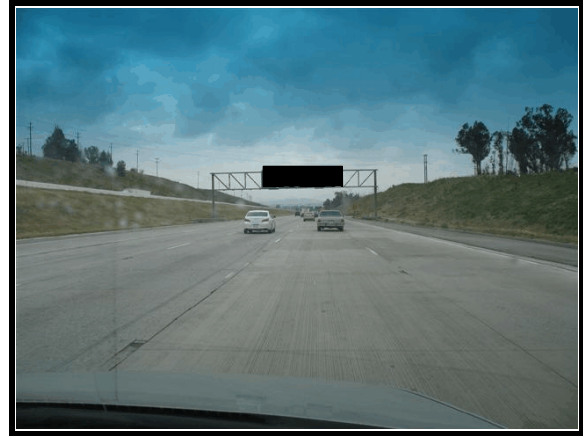
Figure 2. Southbound approach

The crash occurred on a northbound/southbound freeway in southern California. The northbound traffic was separated from the southbound traffic by a wide dirt embankment. The southbound roadway consisted of five travel lanes (Figure 2). The roadway was primarily straight, had a
