**CALSPAN ON-SITE SIDE IMPACT INFLATABLE OCCUPANT PROTECTION  
SYSTEM CRASH INVESTIGATION**

**SCI CASE NO: – CA09007**

**VEHICLE – 2005 NISSAN MAXIMA 3.5 SL**

**CRASH DATE – FEBRUARY 2009**

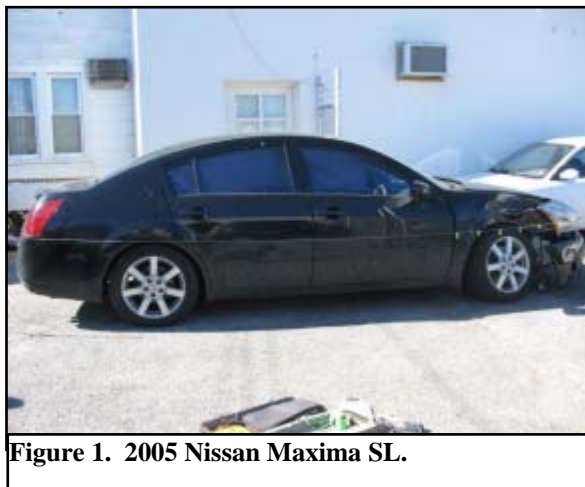
**Figure 1. 2005 Nissan Maxima SL.**

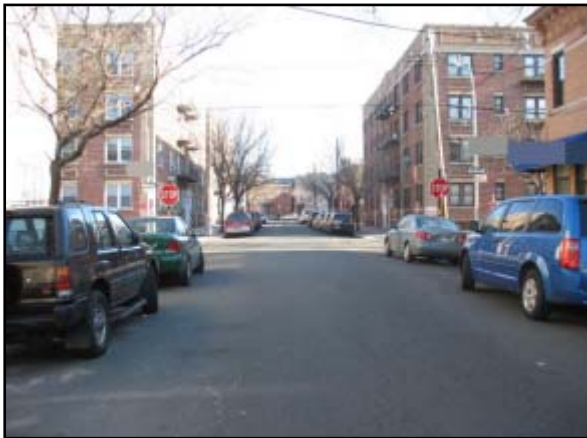
The restrained 44-year-old male driver of the Nissan was traveling north approaching the intersection where his intention was to continue northbound (**Figure 2**). The vehicle was also occupied by a restrained 33-year-old female front right passenger. The driver of the Nissan decelerated and stopped at the regulatory stop sign at the intersection.

**Figure 2. Nissan's pre-crash northbound travel path.**

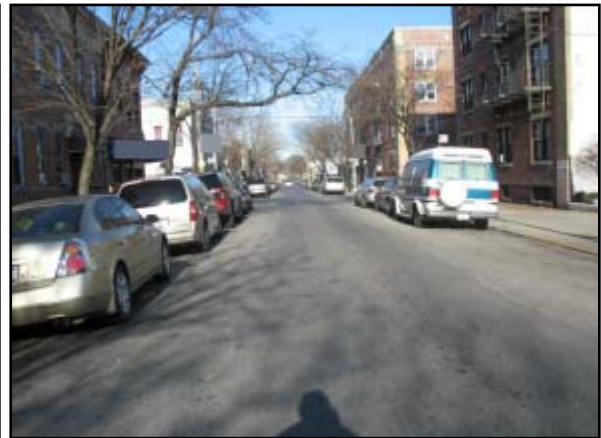
A 54-year-old male was operating the 2000 Chevrolet Astro westbound approaching the intersection (**Figure 3**). Westbound traffic was not regulated through the intersection. This driver was not required to stop at the intersection.

**Figure 3. Westbound trajectory of the Chevrolet.**

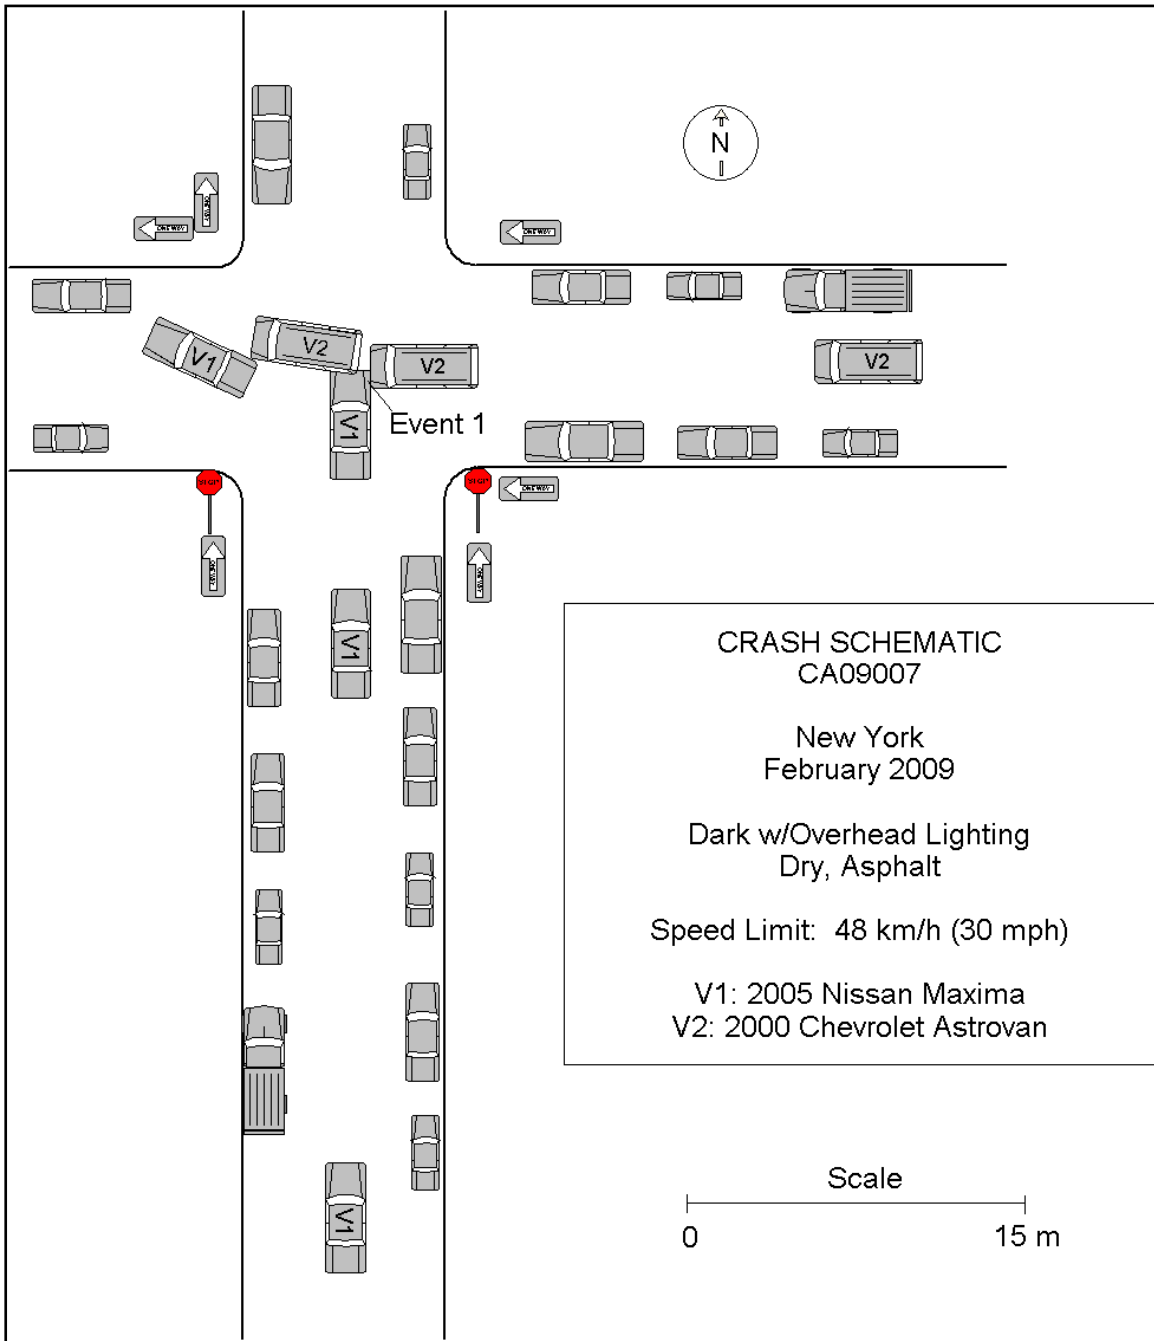
**Figure 13: Scene Schematic**

This crash occurred during the nighttime hours of February 2009, at a four-leg intersection. At the intersection, each roadway was configured for one-way traffic. The respective travel lanes were oriented in the northbound and westbound directions. Each roadway consisted of a single, level, 9.1 meter (29.8 feet) wide travel lane that was bordered by 10 cm (4”) concrete curbs. Traffic flow through the intersection was controlled by stop signs for the northbound travel lane. On-street parking was permitted against all curbs. At the time of the SCI inspection, it was noted that vehicles were parked against the curbs to approximately 5 meters (16 feet) of the intersection. The

posted speed limit for both roadways was 48 km/h (30 mph). The scene schematic is included as **Figure 13** of this report.
