**CALSPAN ON-SITE HYBRID VEHICLE CRASH INVESTIGATION
SCI CASE NO.:CA09012**

VEHICLE: 2005 TOYOTA PRIUS HATCHBACK

LOCATION: NORTH CAROLINA

CRASH DATE: JANUARY 2009

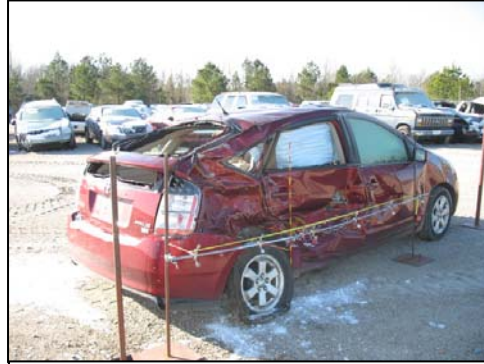
Figure 1. The 2005 Toyota Prius case vehicle

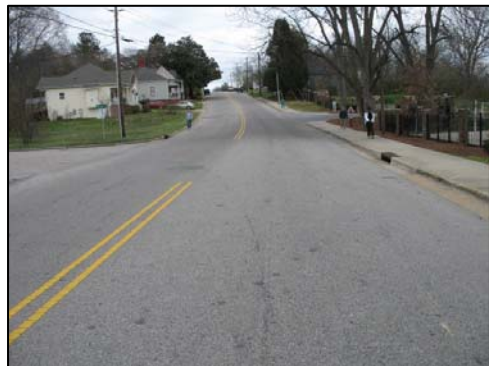
Figure 2: Prius' pre-crash trajectory

The Prius broke traction on the snow covered road and rotated approximately 95 degrees counterclockwise (CCW), crossing the center line into the path of the transit bus. The driver of the Prius applied the brakes and braced with both hands against the steering wheel when he realized the crash was imminent. The safety manager of the company operating the bus stated that the bus driver applied the brakes but did not steer left or right prior to the impact. Due to the snow on the roadway, there were no skid marks present during the scene inspection to mark the trajectory of either vehicle.

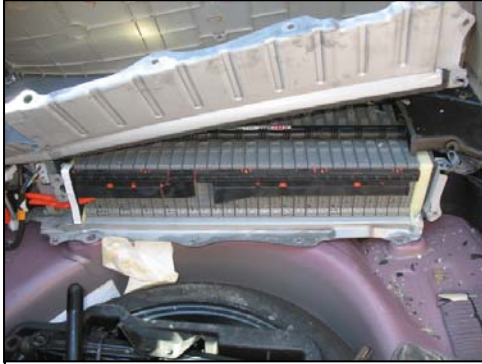
The battery compartment was vented to right side of the vehicle by a plastic duct that extended to the right side of the rear bumper fascia (**Figure 10**). The electrical connections and fuse were under a service panel on the left side of the hybrid battery. There was no damage to the cells of the hybrid battery or leakage of electrolyte. The intrusion of the C-pillar and side panel aft of the C-pillar resulted in displacement of the plastic duct of approximately 3 cm (1.2 in) to the left. There was no damage to the battery pack.

Figure 9: Hybrid battery centered over rear axle behind rear seat

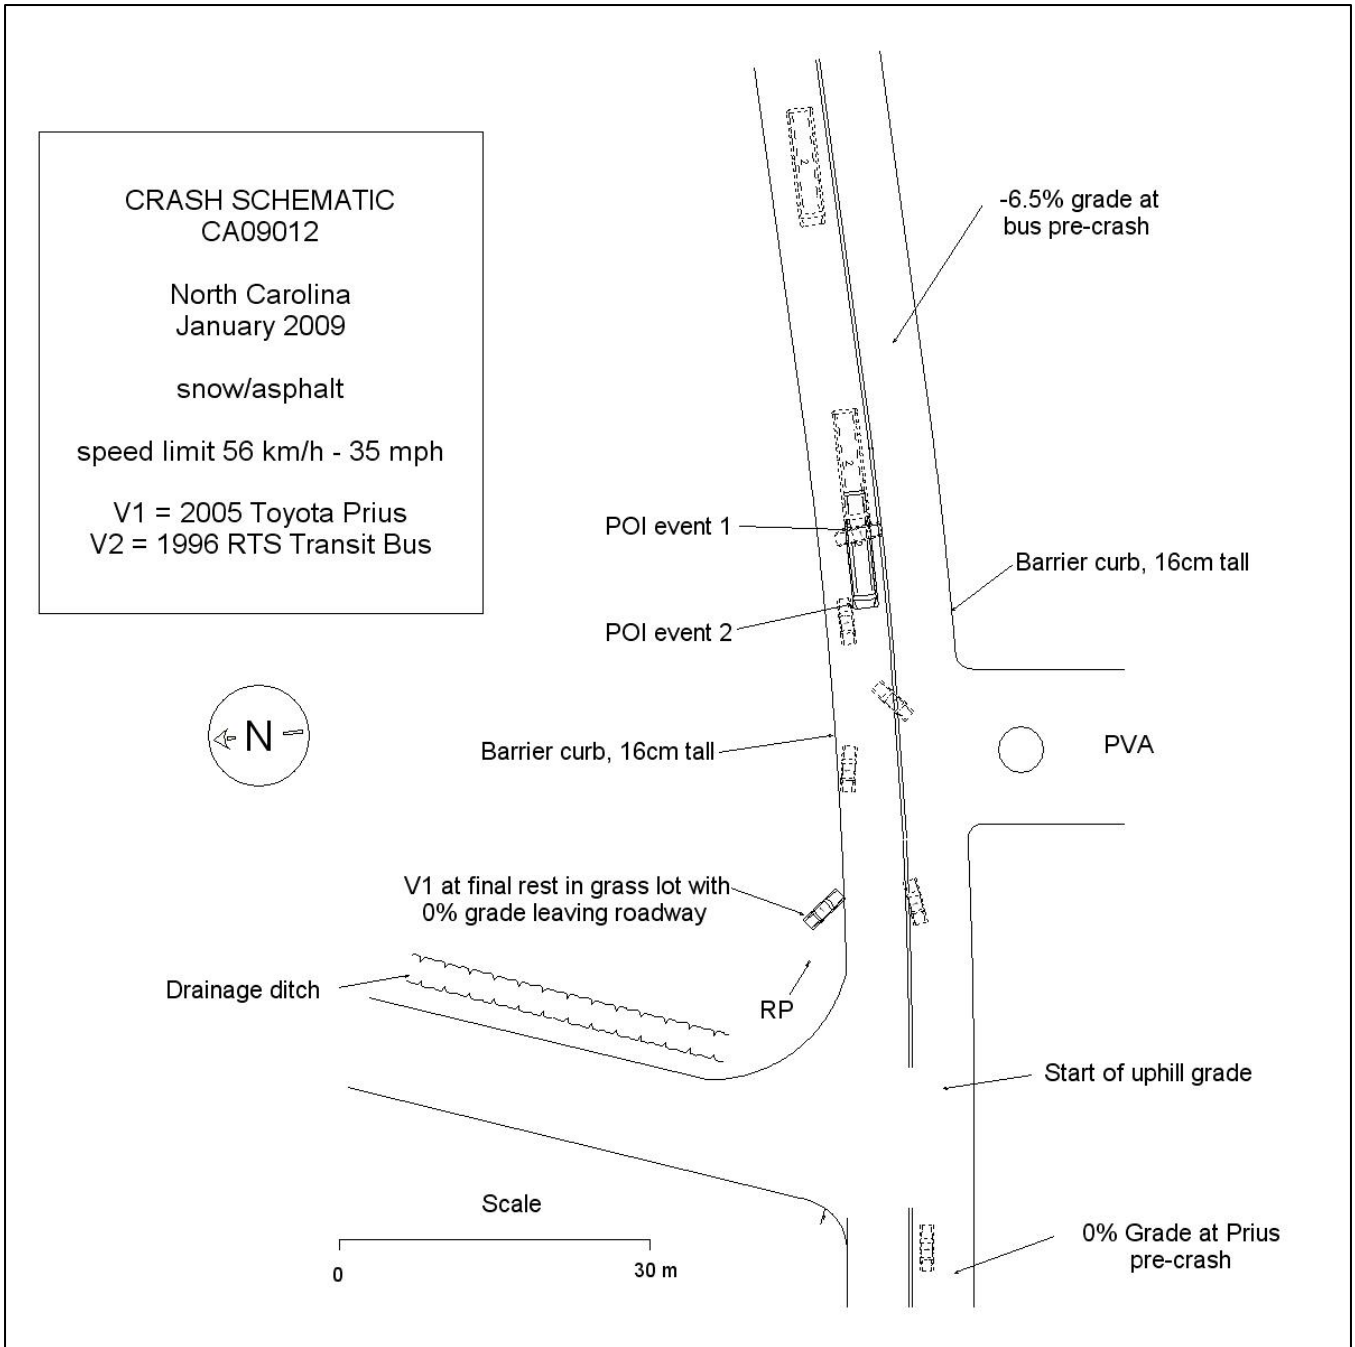
The crash occurred on a residential two-lane roadway during daylight hours. At the time of the crash, the environmental conditions were snow with cloud cover. The asphalt road surface was snow covered with two furrows formed in the snow from previous traffic. The roadway extended in an east/west direction. In the eastbound direction of travel, the roadway was straight and level and transitioned to a shallow curve to the left with a positive grade of 6.5 percent. In the westbound direction of travel, the roadway was straight with a downhill grade of -3.3 percent that transitioned to a right curve with a downhill grade of -6.5 percent. The travel lanes were bordered by barrier curbs that were 16 cm (6.3”) in height. Parallel parking was permitted at both curb lines. The north roadside was surfaced with grass and was level. The posted speed limit was 56 km/h (35 mph). The crash schematic is included as **Figure 12** of this report.

Figure 12: Scene Schematic
