On-Site Rollover Investigation
Dynamic Science, Inc. (DSI), Case Number DS09020
2009 Ford Escape XLT
Arizona
February 2009

1. Report No. DS09020		2. Government Accession No.		3. Recipient Catalog No.	
4. Title and Subtitle On-Site Rollover Investigation			5. Report Date January 22, 2010

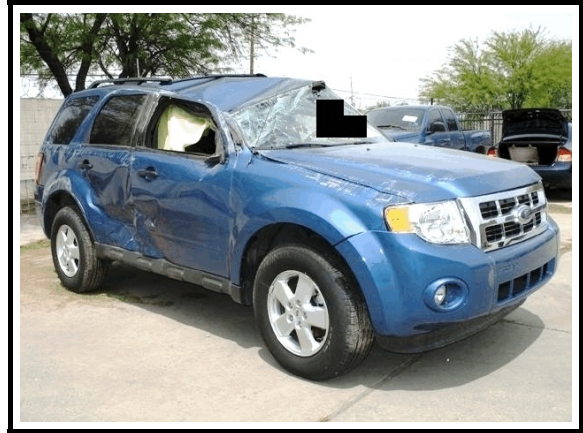
Figure 1. Subject vehicle, 2009 Ford Escape XLT

The Ford sustained direct and induced damage to the right side door panels during the vehicle-to-vehicle impact. The direct damage to the right side began 40 cm (15.7 in) forward of the rear axle, extended 95 cm (37.4 in) forward, and ended 125 cm (49.2 in) aft of the front axle. The Field L began 37 cm (14.6 in) forward of the rear axle, extended 106 cm (41.7 in) forward, and ended 117 cm (46.1 in) aft of the front axle. Six crush measurements were taken at mid-door level as follows: $C_1 = 0$ cm, $C_2 = 5$ cm (2.0 in), $C_3 = 6$ cm (2.8 in), $C_4 = 6$ cm (2.8 in), $C_5 = 3$ cm (1.2 in), $C_6 = 0$ cm. Maximum lateral crush measured 6 cm (2.8 in) and was located at C_3 (**Figure 4**). The Collision Deformation Classification (CDC) for the first impact was 02RPEW1.

The vehicle sustained direct and induced damage to the left and right sides and roof during the rollover. Direct damage to the left side began 62 cm (24.4 in) aft of the rear axle, extended forward 369 cm (145.3 in), and ended 307 cm (120.1 in) forward of the front axle. Vertically, the direct damage began at the sill, extended upward 120 cm (47.2 in), and ended at the roof side rail. The direct damage to the right side began 71 cm (28.0 in) aft of the rear axle, extended 392 cm (154.3 in) forward, and ended at the front right bumper corner. Vertically, the direct damage began 7 cm (2.8 in) above the sill, extended upward 113 cm (44.5 in), and ended at the roof side rail. Direct damage to the top began on the roof at 28 cm (11.0 in) forward of the rear axle, extended forward 295 cm (116.1 in), and ended at the leading edge of the hood. The direct damage was distributed laterally across the top from roof side rail to roof side rail, and measured 112 cm (44.1 in).

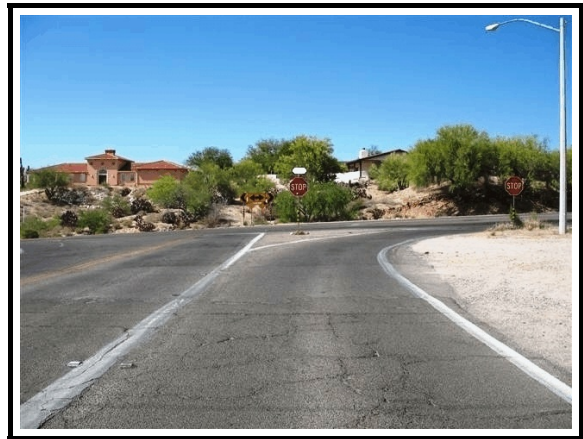
The crash site was a three-leg intersection that comprised an east/west roadway and a north/south roadway (**Figure 2**). The intersection's west leg contained one eastbound lane and one westbound lane that were separated by a painted median. The intersection's east leg contained one eastbound lane, one westbound through lane, and a westbound left turn lane. The intersection's south leg contained one southbound lane and two northbound lanes. The inboard northbound lane was a left turn only lane. The outboard northbound lane curved right and intersected the eastbound lane (**Figure 3**).

Figure 2. Crash site, other vehicle northbound approach

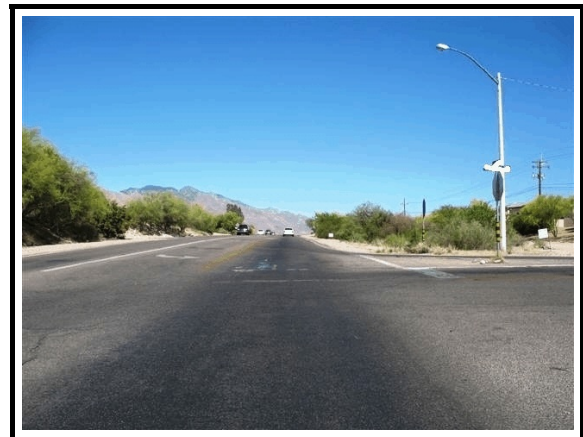
Figure 3. Crash site, subject vehicle eastbound approach
