On-Site Child Restraint System Investigation  
Dynamic Science, Inc. (DSI), Case Number DS09022  
2008 Ford Taurus X  
California  
April 2009

1. Report No. DS09022	2. Government Accession No.	3. Recipient Catalog No.	
4. Title and Subtitle  On-Site Child Restraint System Investigation		5. Report Date March 3, 2010

**Dynamic Science, Inc.**  
**Crash Investigation**  
**Case Number: DS09022**

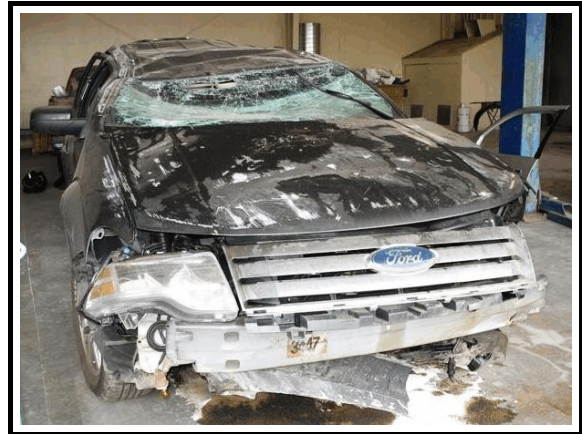
**Figure 1.** Subject vehicle, 2008 Ford Taurus X

The Ford sustained direct and induced damage to the front and back ends, the left and right sides, and the top. The left side rims were fractured due to contact with the roadway, and the left side tires were flattened and de-beaded. The left side view mirror was fractured and displaced during the rollover, and the front bumper fascia was displaced. The left side wheelbase was shortened by 3 cm (1.2 in).

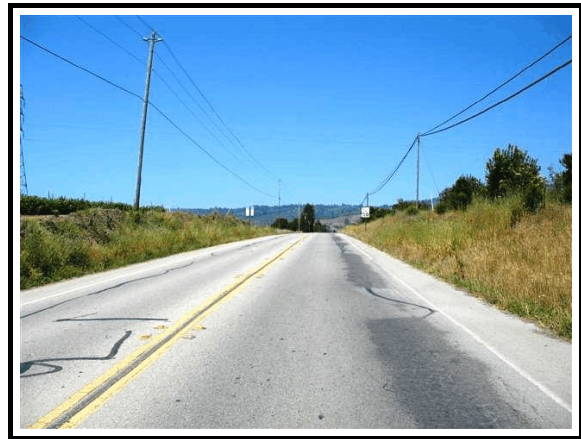
The crash site was a two-lane north/south state highway which had one lane in each direction (**Figure 2**). Outboard of the lanes were paved shoulders, followed by ascending dirt embankments. The lanes were separated by solid double-yellow stripes, and bordered by solid white fog lines. The widths of the northbound lane and shoulder measured 3.8 m and 1.2 m (12.5 ft and 4.0 ft), respectively. The paved shoulder abutted a dirt embankment that ascended at a 45-degree angle. The embankment was 3.7 m (12 ft) in width and ascended to 1.4 m (4.7 ft) above the roadway grade. The southbound lane and shoulder widths measured 3.7 m and 1.3 m (12.1 ft and 4.3 ft).

**Figure 2.** Crash site, northbound approach
