**CALSPAN ON-SITE CERTIFIED ADVANCED 208-COMPLIANT VEHICLE
CRASH INVESTIGATION**

SCI CASE NO.: CA09024

VEHICLE: 2008 HONDA CIVIC COUPE

CRASH DATE: SEPTEMBER 2008

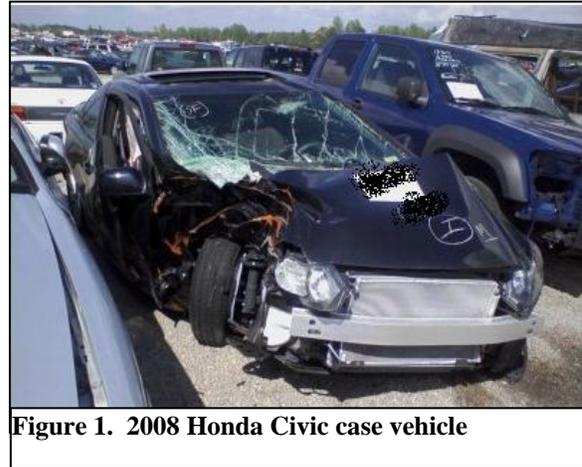
Figure 1. 2008 Honda Civic case vehicle

This on-site investigation focused on the occupant protection of the Certified Advanced 208-Compliant air bag system and the Honda Advanced Compatibility Engineering (ACE) frame structure of a 2008 Honda Civic coupe (**Figure 1**) that was involved in a run-off-road crash with a tree line. The vehicle was equipped with four-wheel anti-lock brakes, a CAC frontal air bag system, front seat back-mounted side impact air bags, and roof side rail-mounted curtain air bags. The manufacturer of the Honda certified that the vehicle is compliant to the advanced air bag portion of Federal Motor Vehicle Safety Standard (FMVSS) No. 208.
