## ON-SITE SIDE IMPACT INFLATABLE OCCUPANT PROTECTION INVESTIGATION

CASE NUMBER - IN09025

LOCATION - NEBRASKA

VEHICLE - 2004 MAZDA TRIBUTE ES

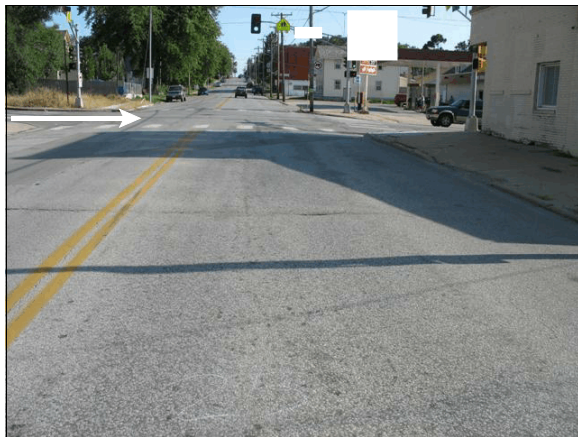
**Pre-Crash:** The Mazda's restrained 28-year-old male driver was traveling south (**Figure 2**) and intended to continue south through the intersection. The Ford's restrained 26-year-old male driver was traveling west (**Figure 3**) and intended to continue west through the intersection. The police report indicated that the Ford's driver was under the influence of alcohol and his blood alcohol

**Figure 2:** Approach of the Mazda to the intersection; arrow shows approach of the Ford

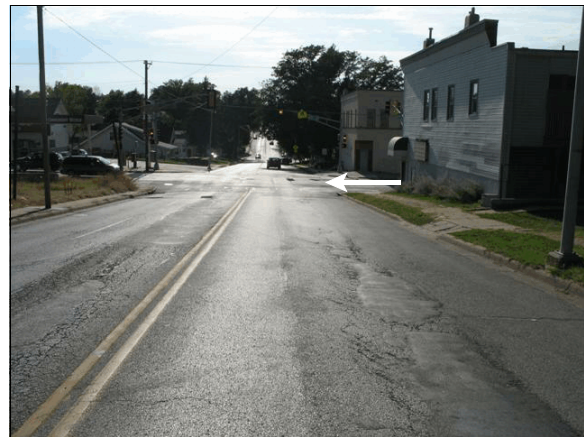
**Figure 3:** Approach of the Ford; arrow shows approach of the Mazda

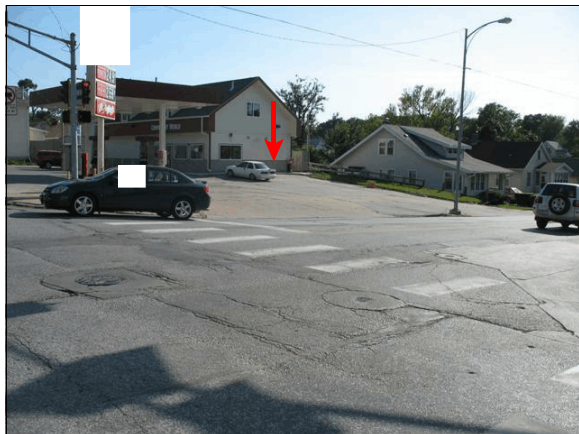
**Figure 6:** Post-impact travel of the Mazda and Ford southwest toward the convenience store lot; arrow shows location of Mazda's front impact on the north wall of the convenience store

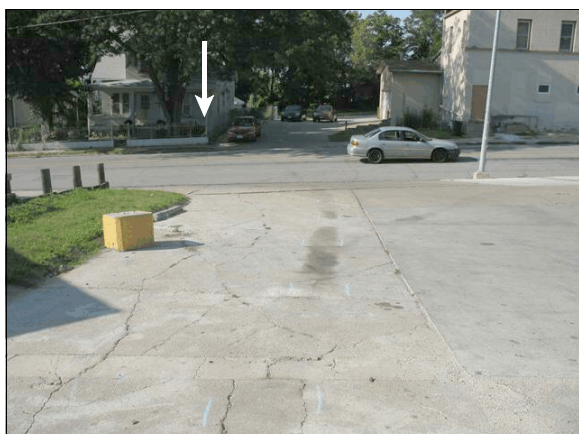
**Figure 8:** View south at Mazda's travel path from the impact location on the convenience store to impact with a metal fence (arrow)

The Mazda's impact with the fence involved the back plane and the back bumper was directly damaged. The direct damage began 51 cm (20.1 in) left of the back right bumper corner and extended 31 cm (12.2 in) across the bumper. The back bumper sustained no residual crush due to this impact. The induced damage involved the bumper fascia.
