## **ON-SITE CERTIFIED ADVANCED 208-COMPLIANT VEHICLE INVESTIGATION**

CASE NUMBER - IN09029

VEHICLE - 2005 HONDA ODYSSEY TOURING

CRASH DATE - May 2009

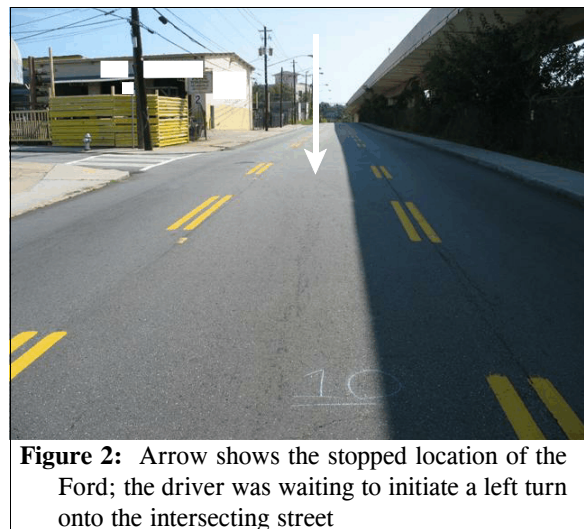
**Pre-Crash:** The Ford was occupied by a 57-year-old male driver. He was stopped heading northeast in the center lane (**Figure 2**) waiting for southwest-bound traffic to clear. He intended to initiate a left turn onto the intersecting street. Based on the SCI interview, the Honda's restrained 60-year-old male driver was traveling northeast in the right lane approaching the intersection (**Figure 3**). He initiated a left steering

**Figure 2:** Arrow shows the stopped location of the Ford; the driver was waiting to initiate a left turn onto the intersecting street

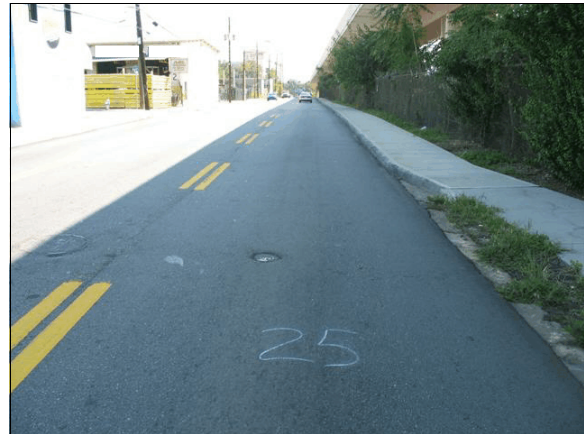
Figure 3: Approach of the Honda in the right lane

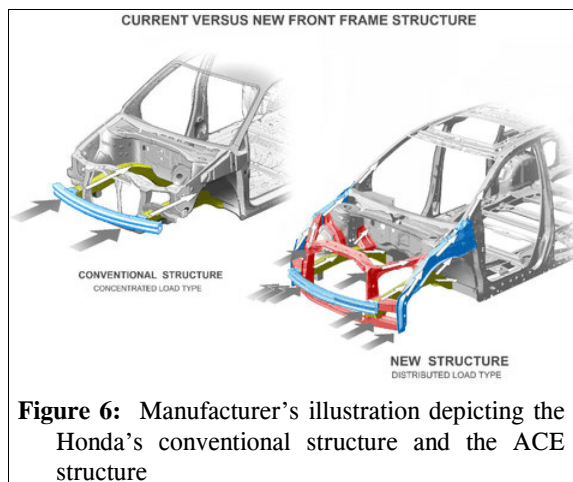
The Honda was also equipped with ACE body structure features. According to the manufacturer’s information<sup>1</sup> the ACE body structure (**Figure 6**) enhances frontal crash energy management through a network of load bearing structures in the front of the vehicle. The ACE design also helps reduce the potential for misalignment with the frame of a dissimilar sized vehicle for increased crash compatibility and enhanced occupant protection during a frontal crash. The specified wheelbase of the Honda was 300 cm (118.1 in). The mileage at the time of the crash was 54,026 miles (86,947 kilometers ), which was obtained from a salvage yard document since the vehicle was equipped with an electronic odometer and was without power.

**Figure 6:** Manufacturer’s illustration depicting the Honda’s conventional structure and the ACE structure

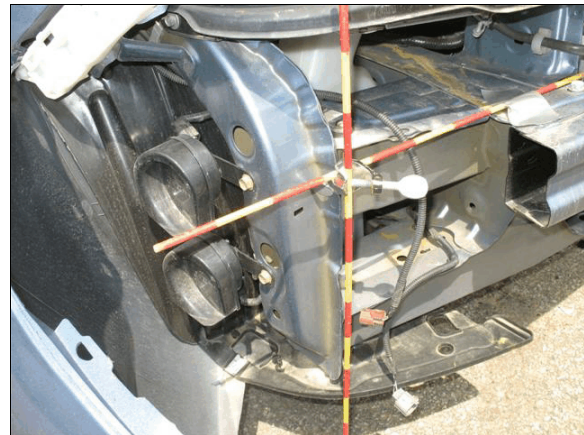
**Figure 9:** View of undamaged ACE components on front right

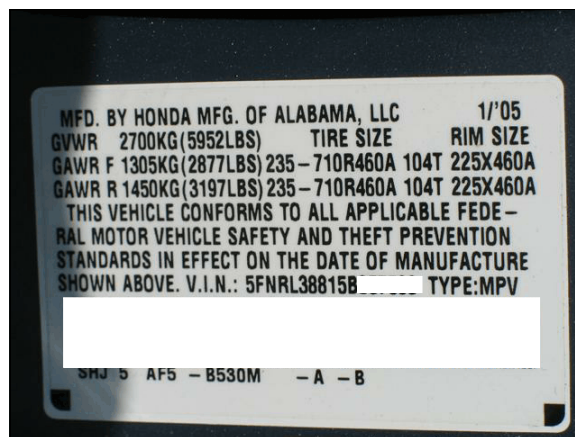
The manufacturer’s recommended tire size was 235-710R460 (**Figure 12**) and the vehicle was equipped with tires of this size. The Honda’s tire data are shown in the table below.

**Figure 12:** The Honda’s tire placard

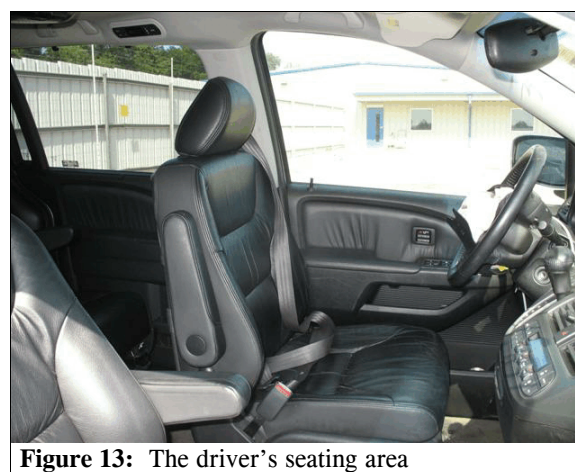
**Vehicle Interior:** Inspection of the interior of the Honda (**Figure 13**) revealed a possible occupant contact scuff on the driver’s frontal air bag. There was no other discernable evidence of occupant contact. The steering wheel rim was not deformed and there was no movement of the energy absorbing steering column.

**Figure 13:** The driver’s seating area
