ON-SITE SIDE IMPACT INFLATABLE OCCUPANT PROTECTION INVESTIGATION

CASE NUMBER - IN09034

VEHICLE - 2007 CHRYSLER SEBRING LX

CRASH DATE - September 2009

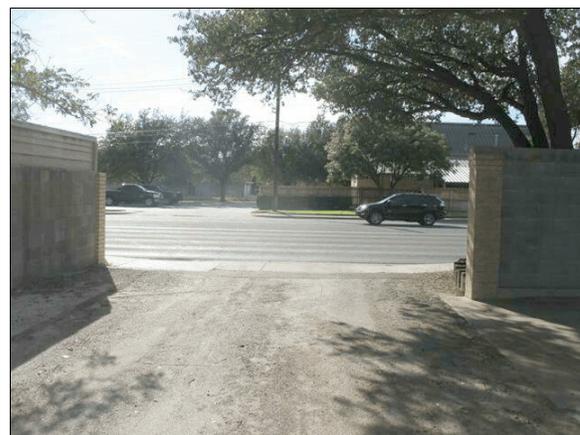
Pre-Crash: The Chrysler was occupied by a restrained 45-year-old female driver. She was stopped in the alley at the intersection heading southwest (**Figure 2**) and initiated a left turn to proceed southeast on the city street. The 20-year-old male driver of the Ford was traveling northwest in the third lane from the right (**Figure**

Figure 2: Approach of the Chrysler in the alley

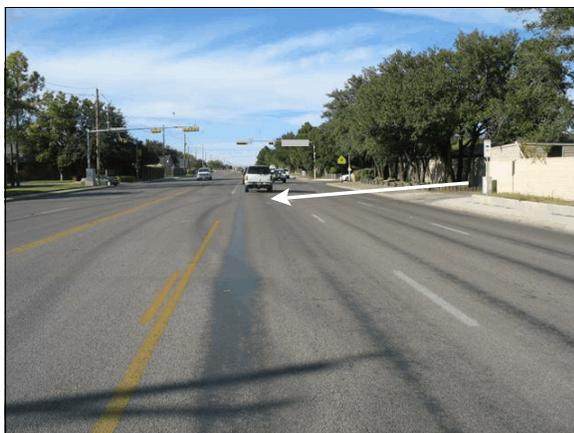
3), and intended to continue straight ahead. The Chrysler's Event Data Recorder (EDR) pre-crash data indicated that the driver applied the brakes. The driver of the Ford applied hard braking in an attempt to avoid the crash. The crash occurred in the third lane from the right on the northwestbound roadway (Figure 3).

Figure 3: Approach of the Ford; arrow shows the approach of the Chrysler from the alley

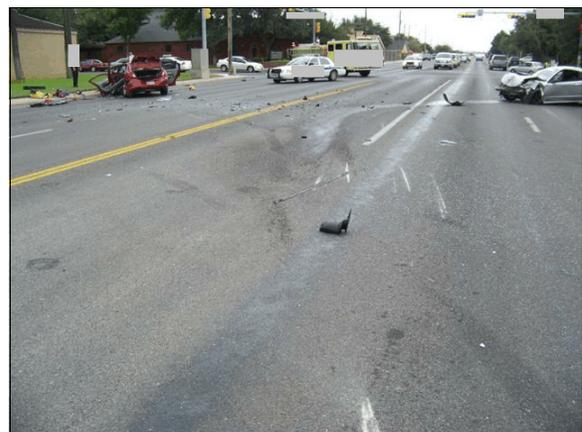
Crash: The left side plane of the Chrysler (Figure 4) was impacted by the front plane of the Ford (Figure 5). The direction of force on the Chrysler was within the 10 o'clock sector and the impact force was sufficient to trigger the deployment of the left IC air bag and the driver's seat-mounted side impact air bag. The impact also triggered the deployment of the driver's and front passenger's frontal air bags. The Chrysler was redirected to the northwest and rotated counterclockwise approximately 295 degrees as it traversed a distance of 24 m (78.7 ft) to its final rest position on the outside southeastbound lane heading west (Figure 6). The Ford was also redirected to the northwest. The vehicle rotated approximately 120 degrees as it traveled along a curved path and separated from the Chrysler. It continued backward in a northeast direction down the negative 3.3% cross grade of the roadway and came to final rest in the center northwestbound lane heading southwest (Figure 6). The Ford traversed a distance of 35 m (114.8 ft) from the impact to the final rest position.

Figure 6: Police on-scene photo showing the final rest positions of the Chrysler and Ford
