**CALSPAN ON-SITE SIDE IMPACT INFLATABLE
OCCUPANT PROTECTION SYSTEM CRASH INVESTIGATION**

SCI CASE NO: CA09036

VEHICLE: 2009 NISSAN VERSA

CRASH DATE: APRIL, 2009

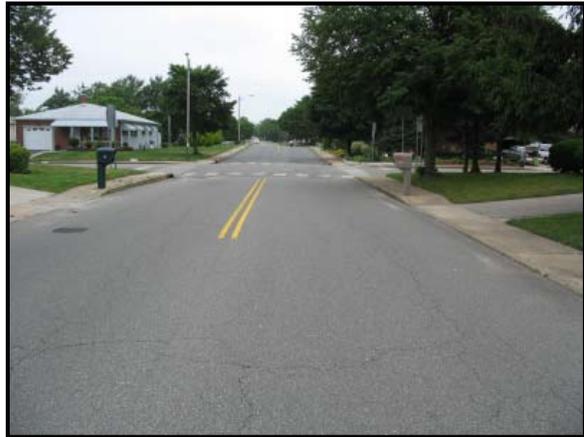
Figure 2: South view of the intersection.

Figure 2 is a south view toward the intersection, the trajectory of the Nissan. A schematic of the crash is included at the end of this report as **Figure 11**.

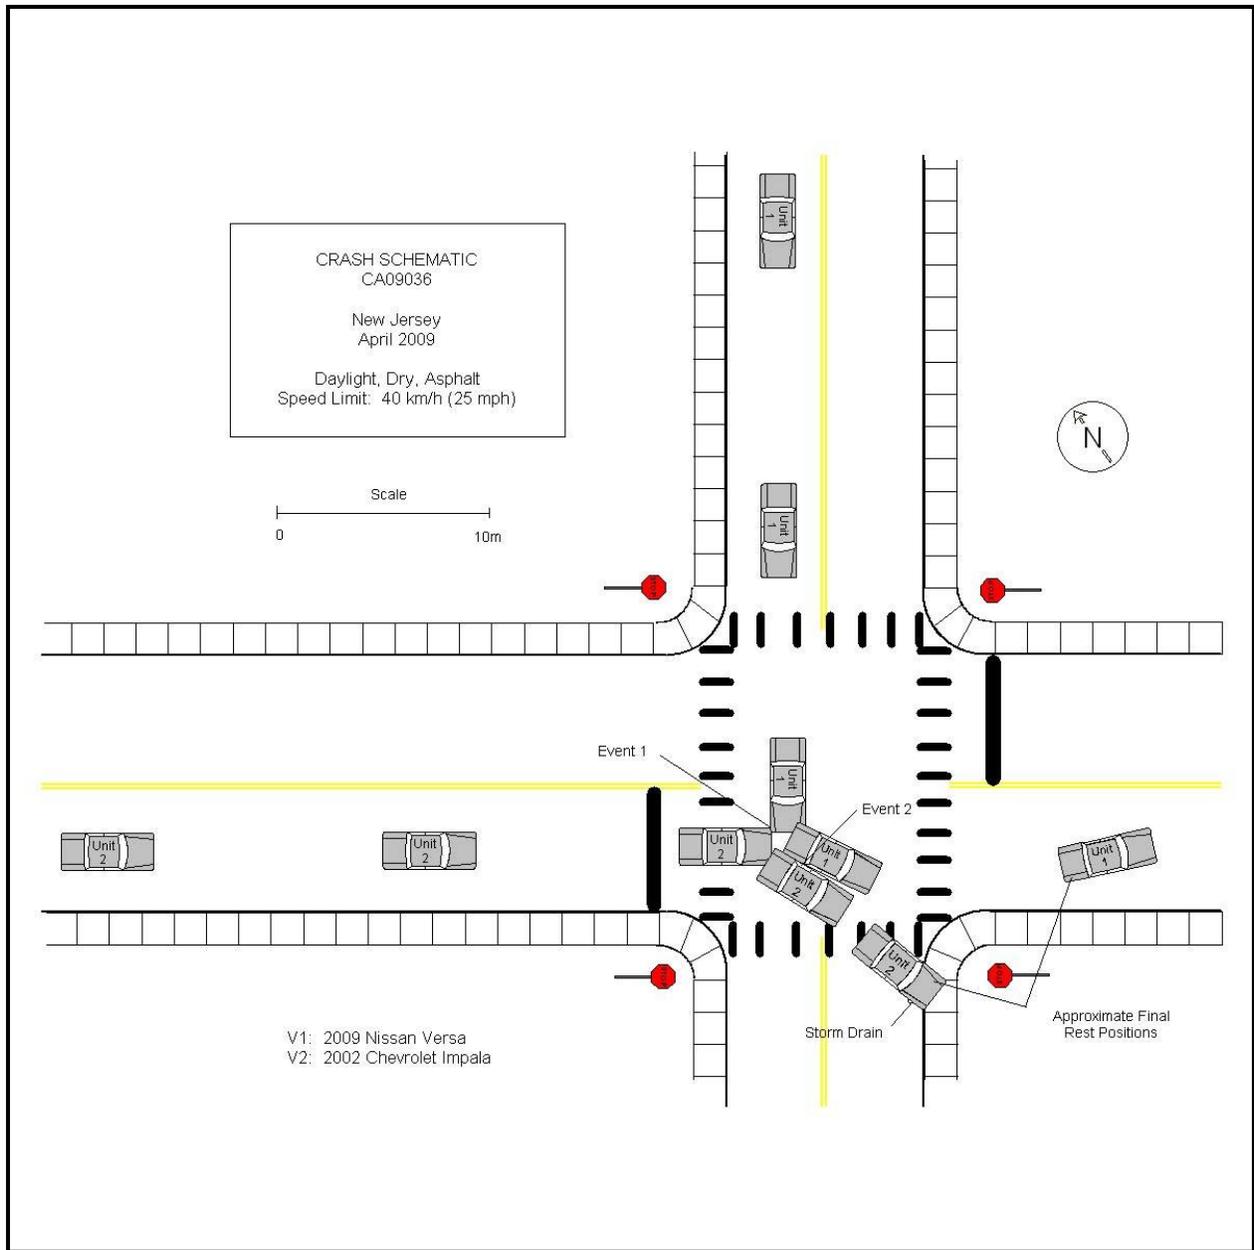
The crash occurred when the center and left aspects of the Chevrolet's front plane impacted the forward aspect of the Nissan's right plane (Event 1). The directions of the impact force were in the 2 o'clock sector for the Nissan and 11 o'clock sector for the Chevrolet. This impact resulted in the actuation of the safety belt pretensioners in the Nissan and the deployment of the vehicle's frontal air bags and right IC air bag. The frontal air bags in the Chevrolet did not deploy. The Damage Algorithm of the WinSMASH program was used to calculate the severity (delta V) of the crash. The total delta V of the Nissan was 28 km/h (17.3 mph). The longitudinal and lateral delta V components were -14 km/h (-8.7 mph) and -24 km/h (-14.9 mph), respectively. The Chevrolet's total delta V was 25 km/h (15.5 mph) with longitudinal and lateral components of -22 km/h (-13.7 mph) and 12 km/h (7.5 mph).

The force of the impact forward of the Nissan's center of gravity caused the vehicle to rotate counterclockwise approximately 45 degrees. The Chevrolet rotated clockwise 45 degrees. The right quarterpanel of the Nissan struck the left plane of the Chevrolet in a secondary side slap (Event 2). The vehicles then separated and slid to final rest. The Nissan came to rest on the west leg of the intersection, facing west, approximately 16 m (52 ft) from the initial impact. The Chevrolet came to rest facing southwest on the south leg of the intersection at the west curb line. The Chevrolet's final rest location was approximately 10 m (33 ft) from the initial impact point.

Figure 11: Crash schematic.
