**CALSPAN ON-SITE SIDE IMPACT INFLATABLE OCCUPANT
PROTECTION SYSTEM CRASH INVESTIGATION**
SCI CASE NO.: CA09041

VEHICLE: 2007 KIA RIO

LOCATION: NORTH CAROLINA

CRASH DATE: MAY 2009

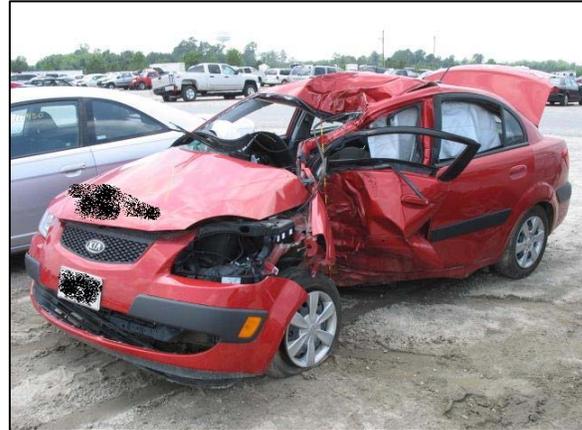
Figure 1: Left oblique view of the 2007 Kia Rio.

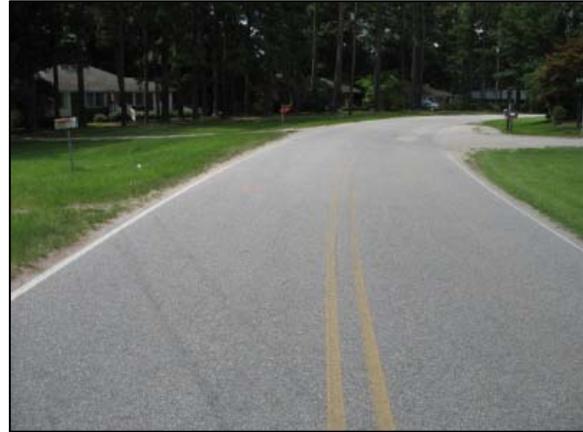
This crash occurred during daylight hours on a two-lane north/south rural roadway (**Figure 2**). The police reported weather conditions were clear and dry. At the area of the crash, there was a moderate radius right curve. The traffic lanes were 3 m (9.8 ft) in width and were surfaced with asphalt. A double-yellow centerline separated the traffic lanes. The shoulders were residential yards surfaced with grass. The west roadside contained a shallow ditch that was 40 cm (15.7 in) in depth which began at the road edge and extended 7 m (23 ft) west. The posted speed limit was 72 km/h (45 mph). In the pre-crash area, the roadway had a positive grade of 1.6 percent. The grade transitioned to a level in the area in where the Kia departed the left roadside and then to a negative 1.6 percent grade as the vehicle neared the point of impact. The struck utility pole measured 30 cm (11.8 in) in diameter and was located 5.4 m (17.7 ft) west of the west fog line. Per a local homeowner, the impacted pole was new and had been replaced approximately two weeks prior to the crash as part of a maintenance project. Crash Schematics are included as **Figures 11 and 12** of this report.

Figure 2: Trajectory view at the crash site.

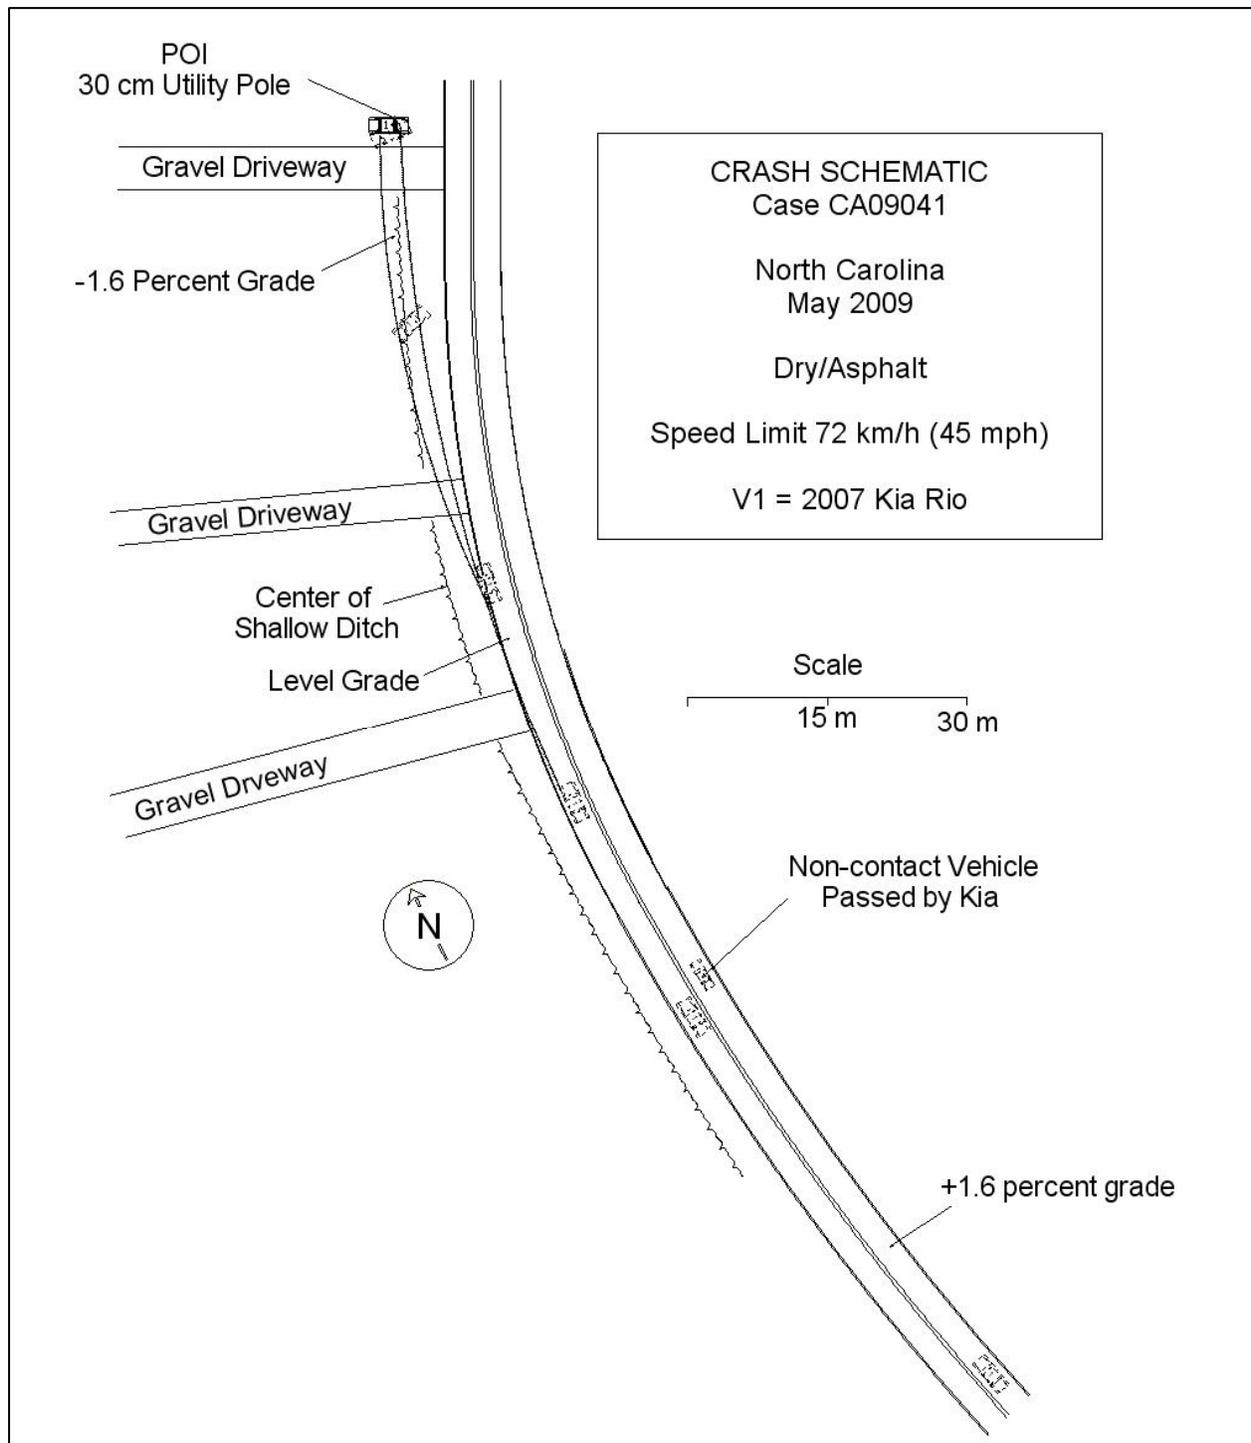
Figure 11: Crash Schematic

The left A-pillar area of the Kia impacted the utility pole. The impact did not fracture the pole. The barrier algorithm of the WINSMASH program was used to calculate a total delta-V of 49 km/h (30.5 mph). The lateral and longitudinal delta-V components were -9 km/h (-5.5 mph) and 48 km/h (29.8 mph), respectively. The Kia remained engaged with the pole and rotated approximately 15 degrees clockwise around the pole before coming to final rest facing east on the west roadside.
