**CALSPAN ON-SITE SIDE IMPACT INFLATABLE OCCUPANT PROTECTION  
SYSTEM CRASH INVESTIGATION  
SCI CASE NO: CA09053**

**VEHICLE 1: 2007 HONDA CIVIC  
LOCATION: NEW YORK  
CRASH DATE: JULY 2009**

1. <i>Report No.</i> CA09053	2. <i>Government Accession No.</i>	3. <i>Recipient's Catalog No.</i>	
4. <i>Title and Subtitle</i> Calspan On-Site Side Impact Inflatable Occupant Protection System Investigation Vehicle: 2007 Honda Civic Location: New York		5. <i>Report Date:</i> September 2010

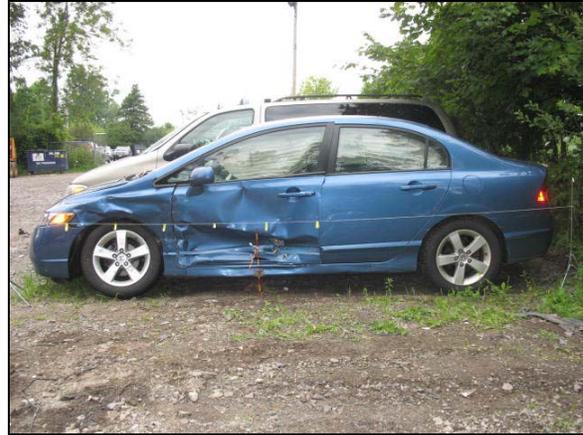
This investigation focused on the side impact inflatable occupant protection system in a 2007 Honda Civic 4-door sedan (**Figure 1**). The Honda was equipped with side impact Inflatable Curtain (IC) air bags, front row seat-mounted side impact air bags, Certified Advanced 208-Compliant (CAC) frontal air bags and front row safety belt pretensioners. The crash occurred when the front plane of the Toyota impacted the left plane of the Honda, as the Honda was in the process of turning left at a 4-leg intersection. The direction of force was in the 11 o'clock sector for the Honda. During the crash sequence the driver's seat-mounted air bag and the left IC air bag deployed in the Honda. This crash took place within the intersection of two undivided multilane roadways, located in a suburban/business environment. The Honda was driven by a 61-year-old restrained male. The driver had police reported possible injuries and was transported to a local hospital by ground ambulance.

**Figure 1: Left side view of the Honda Civic.**

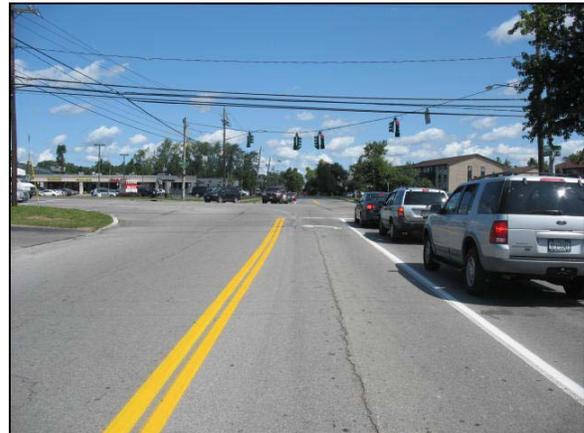
**Figure 2: Pre-crash northbound trajectory of Honda.**

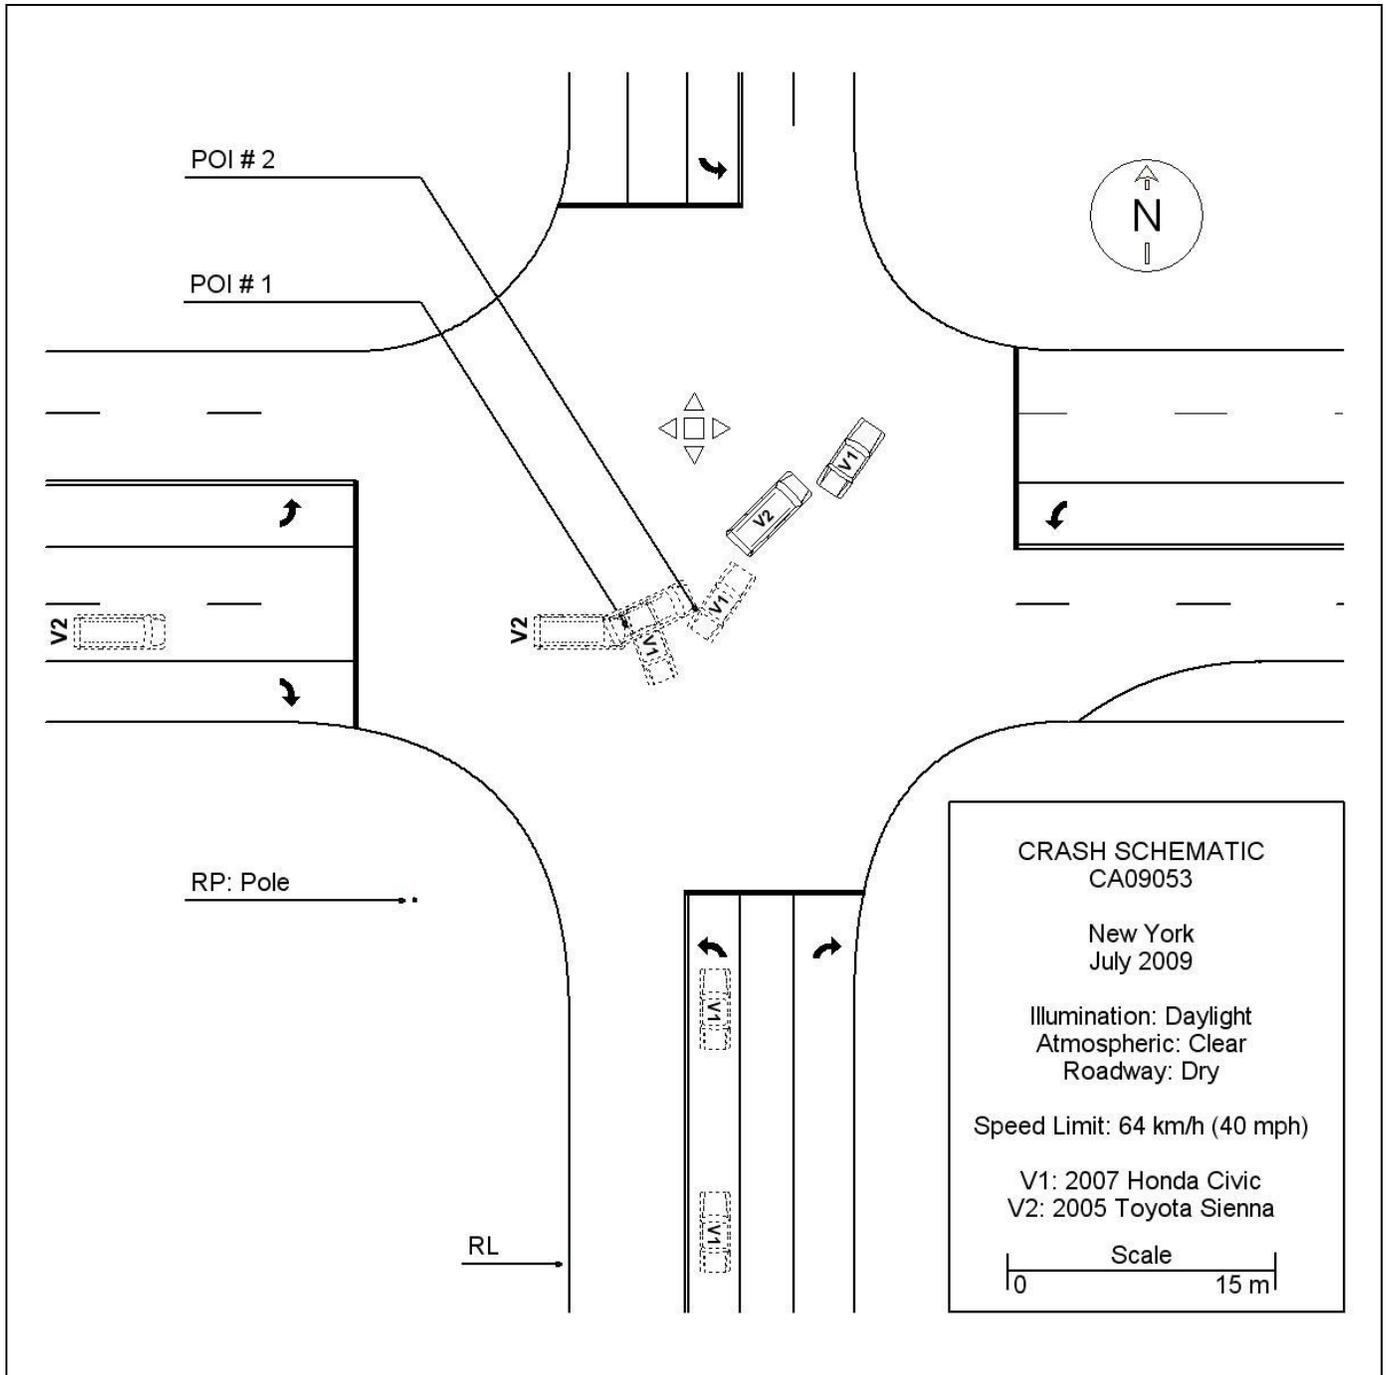
Figure 11: Crash Schematic.

The pre-crash roadway environments for both respective vehicles included a dedicated left turn lane but contained no shoulders that were boarded by a raised concrete curb. The posted speed limit was 64 km/h (40 mph) for all roadways. The east edge of the west curb was used as the reference line (RL) and a wooden utility pole, located 8.6 m (28.2 ft) west of the RL was used as the reference point (RP) during the SCI inspection. **Figure 2** is a northbound view of the intersection which depicts the pre-crash trajectory of the Honda. A schematic of the crash is included at the end of this report as **Figure 11**.
