CALSPAN ON-SITE CHILD RESTRAINT SYSTEM CRASH INVESTIGATION

SCI CASE NO: CA09054

VEHICLE: 2002 GMC ENVOY

CRASH DATE: AUGUST 2009

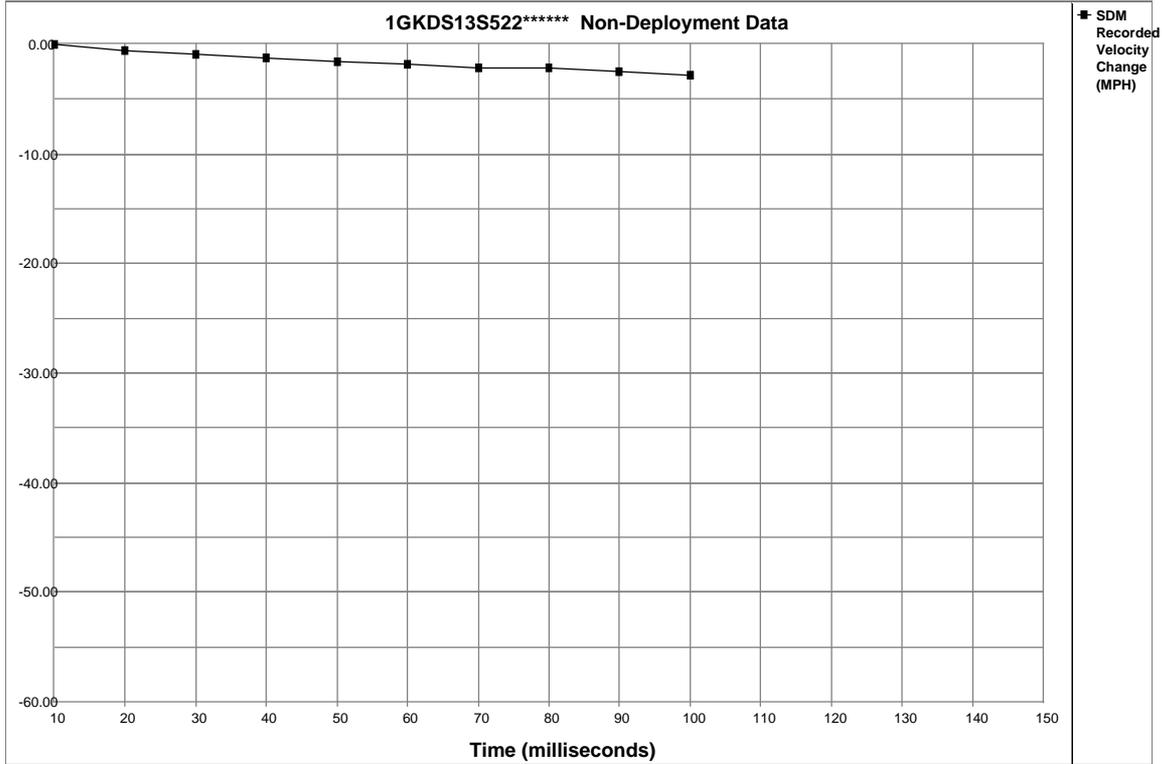
| Time (milliseconds) | 10 | 20 | 30 | 40 | 50 | 60 | 70 | 80 | 90 | 100 | 110 | 120 | 130 | 140 | 150 |
| Recorded Velocity Change (MPH) | 0.00 | -0.62 | -0.93 | -1.24 | -1.55 | -1.86 | -2.17 | -2.17 | -2.48 | -2.79 | N/A | N/A | N/A | N/A | N/A |
