CALSPAN ON-SITE CHILD RESTRAINT SYSTEM CRASH INVESTIGATION

SCI CASE NO.: CA09058

VEHICLE: 2007 NISSAN VERSA

CRASH DATE: MAY 2009

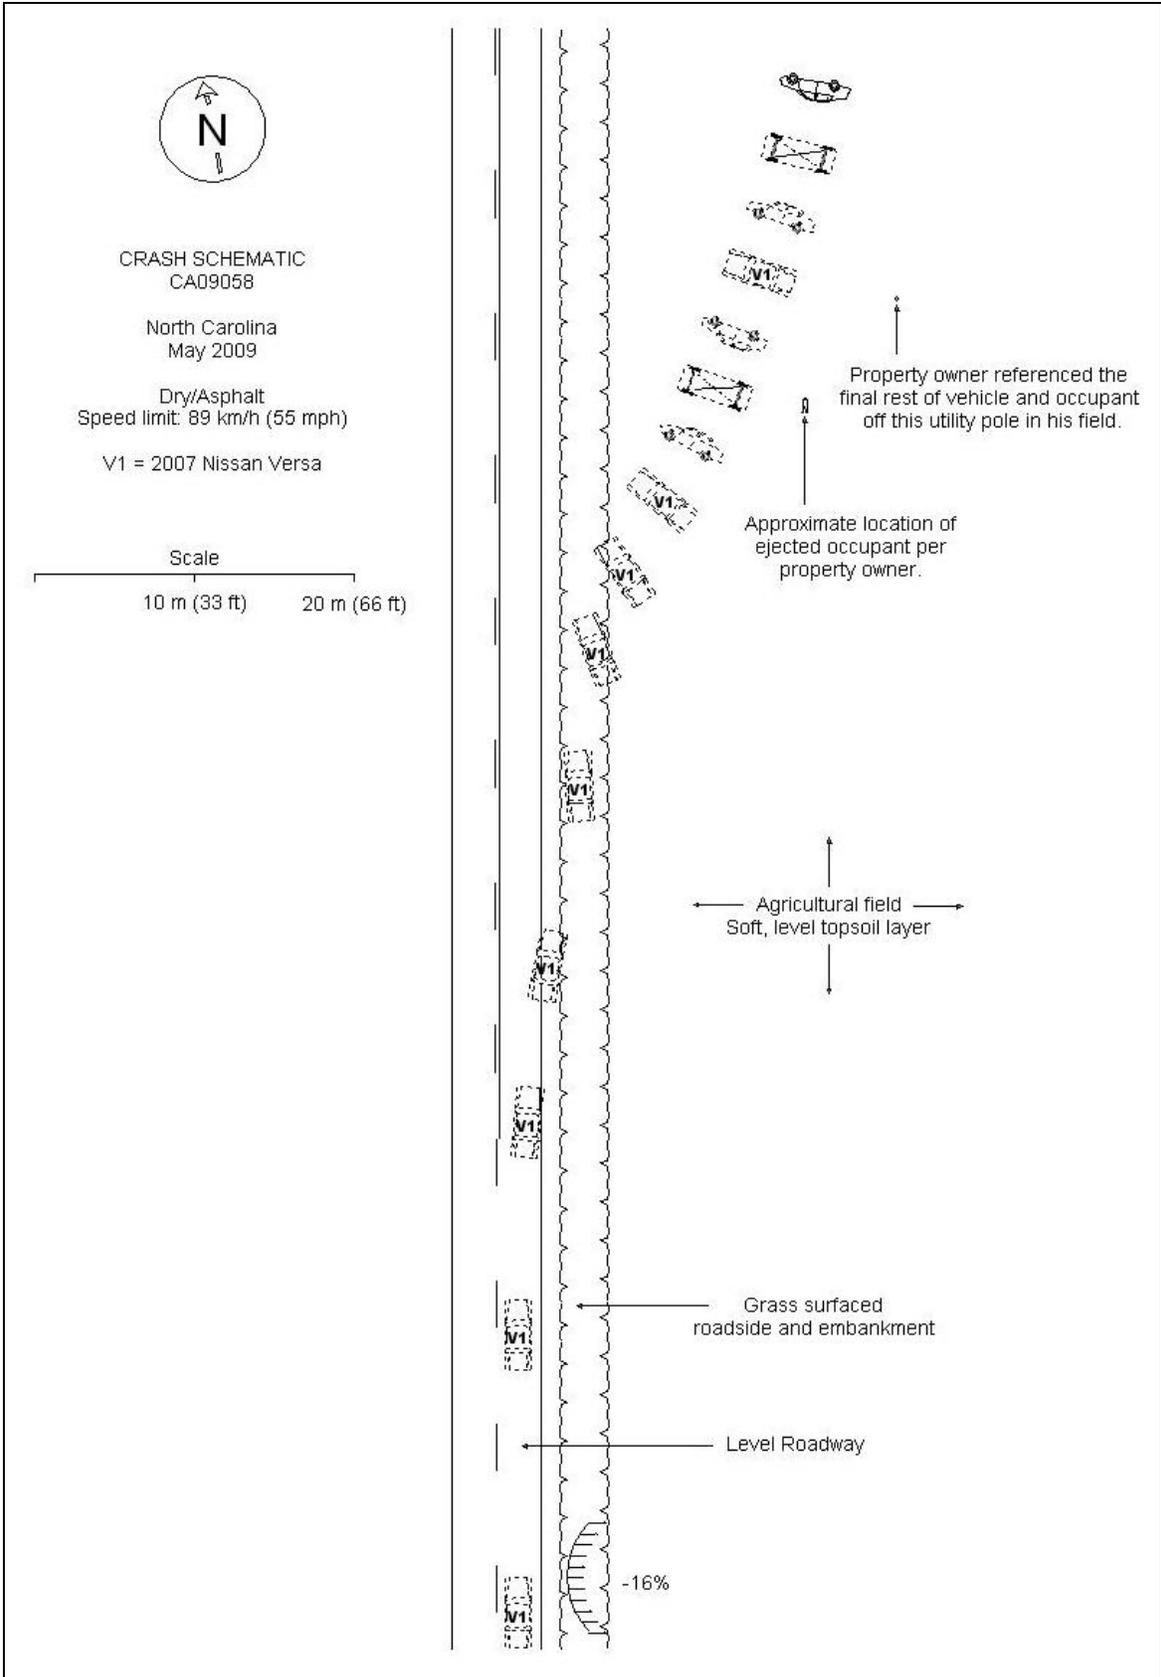
Figure 14: Scene Schematic

The right side tires of the Nissan furrowed into the soft soil and tripped the vehicle into a right side leading rollover. The vehicle rolled over a distance of approximately 34 m (112 ft) based on the description of the property owner. The Nissan completed a minimum number of seven-quarter turns based on the vehicle damage and the distance traveled. The rollover event was not interrupted. During the rollover sequence, the second row left passenger was fully ejected through the disintegrated backlight while secured in her CRS. The Nissan came to rest on its left side facing in a northerly direction in the field below the east roadside.
