Remote SCI/NASS Combination Side Air Bag Investigation
Dynamic Science, Inc. (DSI), Case Number 2010-74-127J
2010 Mazda 3
Nebraska
July 2010

1. Report No. 2010-74-127J	2. Government Accession No.		3. Recipient Catalog No.	
4. Title and Subtitle Remote SCI/NASS Combination Side Air Bag Investigation			5. Report Date January 3, 2011

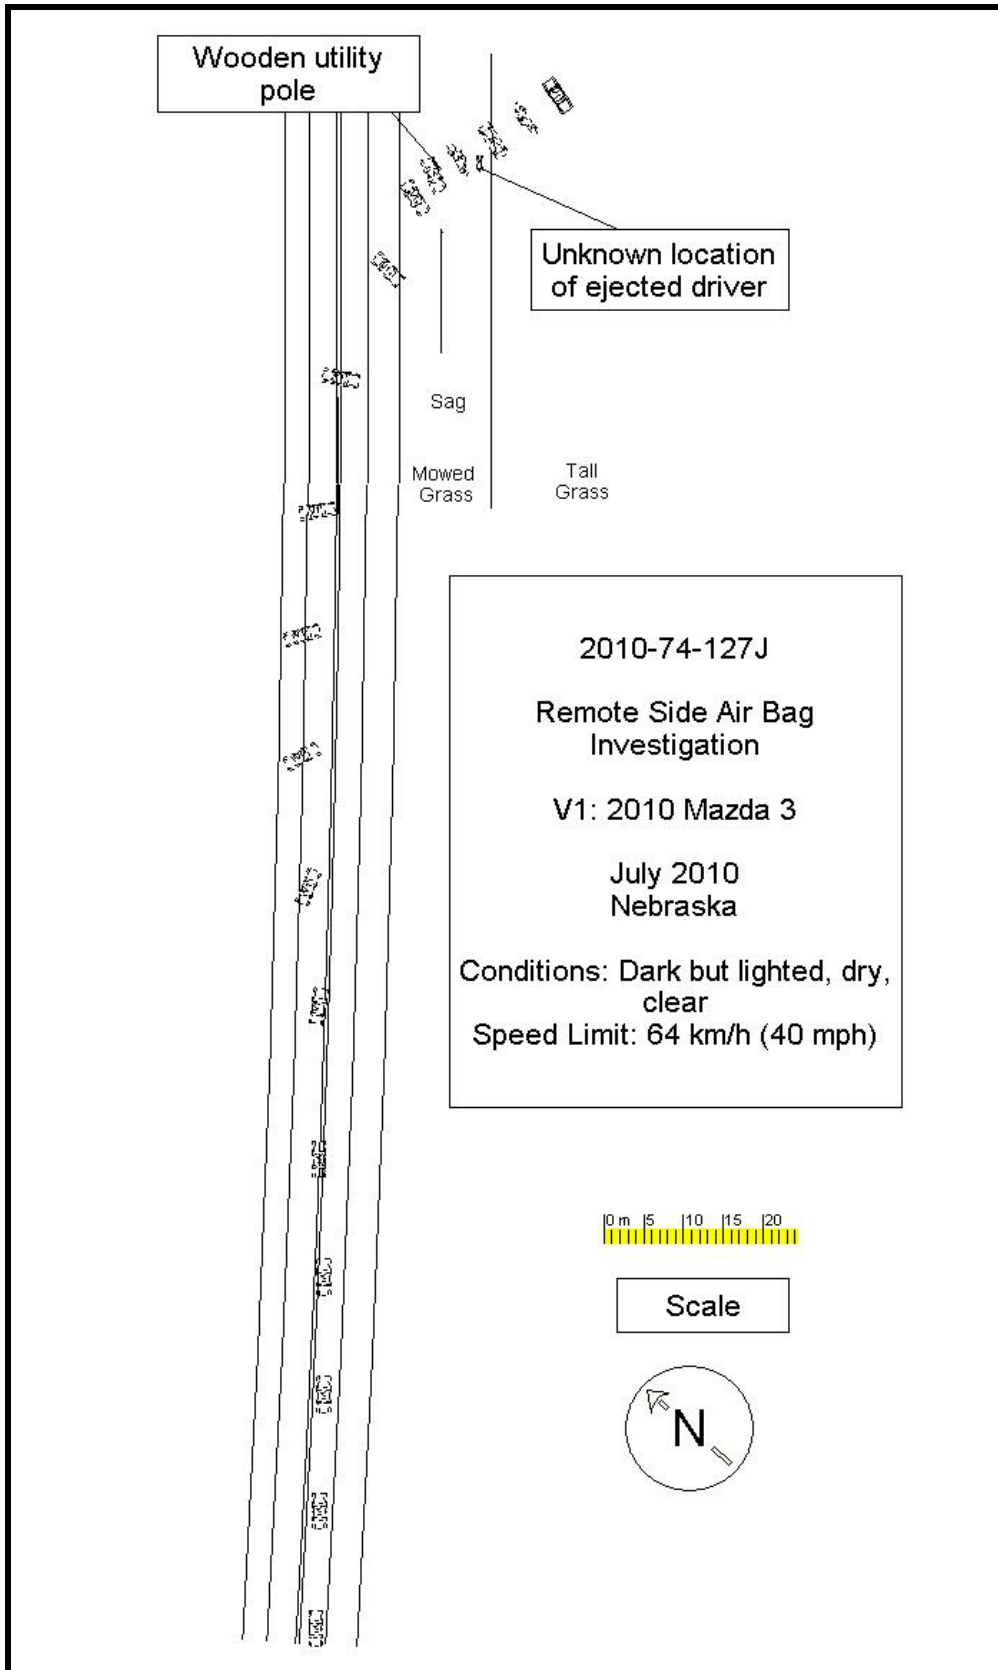
Attachment 1. Scene Diagram

The crash site was the eastbound lane of a rural roadway (**Figure 2**). The roadway was configured with single east and westbound lanes that were separated by double solid yellow centerlines. The travel lanes were bordered by white fog lines and asphalt shoulders. The asphalt roadway was straight, level, and dry. The area beyond the shoulders was grass-covered, partially mowed, and contained areas of standing water. It was dark at the time of the crash and the street lights were illuminated. According to the nearest reporting station, the temperature was 25° C (77° F), the humidity was 69 percent, and the wind was from the south at 18.5 km/h (11.5 mph). The posted speed limit was 64 km/h (40 mph). A crash scene diagram is included at the end of this report as Attachment 1.
