ON-SITE ROLLOVER INVESTIGATION

CASE NUMBER - IN10002

VEHICLE - 2008 HUMMER H3

CRASH DATE - December 2009

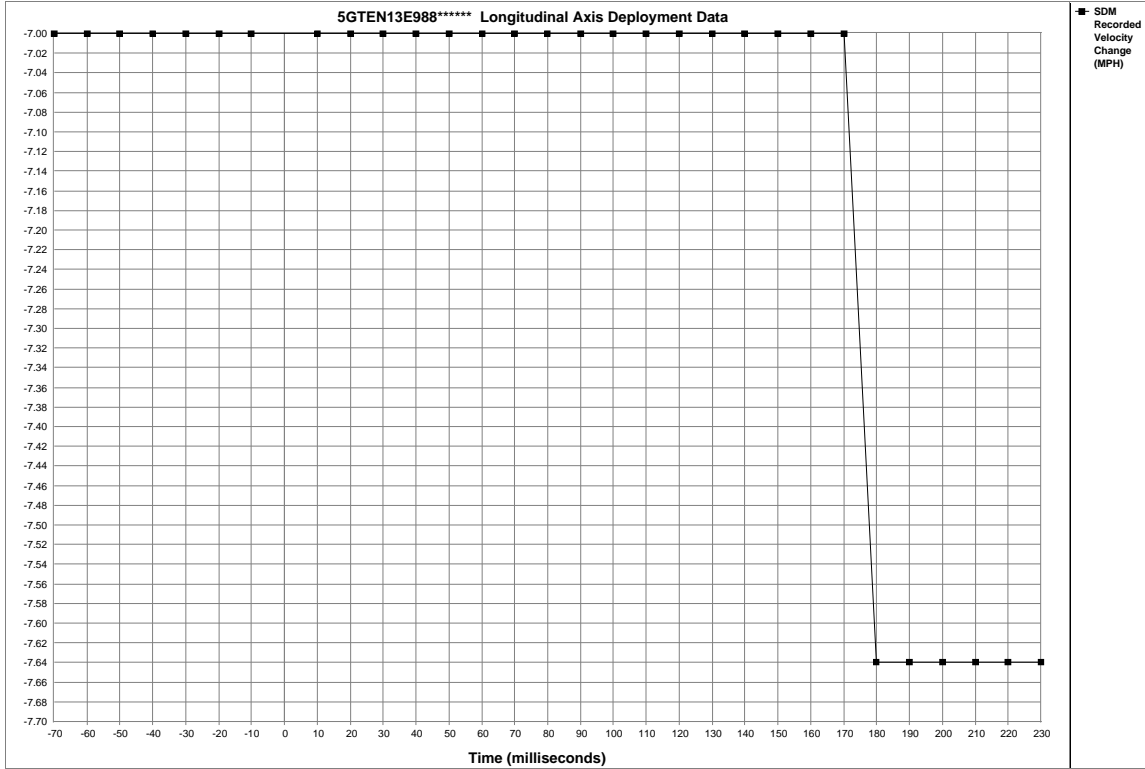
Time (milliseconds)	-70	-60	-50	-40	-30	-20	-10	10	20	30	40	50	60	70	80
SDM Longitudinal Axis Recorded Velocity Change (MPH)	-7.00	-7.00	-7.00	-7.00	-7.00	-7.00	-7.00	-7.00	-7.00	-7.00	-7.00	-7.00	-7.00	-7.00	-7.00
Time (milliseconds)	90	100	110	120	130	140	150	160	170	180	190	200	210	220	230
SDM Longitudinal Axis Recorded Velocity Change (MPH)	-7.00	-7.00	-7.00	-7.00	-7.00	-7.00	-7.00	-7.00	-7.00	-7.64	-7.64	-7.64	-7.64	-7.64	-7.64

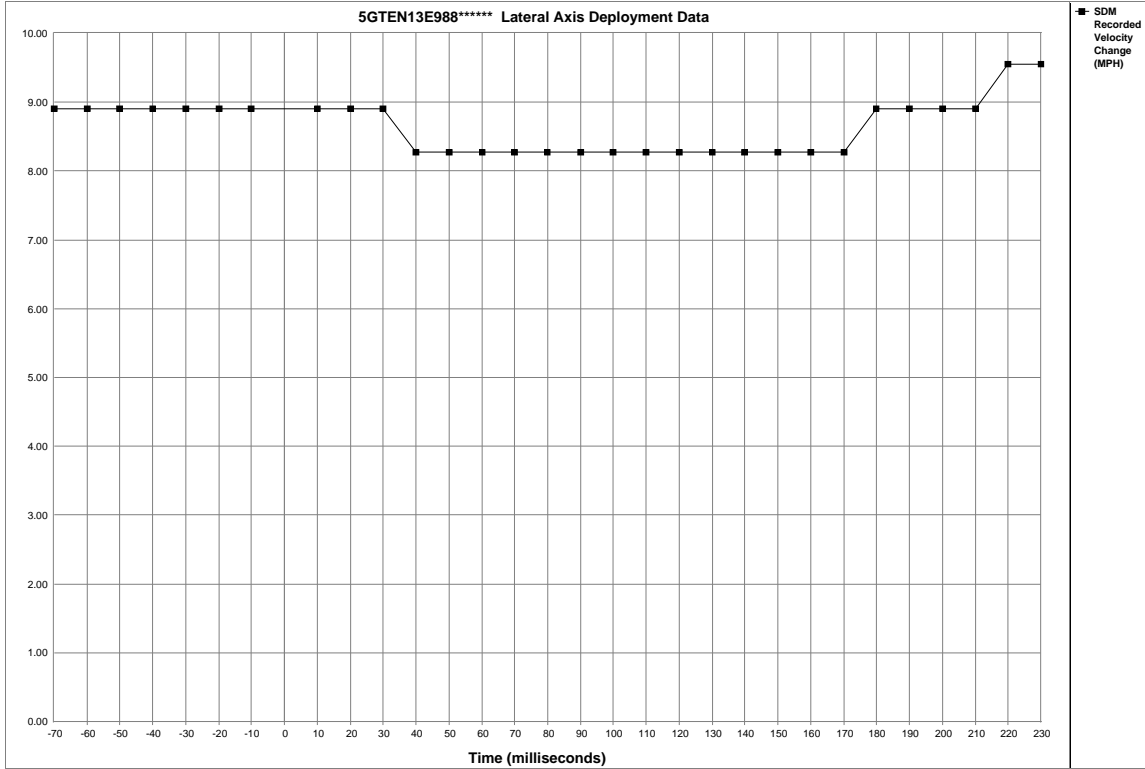
Time (milliseconds)	-70	-60	-50	-40	-30	-20	-10	10	20	30	40	50	60	70	80
SDM Lateral Axis Recorded Velocity Change (MPH)	8.91	8.91	8.91	8.91	8.91	8.91	8.91	8.91	8.91	8.91	8.28	8.28	8.28	8.28	8.28
Time (milliseconds)	90	100	110	120	130	140	150	160	170	180	190	200	210	220	230
SDM Lateral Axis Recorded Velocity Change (MPH)	8.28	8.28	8.28	8.28	8.28	8.28	8.28	8.28	8.28	8.91	8.91	8.91	8.91	9.55	9.55
