**CALSPAN ON-SITE CERTIFIED ADVANCED 208-COMPLIANT  
VEHICLE CRASH INVESTIGATION**

**SCI CASE NO.: CA10002**

**VEHICLE: 2008 HONDA CIVIC LX**

**CRASH DATE: DECEMBER 2009**

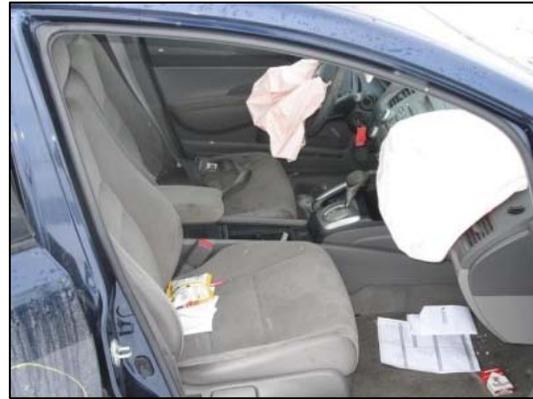
The interior of the Civic was configured with cloth-surfaced, five-passenger seating. The front row seating positions consisted of manually adjustable bucket seats, separated by a center console that contained the emergency brake and transmission selector levers. **Figure 3** is a right interior view of the Honda. The front row seat backs had adjustable head restraints equipped with a whiplash protection system. The driver's head restraint was adjusted 3 cm (1 in) above the seat back while the front right was 4 cm (1.5 in) above its respective seat back. The rear seat was a three-passenger bench seat with a split, forward folding seatback and adjustable head restraints at each position.

**Figure 3: Right interior view of the 2008 Honda Civic.**
