On-Site Rollover Investigation  
Dynamic Science, Inc. (DSI), Case Number DS10003  
2008 GMC Yukon Denali  
Arizona  
December 2009

**Dynamic Science, Inc.**  
**Crash Investigation**  
**Case Number: DS10003**

The focus of this on-site investigation was the rollover dynamics of a 2008 GMC Yukon Denali involved in a side-impact crash. The GMC was equipped with an Electronic Stability Control (ESC) system designed to mitigate the chance of rollover, a rollover sensor, and combination side impact/rollover inflatable curtain (IC) air bags. Following the side impact with a 2007 GMC Sierra C1500, the Yukon initiated a left side leading one-quarter turn rollover. During the crash, the vehicle's IC air bags deployed.

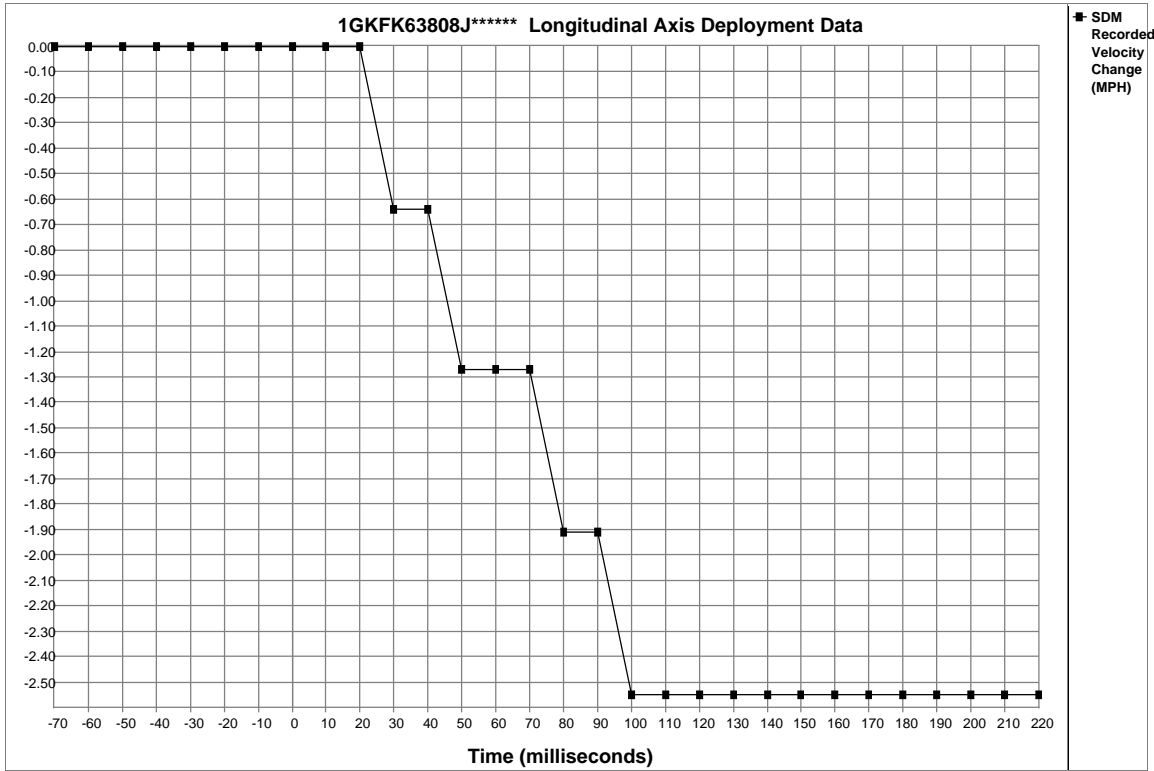
Time (milliseconds)	-70	-60	-50	-40	-30	-20	-10	0	10	20	30	40	50	60	70
SDM Longitudinal Axis Recorded Velocity Change (MPH)	0.00	0.00	0.00	0.00	0.00	0.00	0.00	0.00	0.00	0.00	-0.64	-0.64	-1.27	-1.27	-1.27
Time (milliseconds)	80	90	100	110	120	130	140	150	160	170	180	190	200	210	220
SDM Longitudinal Axis Recorded Velocity Change (MPH)	-1.91	-1.91	-2.55	-2.55	-2.55	-2.55	-2.55	-2.55	-2.55	-2.55	-2.55	-2.55	-2.55	-2.55	-2.55

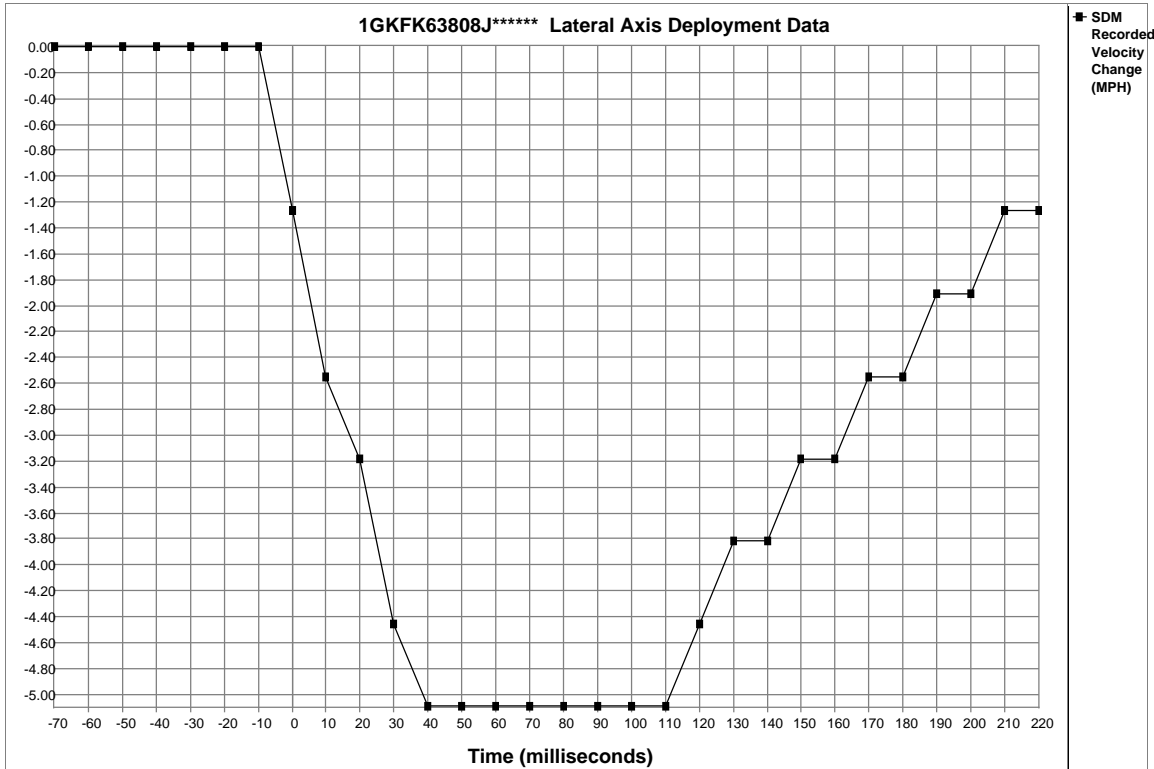
Time (milliseconds)	-70	-60	-50	-40	-30	-20	-10	0	10	20	30	40	50	60	70
SDM Lateral Axis Recorded Velocity Change (MPH)	0.00	0.00	0.00	0.00	0.00	0.00	0.00	-1.27	-2.55	-3.18	-4.46	-5.09	-5.09	-5.09	-5.09
Time (milliseconds)	80	90	100	110	120	130	140	150	160	170	180	190	200	210	220
SDM Lateral Axis Recorded Velocity Change (MPH)	-5.09	-5.09	-5.09	-5.09	-4.46	-3.82	-3.82	-3.18	-3.18	-2.55	-2.55	-1.91	-1.91	-1.27	-1.27

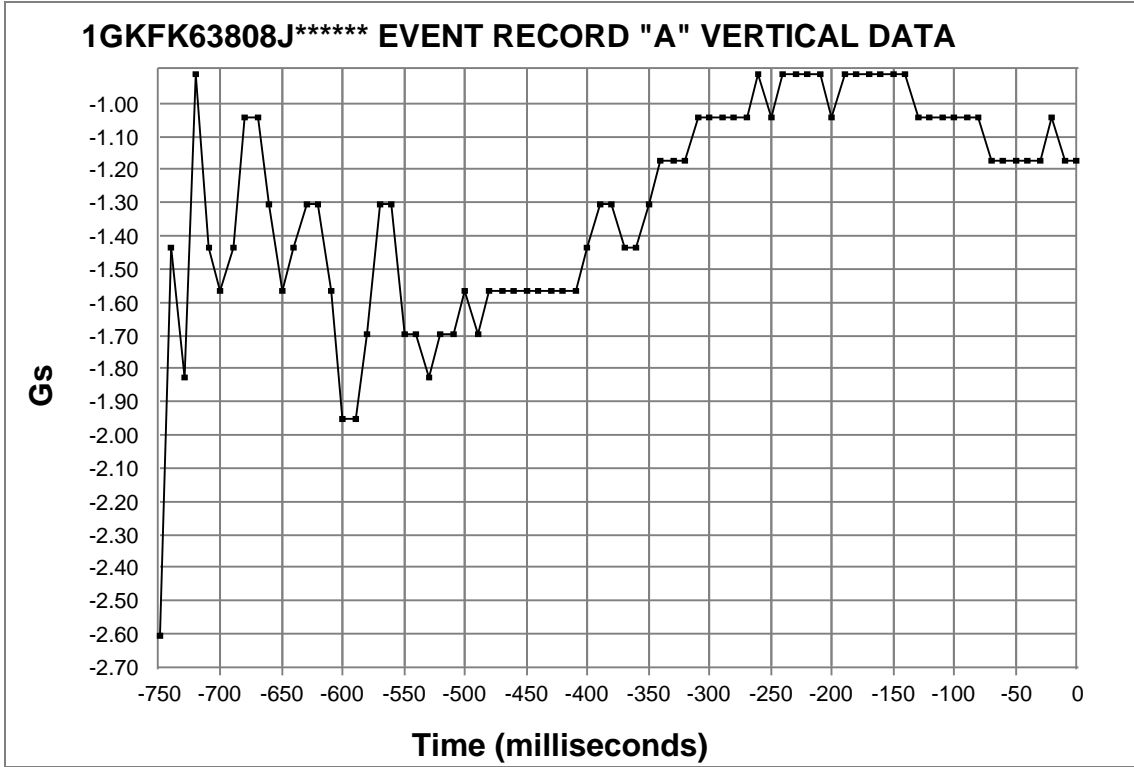
### Event Record "A" ROS Recorded Vehicle Vertical Acceleration

Time (ms)	Acceleration (G)
-750	-2.61
-740	-1.43
-730	-1.82
-720	-0.91
-710	-1.43
-700	-1.56
-690	-1.43
-680	-1.04
-670	-1.04
-660	-1.30
-650	-1.56
-640	-1.43
-630	-1.30
-620	-1.30
-610	-1.56
-600	-1.95
-590	-1.95
-580	-1.69
-570	-1.30
-560	-1.30
-550	-1.69
-540	-1.69
-530	-1.82
-520	-1.69
-510	-1.69
-500	-1.56
-490	-1.69
-480	-1.56
-470	-1.56
-460	-1.56
-450	-1.56
-440	-1.56
-430	-1.56
-420	-1.56
-410	-1.56
-400	-1.43
-390	-1.30
-380	-1.30

Time (ms)	Acceleration (G)
-370	-1.43
-360	-1.43
-350	-1.30
-340	-1.17
-330	-1.17
-320	-1.17
-310	-1.04
-300	-1.04
-290	-1.04
-280	-1.04
-270	-1.04
-260	-0.91
-250	-1.04
-240	-0.91
-230	-0.91
-220	-0.91
-210	-0.91
-200	-1.04
-190	-0.91
-180	-0.91
-170	-0.91
-160	-0.91
-150	-0.91
-140	-0.91
-130	-1.04
-120	-1.04
-110	-1.04
-100	-1.04
-90	-1.04
-80	-1.04
-70	-1.17
-60	-1.17
-50	-1.17
-40	-1.17
-30	-1.17
-20	-1.04
-10	-1.17
0	-1.17

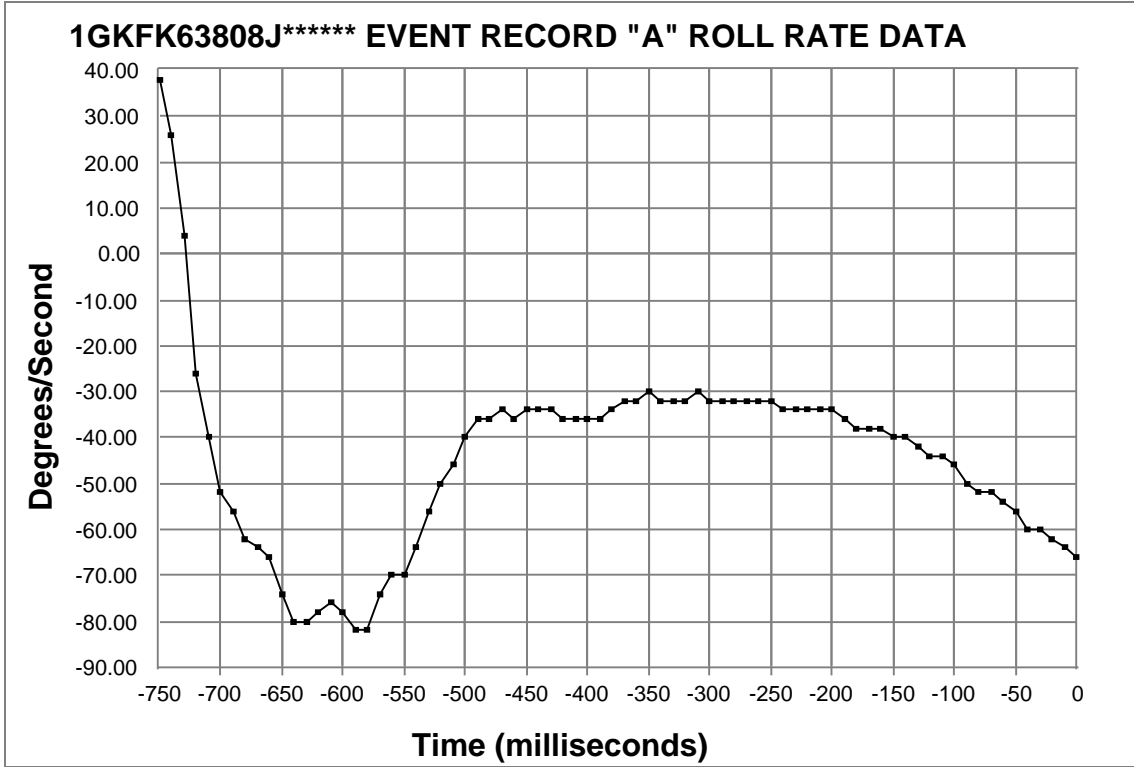
## Event Record "A" ROS Recorded Vehicle Roll Rate Data

Time (ms)	Roll Rate (degrees/second)
-750	38.00
-740	26.00
-730	4.00
-720	-26.00
-710	-40.00
-700	-52.00
-690	-56.00
-680	-62.00
-670	-64.00
-660	-66.00
-650	-74.00
-640	-80.00
-630	-80.00
-620	-78.00
-610	-76.00
-600	-78.00
-590	-82.00
-580	-82.00
-570	-74.00
-560	-70.00
-550	-70.00
-540	-64.00
-530	-56.00
-520	-50.00
-510	-46.00
-500	-40.00
-490	-36.00
-480	-36.00
-470	-34.00
-460	-36.00
-450	-34.00
-440	-34.00
-430	-34.00
-420	-36.00
-410	-36.00
-400	-36.00
-390	-36.00
-380	-34.00

Time (ms)	Roll Rate (degrees/second)
-370	-32.00
-360	-32.00
-350	-30.00
-340	-32.00
-330	-32.00
-320	-32.00
-310	-30.00
-300	-32.00
-290	-32.00
-280	-32.00
-270	-32.00
-260	-32.00
-250	-32.00
-240	-34.00
-230	-34.00
-220	-34.00
-210	-34.00
-200	-34.00
-190	-36.00
-180	-38.00
-170	-38.00
-160	-38.00
-150	-40.00
-140	-40.00
-130	-42.00
-120	-44.00
-110	-44.00
-100	-46.00
-90	-50.00
-80	-52.00
-70	-52.00
-60	-54.00
-50	-56.00
-40	-60.00
-30	-60.00
-20	-62.00
-10	-64.00
0	-66.00
