## ON-SITE SIDE IMPACT INFLATABLE OCCUPANT PROTECTION INVESTIGATION

CASE NUMBER - IN10004

LOCATION - MISSOURI

VEHICLE - 2009 FORD FOCUS SE

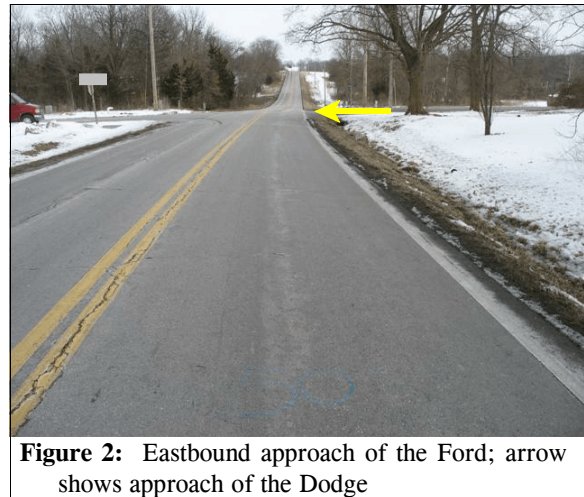
**Figure 2:** Eastbound approach of the Ford; arrow shows approach of the Dodge

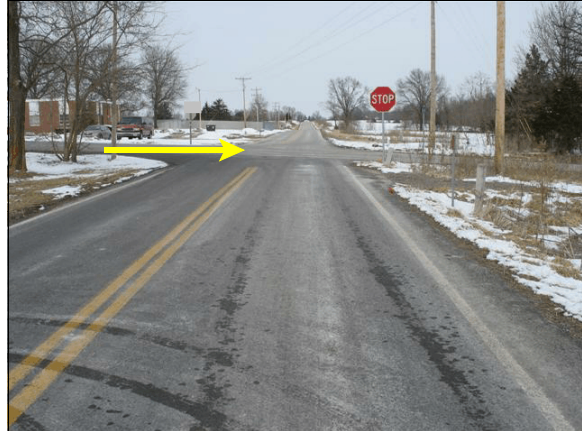
**Figure 3:** Northbound approach of the Dodge; arrow shows approach of the Ford

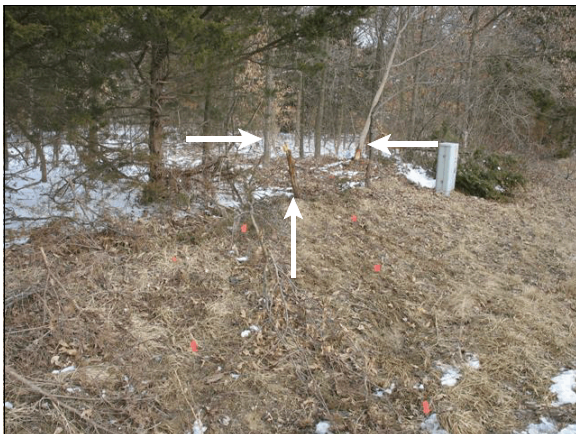
**Figure 8:** Approach of the Ford to the three tree impacts; arrow in center, left, and right shows trees impacted in events 3, 4, and 5, respectively

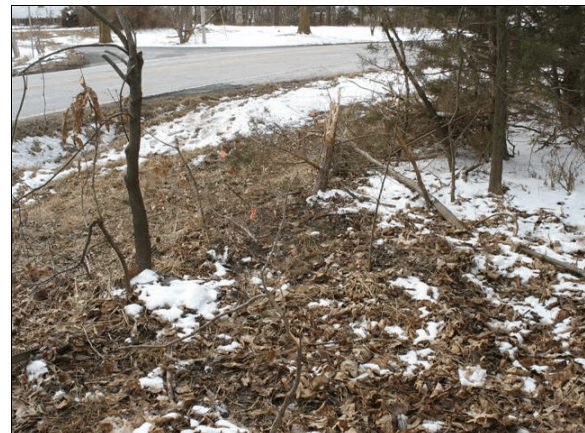
**Figure 10:** View back to area of initial impact in the intersection from the final rest position of the Ford

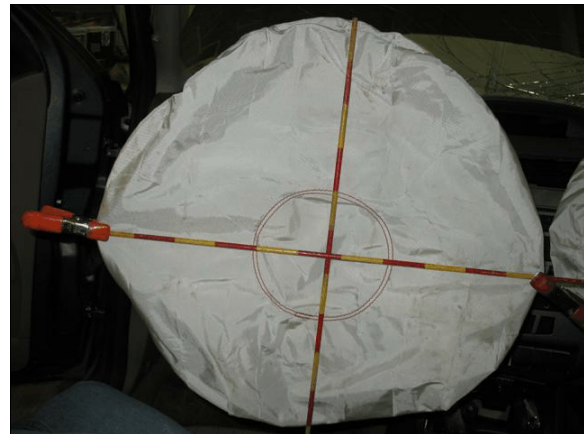
The driver's frontal air bag was located within the steering wheel hub and the module cover was a two-flap configuration constructed of pliable vinyl. Each cover flap was 15 cm (5.9 in) in height and 7.5 cm (3 in) in width. The flaps opened at the designated tear points and were undamaged. The deployed air bag (**Figure 13**) was 56 cm (22 in) in diameter and was designed with two 12 cm (4.7 in) wide internal tethers, which were sewn to the center of the air bag. There were two 3 cm (1.2 in) diameter vent ports located on the back of the air bag at the 11 and 1 o'clock positions. Inspection of the air bag revealed no damage and no discernable evidence of occupant contact.

**Figure 13:** The driver's frontal air bag

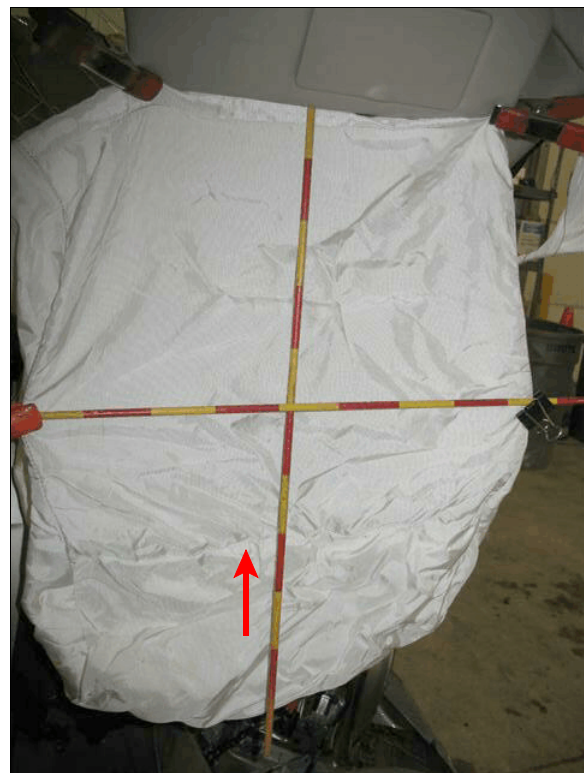
The front passenger air bag was located within the top of the instrument panel and the module cover was a single horizontal flap constructed of firm vinyl with a plastic backing. The cover flap was 34 cm (13.4 in) in width and 15 cm (5.9 in) in height. It opened at the designated tear points and was undamaged. The deployed air bag (**Figure 14**) was 44 cm (17.3 in) in width and 36 cm (14.2 in) in height and had on

**Figure 14:** The front passenger's frontal air bag; arrow shows the bottom seam

vent port on each side of the air bag at the 3 and 9 o'clock positions. There was no damage to the air bag and no discernable evidence of occupant contact.

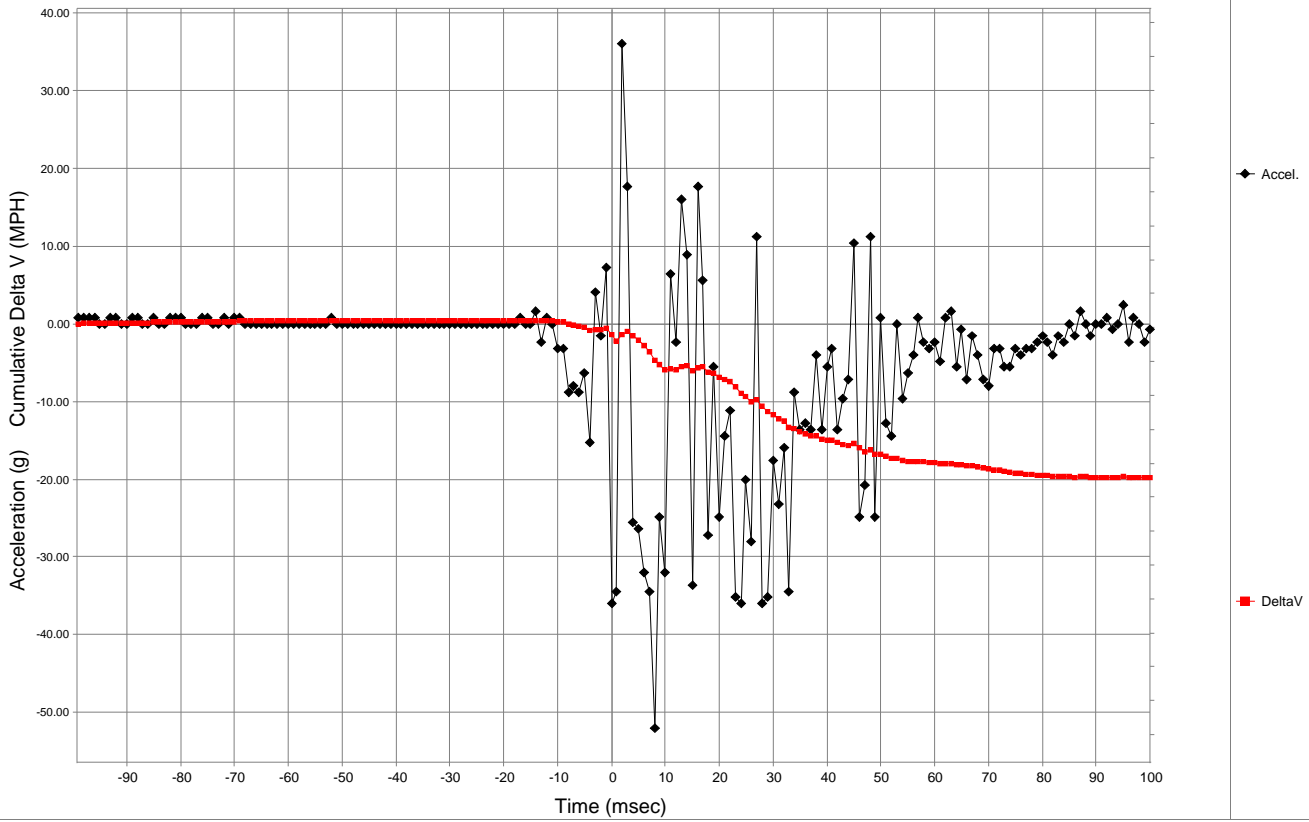
1FAHP35N49W\*\*\*\*\* Longitudinal Crash Pulse (First Record)

The Missing Vehicle algorithm of the WinSMASH program calculated the total Delta V for the Ford's front impact with the Dodge as 23 km/h (14.3 mph). The longitudinal and lateral velocity changes were -21.6 km/h (-14.4 mph) and -7.9 km/h (-4.9 mph), respectively. The results should be considered borderline since there was overlapping damage on the Ford and the results are based only on the crush on the Dodge. In addition, the Ford sustained narrow end engagement during this impact. The cumulative velocity change recorded by the EDR reached -31.88 km/h (-19.81 mph) at 100 ms, which was the limit of the recording.
