**CALSPAN ON-SITE POTENTIAL UNINTENDED ACCELERATION
CRASH INVESTIGATION
SCI CASE NO.: CA10007**

VEHICLE: 2008 TOYOTA AVALON

LOCATION: GEORGIA

CRASH DATE: FEBRUARY 2010

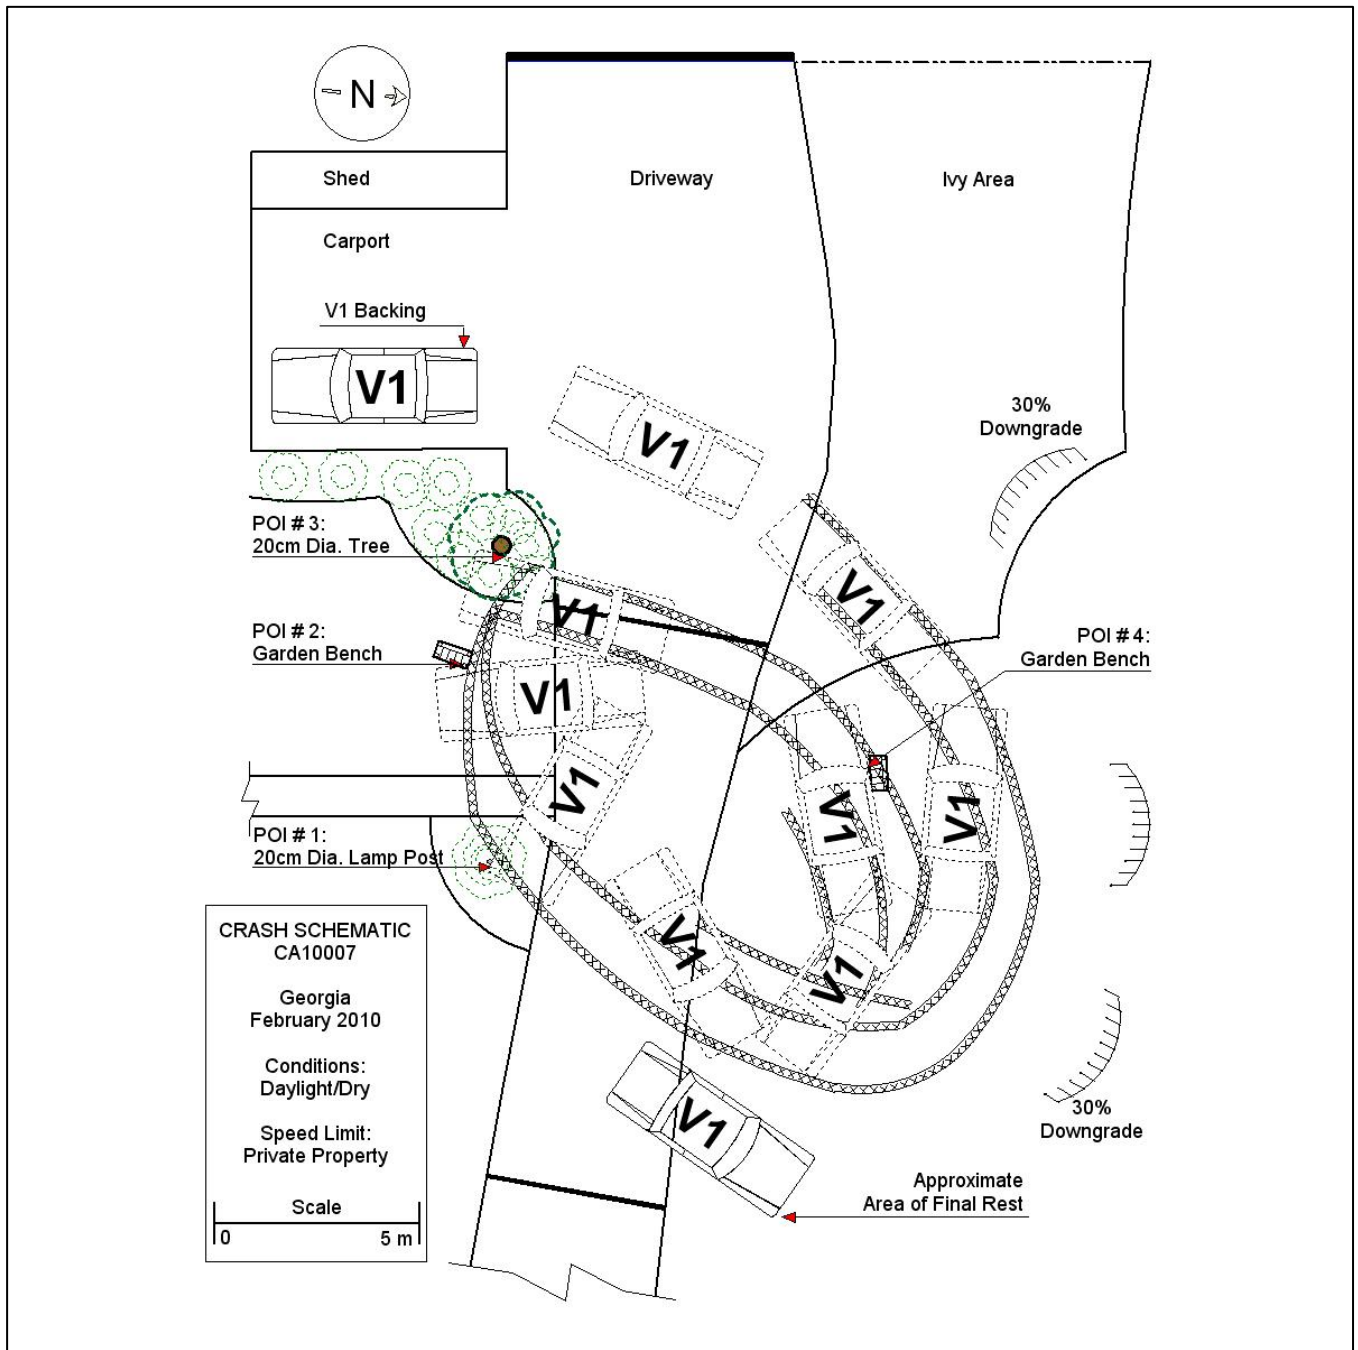
Figure 21. Crash Schematic

At the time of this crash, the weather was clear and the temperature was reported at 3.3 degrees C (38.0 degree F). The concrete driveway surface was dry and the dirt within the lawn areas was soft from previous precipitation. A schematic of the crash site is attached as **Figure 21**.
