On-Site Side Air Bag Investigation
Dynamic Science, Inc. (DSI), Case Number DS10008
2005 Toyota Corolla LE
Arizona
January 2010

1. Report No. DS10008	2. Government Accession No.	3. Recipient Catalog No.	
4. Title and Subtitle On-Site Side Air Bag Investigation		5. Report Date October 12, 2010

14. Sponsoring Agency Code	
15. Supplemental Notes			
16. Abstract The focus of this investigation was the deployed side air bags in a 2005 Toyota Corolla LE involved in a crash and the serious injuries sustained by the vehicle's front right occupant. The single vehicle crash occurred on an undivided two-lane north/south roadway during January 2010 in the state of Arizona. The Toyota was being driven by a 23-year-old male and was occupied by a 23-year-old female front right passenger. While traveling southbound the driver lost control of the vehicle and it departed the roadway. The Toyota then impacted a raised curb, a metal utility pole, and a masonry wall. The vehicle was equipped with side impact inflatable curtain (IC) air bags and seat-mounted side air bags, and all four side air bags deployed during the crash. The driver of the Toyota sustained minor injuries and was transported to a l

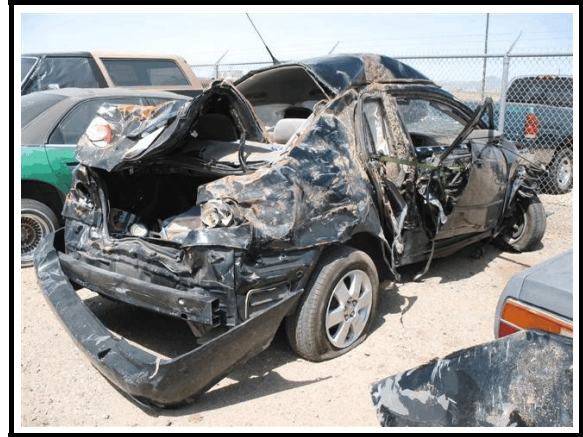
The focus of this investigation was the deployed side air bags in a 2005 Toyota Corolla LE (**Figure 1**) involved in a crash and the serious injuries sustained by the vehicle's front right occupant. The single vehicle crash occurred on an undivided two-lane north/south roadway during January 2010 in the state of Arizona. The Toyota was being driven by a 23-year-old male and was occupied by a 23-year-old female front right passenger.

Figure 1. Subject vehicle, 2005 Toyota Corolla LE

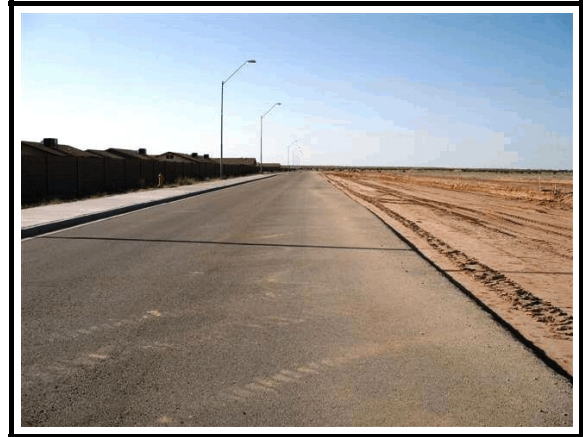
The crash site was a two-way undivided north/south level roadway composed of asphalt (**Figure 2**). The lanes were not delineated by striping or markers. At 213.4 m (700.0 ft) north of the point of impact (POI), the roadway width measured 14.3 m (47.0 ft). Approaching the POI the roadway narrowed first on the right edge resulting in a roadway width of 11.0 m (36.0 ft) and then on the left edge resulting in a roadway width of 7.4 m (24.2 ft). From 101.2 m (332.0 ft) north of the POI to

Figure 2. Crash site, southbound approach
