ON-SITE OFFICE OF DEFECTS INVESTIGATION POTENTIAL UNINTENDED ACCELERATION INVESTIGATION

CASE NUMBER - IN10009

VEHICLE - 2007 LEXUS ES-350

CRASH DATE - March 2010

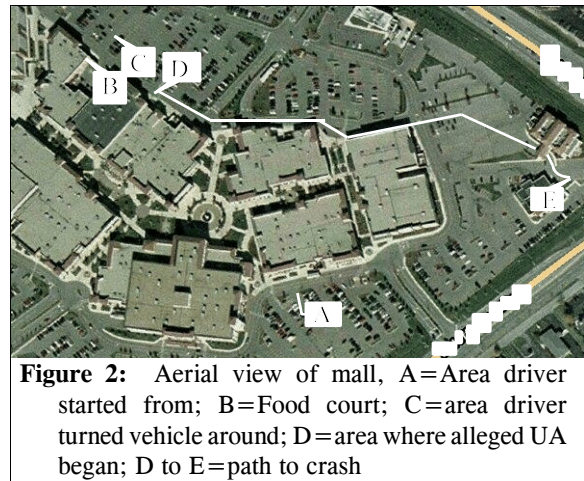
Figure 2: Aerial view of mall, A=Area driver started from; B=Food court; C=area driver turned vehicle around; D=area where alleged UA began; D to E=path to crash

event began (Figure 3, and D in Figure 2). The driver stated that she suddenly felt the accelerator pedal move from under her foot to the floor and the vehicle accelerated rapidly. She stated that she immediately applied the brakes but the vehicle continued to accelerate. The driver avoided several cars and pedestrians as the vehicle accelerated. She shifted the transmission into neutral and attempted to turn the keyless ignition off but was unsuccessful. The vehicle traveled approximately 181 m (592 ft) where it passed through a 4-leg intersection at the northeast corner of the mall (Figure 4). After the vehicle crossed the intersection and entered a parking lot, the driver initiated a right steering maneuver. The vehicle traveled on a southeast trajectory an additional 121 m (398 ft) from the intersection to a restaurant where it passed under a covered customer drop-off area (Figure 5). The driver initiated a right steering maneuver to negotiate the restaurant driveway. She initiated a hard left steering maneuver as the vehicle exited the driveway and approached the area of the crash (Figure 6). The right front tire created a curved tire mark 11 m (36.2 ft) in length, which led to the initial impact with a 15 cm (6 in) high concrete curb (Figure 6). The vehicle traveled a total distance of approximately 328 m (1109 ft) from the area where the alleged UA began to the area of the crash (D to E in Figure 2).

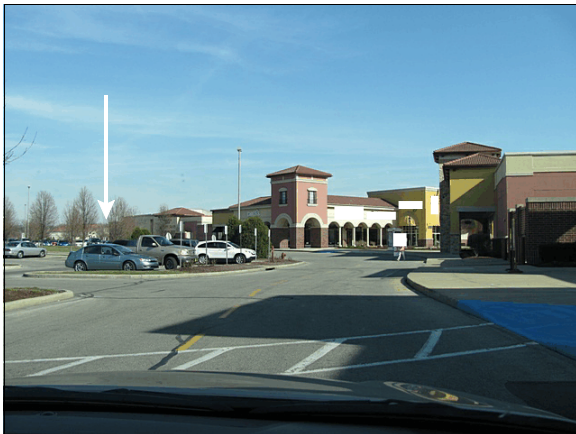
Figure 3: Area on north side of mall where alleged UA began; arrow shows area of 4-leg intersection at northeast corner of mall and referenced in Figure 4

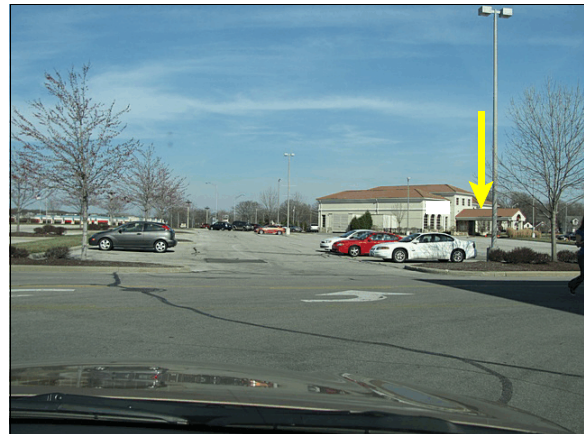
Figure 4: Lexus passes through 4-leg intersection enters parking lot and approaches restaurant (arrow)

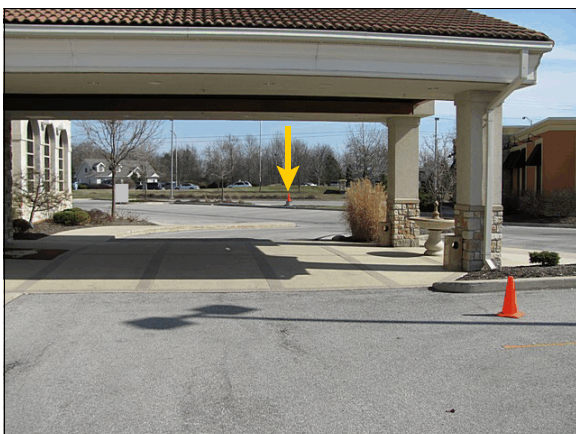
Figure 5: Lexus traveled under covered customer drop off area of restaurant; arrow shows location of impacted concrete light pole
