On-Site Side Air Bag Investigation
Dynamic Science, Inc. (DSI), Case Number DS10012
2006 Buick LaCrosse
Arizona
March 2010

1. Report No. DS10012	2. Government Accession No.	3. Recipient Catalog No.	
4. Title and Subtitle On-Site Side Air Bag Investigation		5. Report Date October 28, 2010

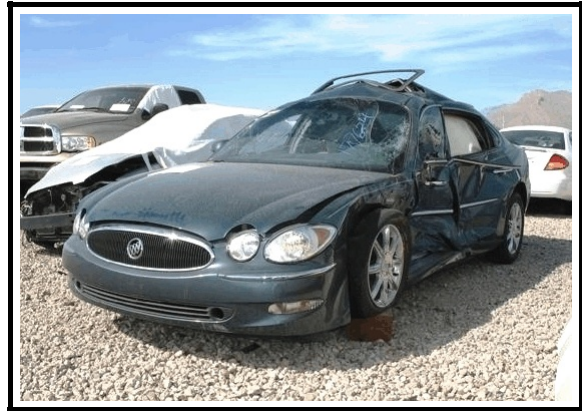
The focus of this on-site investigation was the deployed side air bag and the injuries sustained by the driver of a 2006 Buick LaCrosse involved in a vehicle-to-vehicle crash (**Figure 1**). The Buick was being driven by a restrained 60-year-old female who was traveling southbound through a four-leg intersection. The other vehicle was a 2008 Ford F-150 that was being driven by a 19-year-old male who was traveling westbound through the intersection. The Buick crossed the path of the Ford and the front end of the Ford impacted the left side of the Buick. The Buick was equipped with frontal air bags and side impact inflatable curtain (IC) air bags and at impact the driver's frontal air bag and the left IC air bag deployed. The driver of the Buick sustained serious injuries and was transported to a local hospital where she was admitted for treatment. Both vehicles were towed due to damage and the Buick was later declared a total loss by the insurance company. The Ford was not inspected.

Figure 1. Subject vehicle, 2006 Buick LaCrosse

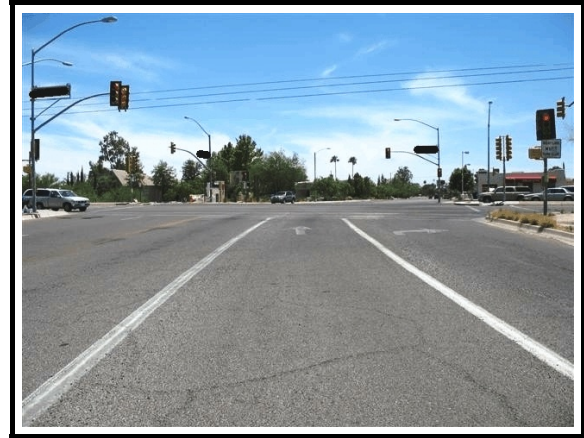
The north leg of the intersection consisted of an undivided north/south roadway including two northbound lanes and three southbound lanes. The northbound and southbound lanes were separated by double yellow solid painted stripes and the individual lanes were delineated by solid white painted stripes. The three southbound lanes were designated as left turn only, through only, and right turn only, respectively. The outboard roadway edges were bordered by solid white painted fog lines and raised concrete curbs. The roadway curved slightly right where it approached the intersection and the profile was a 2.0 percent uphill grade (**Figure 2**). The roadway surface composition was asphalt in good condition. The speed limit for the southbound lanes of this roadway was 40 km/h (25 mph).

Figure 2. Southbound approach to intersection, subject vehicle

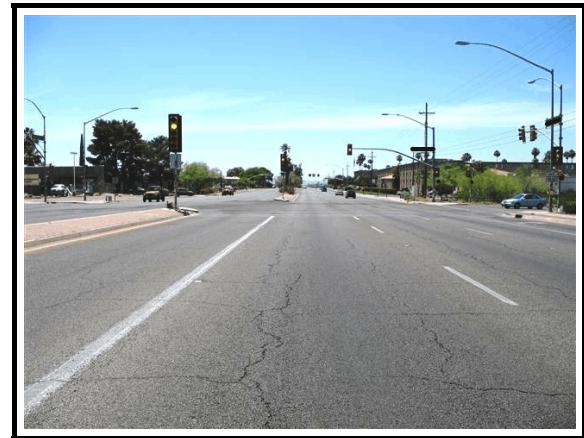
The east leg of the intersection consisted of an east/west roadway divided by a raised median without a positive barrier (**Figure 3**). The roadway included four eastbound lanes and five westbound lanes. The outboard westbound lanes were left turn and right turn only and were separated from the through lanes by solid white painted stripes. The through lanes were delineated by dashed white painted stripes. The east/west roadway surface composition was asphalt and the roadway was straight and level. The outboard roadway edges were bordered by solid white painted fog lines and raised concrete curbs. The speed limit for the westbound lanes of this roadway was 64 km/h (40 mph). A crash scene schematic is included at the end of this report as Attachment A.

Figure 3. Westbound approach to intersection, other vehicle

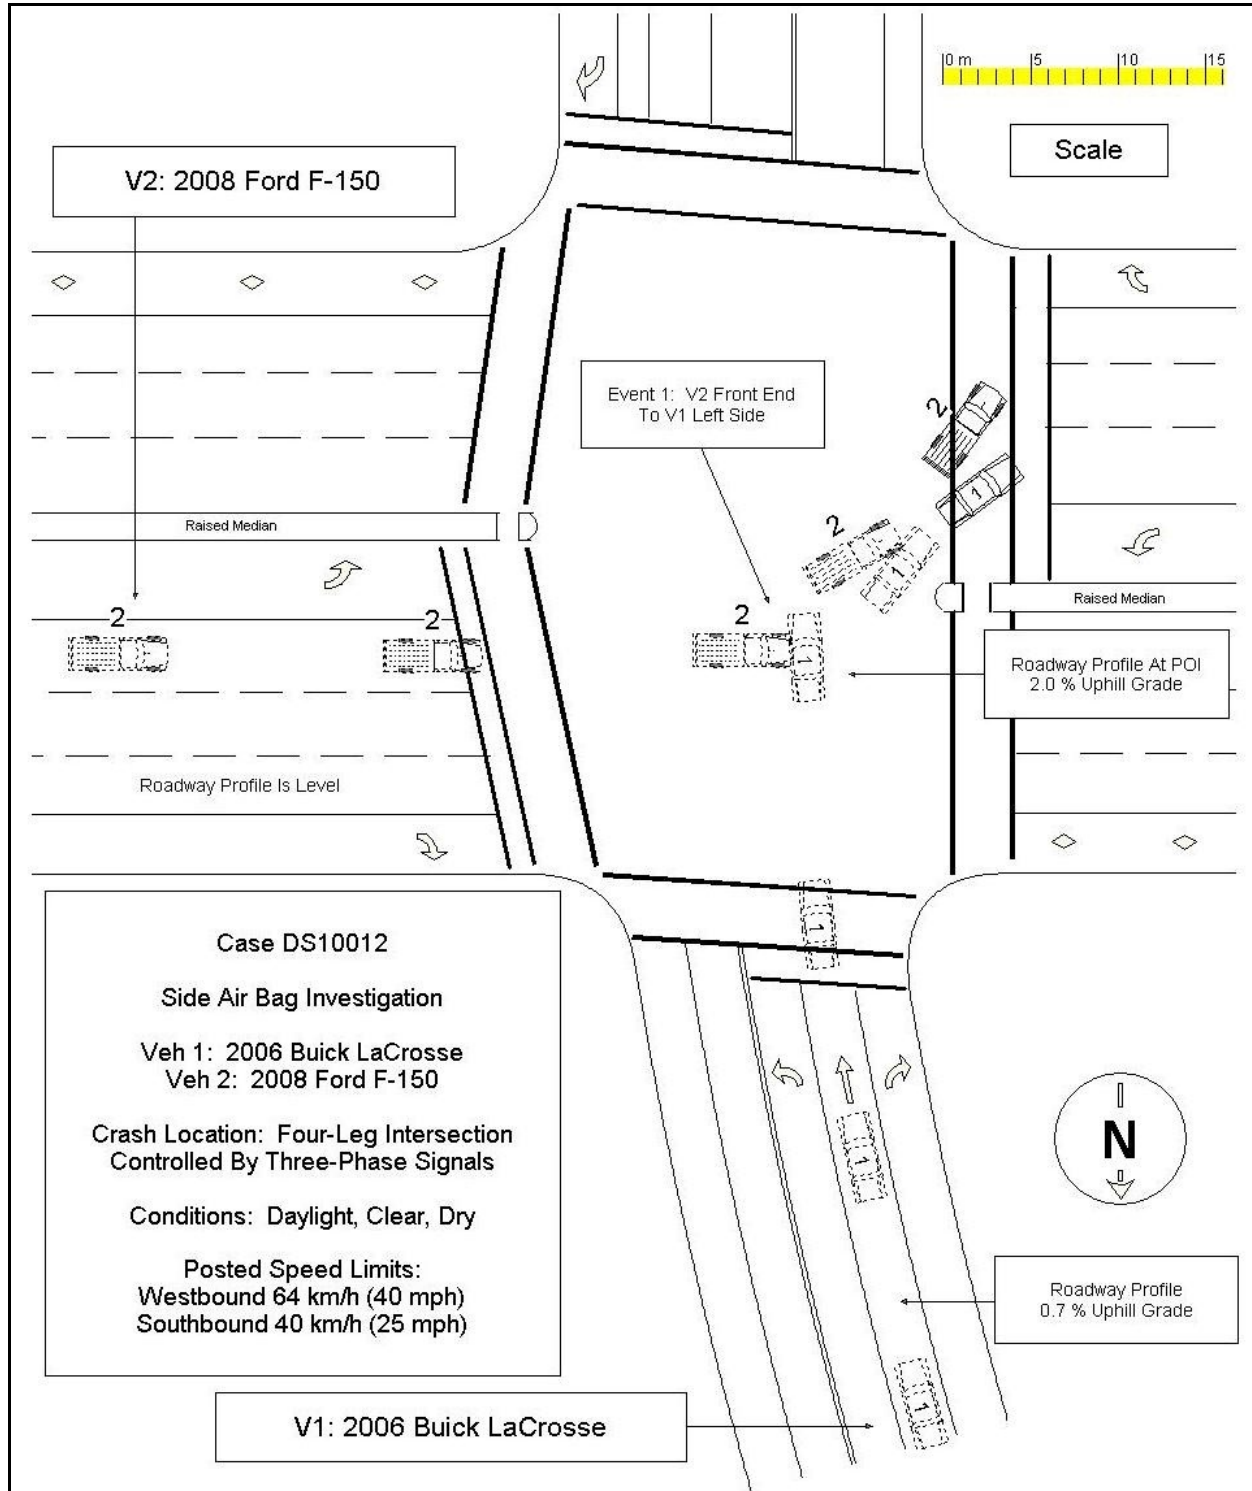
Attachment 1. Scene Diagram

The Ford was traveling westbound in the fourth lane from the right and entered the intersection against a red signal at a police-reported speed of 64 km/h (40 mph). The southbound Buick crossed over the path of the westbound Ford.
