**OFFICE OF DEFECTS INVESTIGATION
CALSPAN ON-SITE POTENTIAL UNINTENDED ACCELERATION
CRASH INVESTIGATION**

SCI CASE NO.: CA10013

VEHICLE: 2002 TOYOTA HIGHLANDER

CRASH DATE: OCTOBER 2009

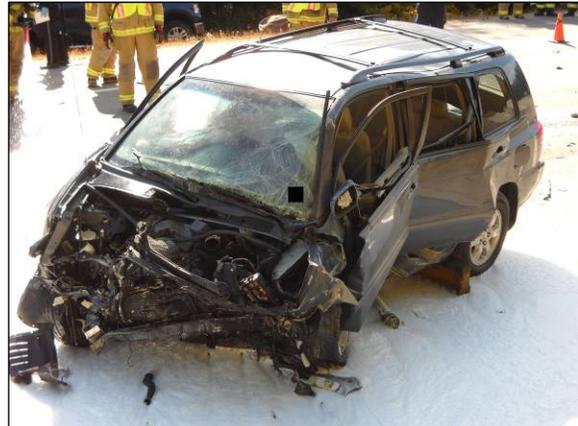
This on-site investigation focused on the alleged Unintended Acceleration (UA) of a 2002 Toyota Highlander sport utility vehicle (**Figure 1**). The 63-year-old male driver of the Toyota was allegedly traveling at a witness reported high-rate of speed and passing a non-contact vehicle on the right shoulder when he lost directional control while attempting to re-enter the travel lanes. The Toyota crossed the roadway centerline and impacted a 2005 Chevrolet Malibu that was traveling in the opposite direction. The severe head-on crash killed all three occupants of the Toyota, including the driver, a 61-year-old female front right passenger, and a 94-year-old female rear right passenger, as well as the 56-year-old male driver of the Chevrolet. All of the occupants were restrained by the safety belt systems of their respective vehicles at the time of the crash, and the frontal air bag systems equipped within each vehicle deployed.

Figure 1: Left front oblique view of the Toyota.
(Local law enforcement on-scene image)

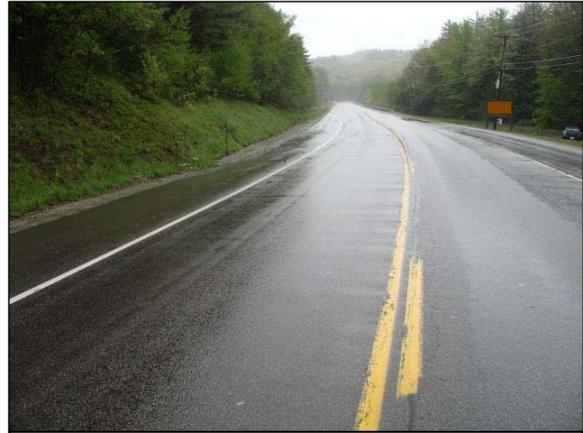
The subject crash occurred during daylight hours on a rural two-lane New Hampshire road in October of 2009. **Figure 2** depicts a northbound trajectory view of the crash site. According to the online weather database, the local weather conditions at the time of the crash were clear skies with a temperature of 7.2 Celsius (45 Fahrenheit) degrees, 46-percent relative humidity, and calm winds. The bituminous (asphalt) road surface was dry.

Figure 2: Northbound trajectory view of crash site.

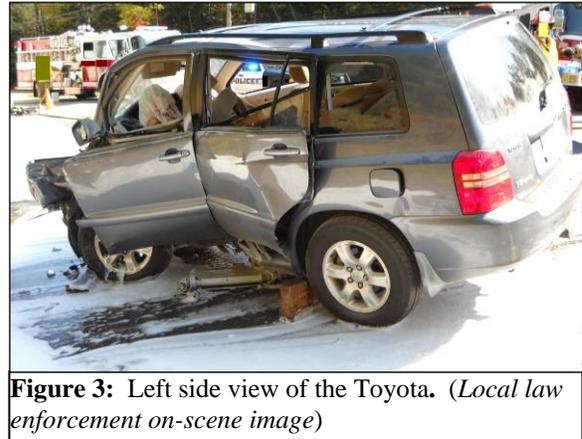
The Toyota Highlander Limited was manufactured in January 2002 and identified by the Vehicle Identification Number (VIN): JTEHF21A820 (production number deleted). The Toyota was a four-door sport utility vehicle with all-wheel drive (**Figure 3**). Power was derived from a 3.0-liter, conventionally mounted V-6 gasoline engine linked to a 4-speed automatic transmission with a console-mounted shifter. The service brakes were power-assisted 4-wheel disc with anti-lock and Electronic Brakeforce Distribution (EBD). The parking brake was a cable activated drum system within the rear rotors. It is unknown if this Toyota was equipped with Electronic Stability Control or Brake Assist. Additional exterior features included an original equipment manufacturer (OEM) roof rack with two adjustable load bars positioned at the fore and aft ends of the rack system. The manufacturer's recommended tire size was P225/70R16 with front and rear axle cold tire pressures of 207 kPa (30 PSI). The Toyota was equipped with matching Wildcat Touring XLT tires of the recommended size, mounted on OEM 5-spoke alloy wheels. The tires were manufactured by Cooper, but were sold through the brand name of Dean Tires. Specific tire data recorded at the time of the SCI inspection was as follows:

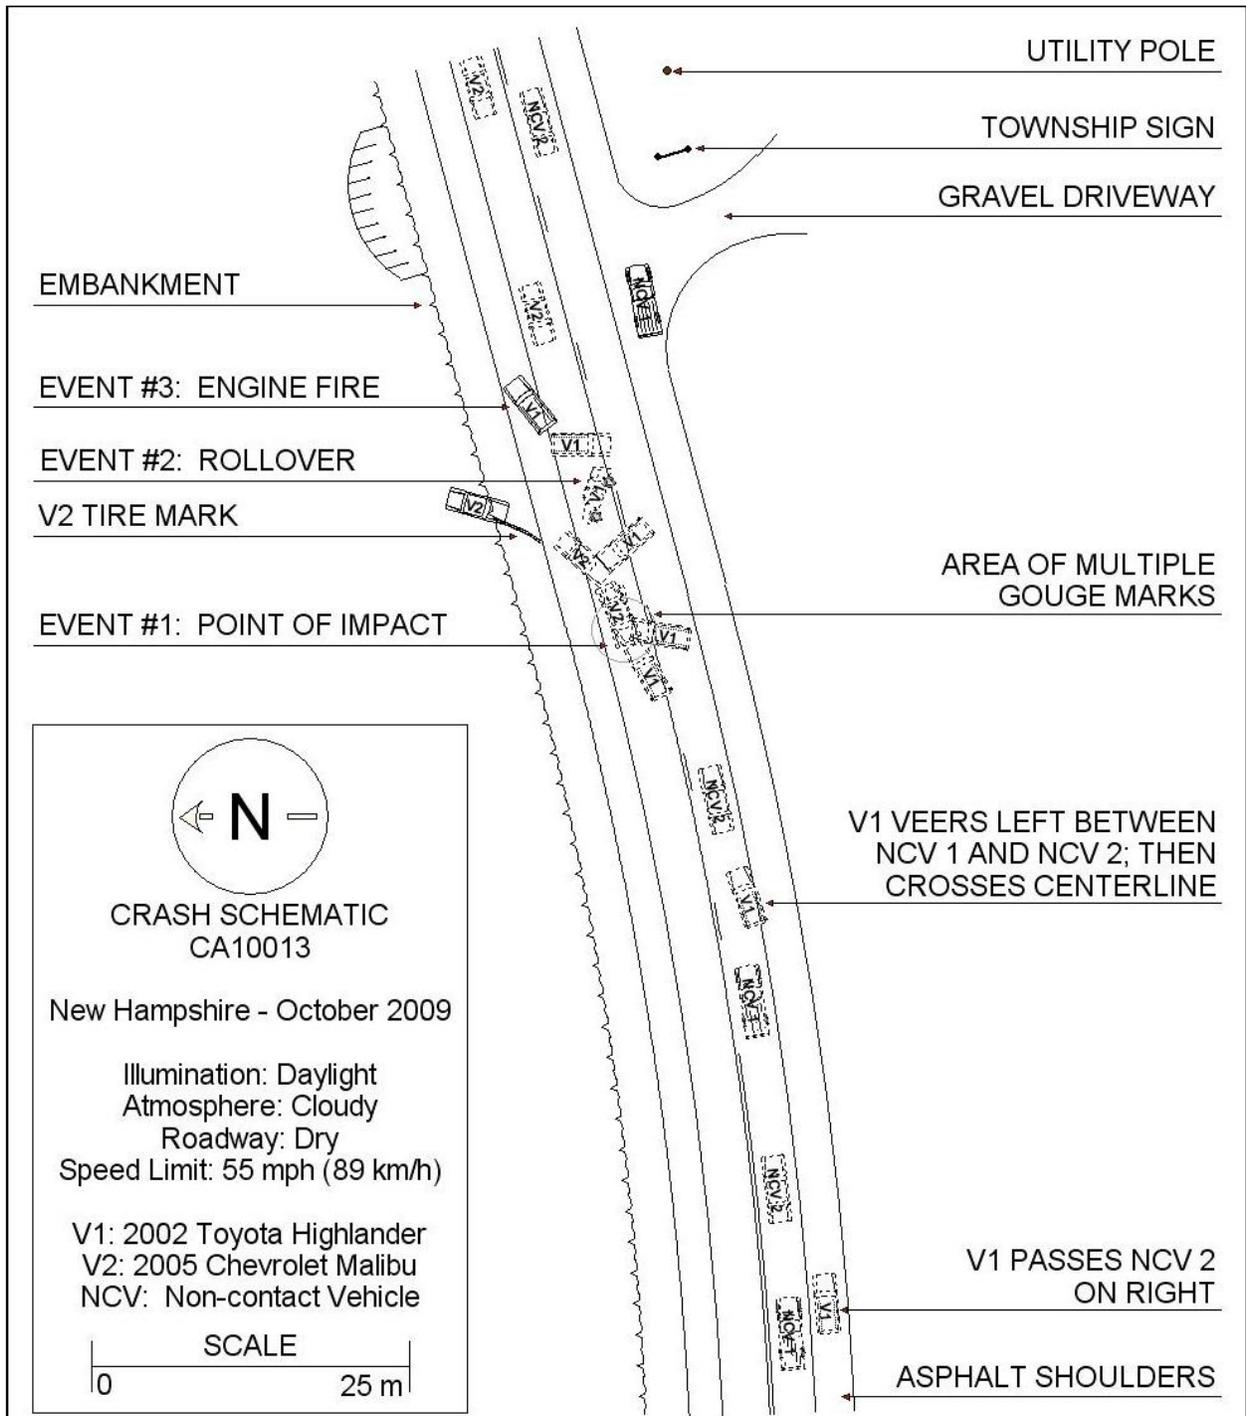
Figure 19: Crash schematic.

For the pre-crash northbound travel trajectory of the Toyota, the roadway followed a slight left curve with a radius of curvature of approximately 625 m (2050 ft) and negative grade of 2.8 percent. Northbound traffic was restricted by a no-passing zone that transitioned to a passing zone at the culmination of the curve, as dictated by the yellow centerline. Southbound traffic, however, was restricted by a continuous solid-yellow centerline distinguishing a no-passing zone. In the vicinity of the southbound Chevrolet's pre-crash location prior to the curve, the straight roadway had a positive 2.5 percent grade. The posted speed limit in both travel directions was 89 km/h (55 mph). A schematic of the crash is attached as **Figure 19**.
