On-Site Side Air Bag Investigation  
Dynamic Science, Inc. (DSI), Case Number DS10021  
2009 Toyota Camry  
California  
August 2010

1. Report No. DS10021	2. Government Accession No.	3. Recipient Catalog No.	
4. Title and Subtitle  On-Site Side Air Bag Investigation		5. Report Date  January 5, 2011

**Dynamic Science, Inc.**  
**Crash Investigation**  
**Case Number: DS10021**

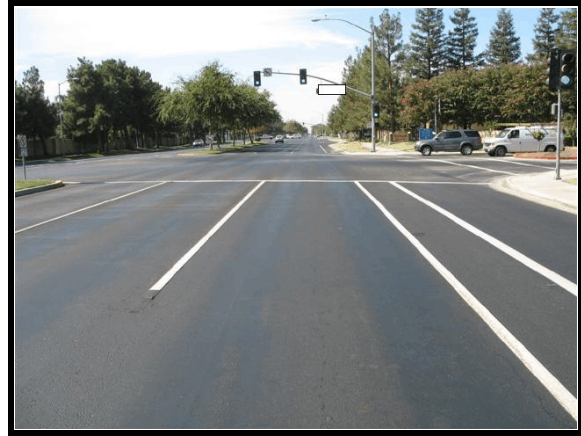
a marked bicycle lane (**Figure 2**). The north leg of the intersection was comprised of one northbound and one southbound travel lane that were separated by a grass-covered median (**Figure 3**). The asphalt roadways were straight and the posted speed limit at this location is 72 km/h (45 mph) for both roadways. Conditions at the time of the crash were daylight, clear, and dry. The weather at the nearest reporting station was 26.7° C (80.1 ° F), 29 percent humidity, and 16.0 km (10.0 mph) winds out of the north.

**Figure 2.** Westbound approach

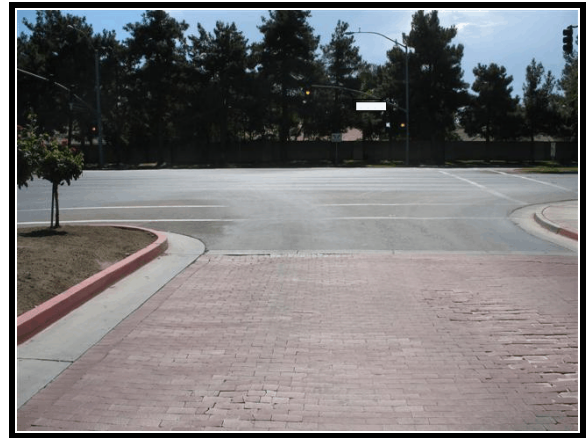
**Figure 3.** Southbound approach
