On-Site Child Restraint System Investigation  
Dynamic Science, Inc. (DSI), Case Number DS10022  
2001 Toyota Land Cruiser  
Idaho  
September 2010

| 15. Supplemental Notes<br><br>The focus of this on-site investigation was the child occupant and Child Restraint System (CRS) in a 2001 Toyota Land Cruiser that was involved in a single-vehicle rollover crash. | | | |

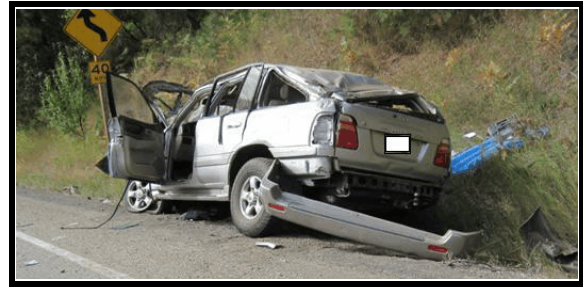
The focus of this on-site investigation was the child occupant and Child Restraint System (CRS) in a 2001 Toyota Land Cruiser that was involved in a single-vehicle rollover crash (**Figure 1**). This crash occurred in September 2010 in the southbound lanes of a state highway. The Toyota was being driven by a restrained 36-year-old female and the second row left seat was occupied by a restrained 3-year-old female seated in a high-back booster safety seat (BSS). The driver noticed that the child was attempting to get out of the seat.

**Figure 1.** Subject vehicle, 2001 Toyota Land Cruiser (police photo)

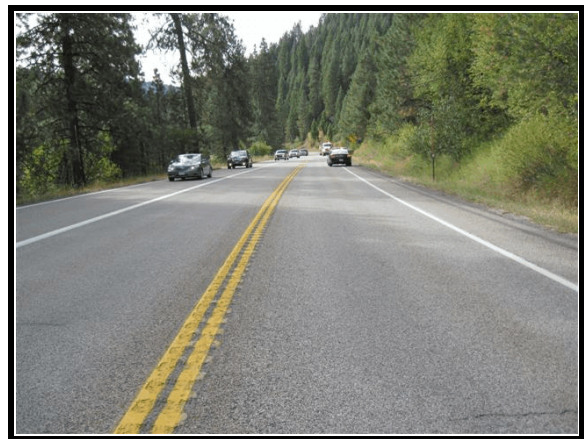
The crash site was the southbound lane of a state highway (**Figure 2**). The highway was configured with single northbound and southbound lanes that were separated by double solid yellow lines painted over a centerline rumble strip. The travel lanes were 3.3 m (11.0 ft) wide and were bordered on either side by white fog lines. The roadway was bordered on the east by an asphalt shoulder and on the west by an asphalt shoulder, a shallow ditch, and an ascending grass-covered embankment. Beyond the west shoulder there were a series of

**Figure 2.** Southbound approach (police photo)

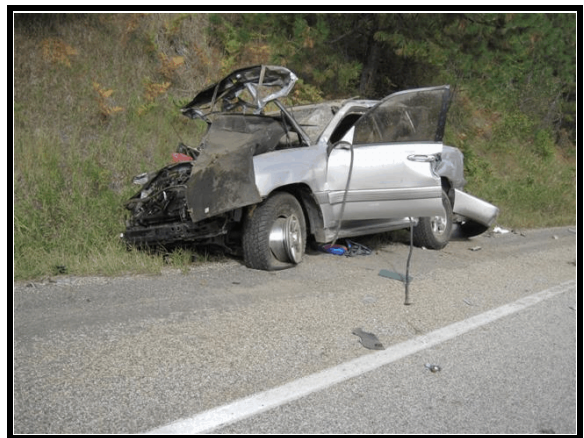
The Toyota traveled off the asphalt shoulder and impacted a metal snow pole (Event 1) (**Figure 3**). The Toyota continued off-road and traveled up an embankment. The vehicle vaulted, became airborne, and began an end-over-end rollover about its lateral axis (Event 2). The vehicle completed four quarter-turns and came to rest on the roadside on its wheels (**Figure 4**).

**Figure 4.** Subject vehicle at final rest (police photo)

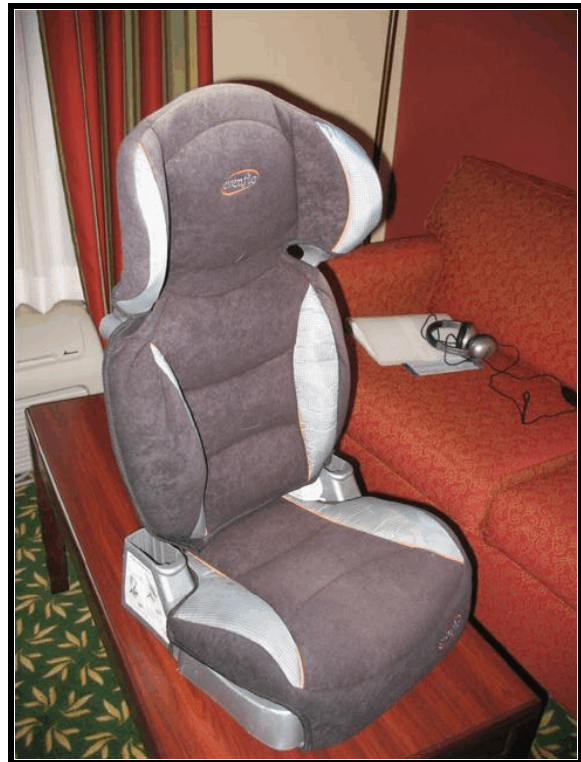
The Toyota's second row left seat position was occupied by a 3-year-old female seated in an Evenflo Big Kid forward-facing belt positioning BSS (**Figure 11**). The vehicle's lap and shoulder belt was being used in combination with the BSS. The BSS is available with or without a detachable high back support. The seat was being used with the back support in this crash.

**Figure 11.** Evenflo Big Kid BSS

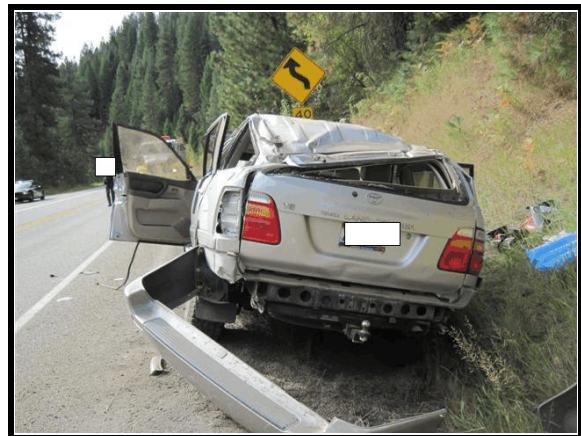
This vehicle was involved in an end-over-end, four quarter-turn rollover. The Toyota departed the roadway on the right side and traveled in a diagonal up an ascending embankment. As the vehicle reached a point on the embankment where the ground dropped away, the vehicle vaulted and became airborne. The vehicle traveled approximately 12.1 m (40.0 ft) in the air before the front of the vehicle impacted the ground, gouged the ground, and then displaced the hood (**Figure 13**). The vehicle continued the end-over-end movement as it went over on its roof and heavily impacted the area around the left D-pillar. The vehicle continued tumbling until landing on its wheels partially on the roadway. The vehicle then rolled forward a short distance and came to rest on the side of the road (**Figure 14**).

**Figure 14.** Final rest (police photo)
