**CALSPAN ON-SITE REAR IMPACT CRASH AND FIRE INVESTIGATION
OFFICE OF DEFECTS INVESTIGATION
SCI CASE NO: CA10023**

VEHICLE: 2006 FORD CROWN VICTORIA POLICE INTERCEPTOR

LOCATION: FLORIDA

CRASH DATE: MAY 2010

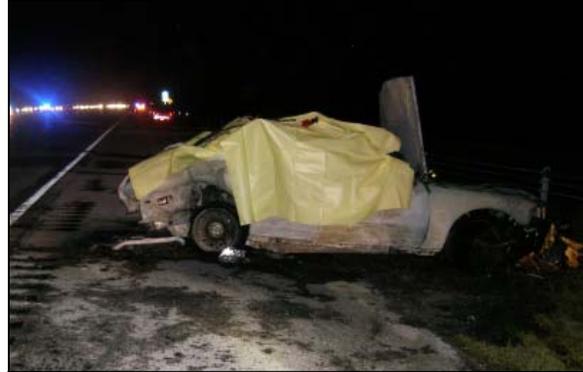
This investigation focused on the rear-impact crash of a 2006 Ford Crown Victoria Police Interceptor (CVPI) and the cause/origin of its subsequent major fire. The force of the impact incapacitated the on-duty 35-year-old male law enforcement officer, who perished in the post-crash fire. **Figure 1** is an on-scene police image of the Ford at its final rest position. At the time of the crash, the Ford was parked on the right shoulder of a northbound interstate when it was struck in the rear by a 1995 Lexus SC 300,

Figure 1: North-facing view of the Ford at final rest. Image supplied by the police investigator.

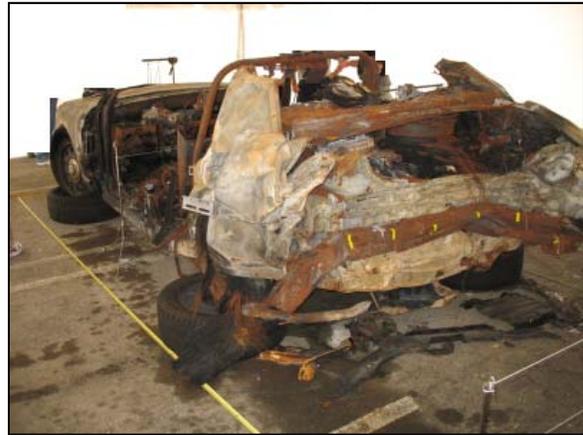
Figure 2: Right rear oblique view of the 2006 Ford CVPI.

POSITION	MAKE / MODEL	PRESSURE	TREAD DEPTH	DAMAGE
LF	Goodyear Eagle	Flat	6 mm (7/32 in)	Sidewall burned full-thickness
RF	Goodyear Eagle	Flat	7 mm (9/32 in)	Sidewall burned full-thickness
LR	Unknown	Flat	Unknown	Consumed by fire
RR	Unknown	Flat	Unknown	Consumed by fire

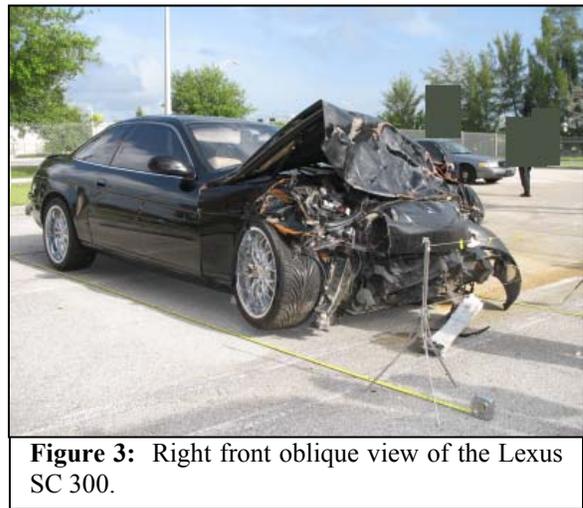
Figure 3: Right front oblique view of the Lexus SC 300.

POSITION	PRESSURE	TREAD DEPTH	DAMAGE
LF	200 kPa (29 PSI)	6 mm (7/32 in)	None
RF	Flat	6 mm (8/32 in)	Two punctures in sidewall with corresponding cut
LR	200 kPa (29 PSI)	6 mm (7/32 in)	None
RR	193 kPa (28 PSI)	4 mm (5/32 in)	None

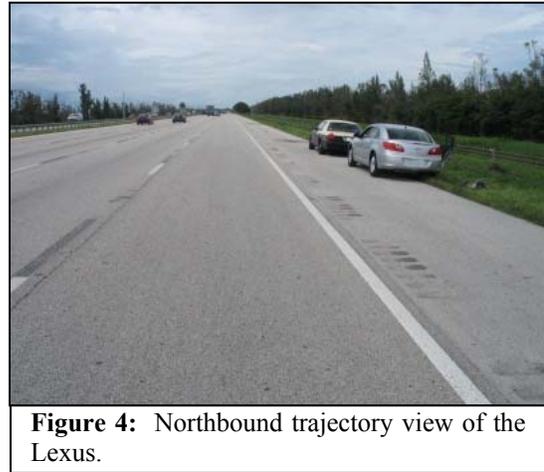
Figure 4: Northbound trajectory view of the Lexus.

According to local weather reports, the conditions during the night of the crash were clear with a temperature of 30 Celsius (86 Fahrenheit) degrees, 37-percent relative humidity, and west-southwest breeze of 10 km/h (6 mph). **Figure 4** depicts the northbound trajectory view of the Lexus as it approached the shoulder where the Ford was parked. The Crash Schematic is attached as **Figure 20**.

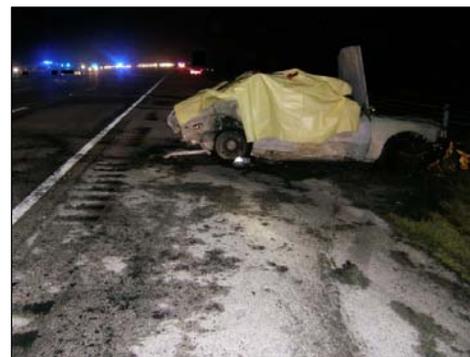
The left offset of the impact forces resulted in the clockwise (CW) rotation of the Ford as it separated from the Lexus. It rotated 100 degrees CW as it slid to rest, facing east, approximately 34.2 m (112 ft) north of the initial impact point. At rest, the Ford was straddling the pavement edge; the front tires of the vehicle were in the grass. This final rest position was documented by the on-scene law enforcement as depicted in **Figure 6**. As the gasoline continued to leak from the compromised fuel tank, the fuel pooled underneath the forward aspect of the vehicle due to the negative cross slope of the road shoulder. As the gasoline burned, the fire completely consumed the vehicle.

Figure 6: North view of the Ford's final rest position. Image supplied by the police investigator.

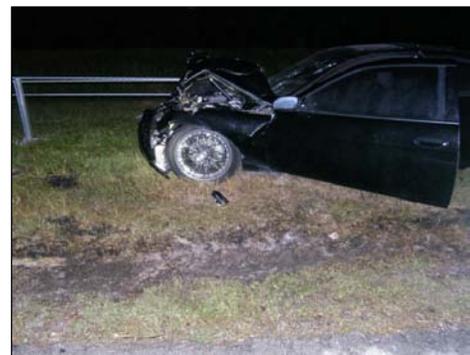
The Lexus separated with a northeast trajectory after the prolonged engagement, departed the outboard shoulder and entered the roadside grass swale area. It impacted the outboard cable guardrail in a sideswipe configuration (Event 3) and came to rest. At final rest, the Lexus remained in contact with the cable guardrail and was located approximately 22.5 m (74 ft) from the point of initial impact. The final rest position of the Lexus as documented by on-scene law enforcement is depicted in **Figure 7** (*note the burn pattern in the roadside grass swale area*).

Figure 7: East view of the Lexus's final rest position. Image supplied by the police investigator.

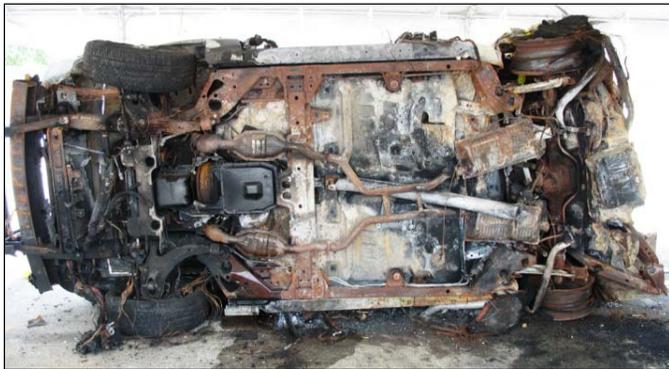
Figure 11: View of the undercarriage of the Ford.

During the impact sequence, the back section of the Ford crushed and deformed forward. The impact force fully compressed the trunk's volume and produced significant forward displacement of the rear undercarriage components resulted. The fuel tank mounted on the trunk's forward wall was displaced forward into the differential and the rear axle tube. The rear axle was displaced forward and the drive shaft fractured and separated from the differential. The aft aspect of the vehicle's frame members deformed and crushed. The arch of the left frame at the left rear wheel opening was compressed and hindered the removal of the rear axle. There was no apparent frame deformation forward of the C-pillar area. Relief cuts into the left frame arch allowed the rear axle to then be removed.

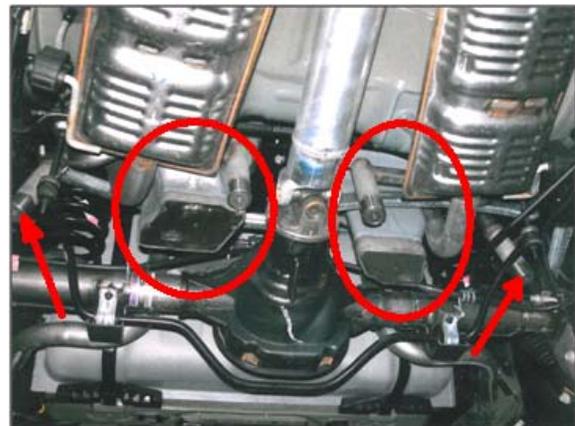
Figure 16 is an image depicting the undamaged undercarriage of an exemplar Ford and the location of the FSS. The system was designed and tested to withstand a 121 km/h (75 mph) 50 percent offset rear impact by a 1587 kg (3500 lb) vehicle under controlled conditions that involved the artificial deployment and ignition of 5.7 liter (200 oz) of gasoline.^[2]

Figure 16: View of the undamaged undercarriage of an exemplar Ford and the location of the FSS.
