CALSPAN ON-SITE MOTORCOACH FIRE INVESTIGATION

SCI CASE NO.: CA10028

VEHICLE: 1990 MCI MODEL 102-C3 MOTORCOACH

INCIDENT DATE: JUNE 2010

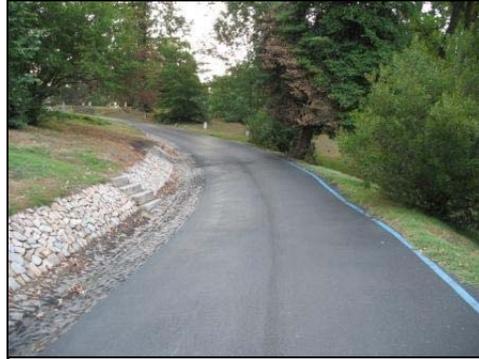
Figure 2. Overall view of the incident site and the easterly trajectory of the motorcoach.

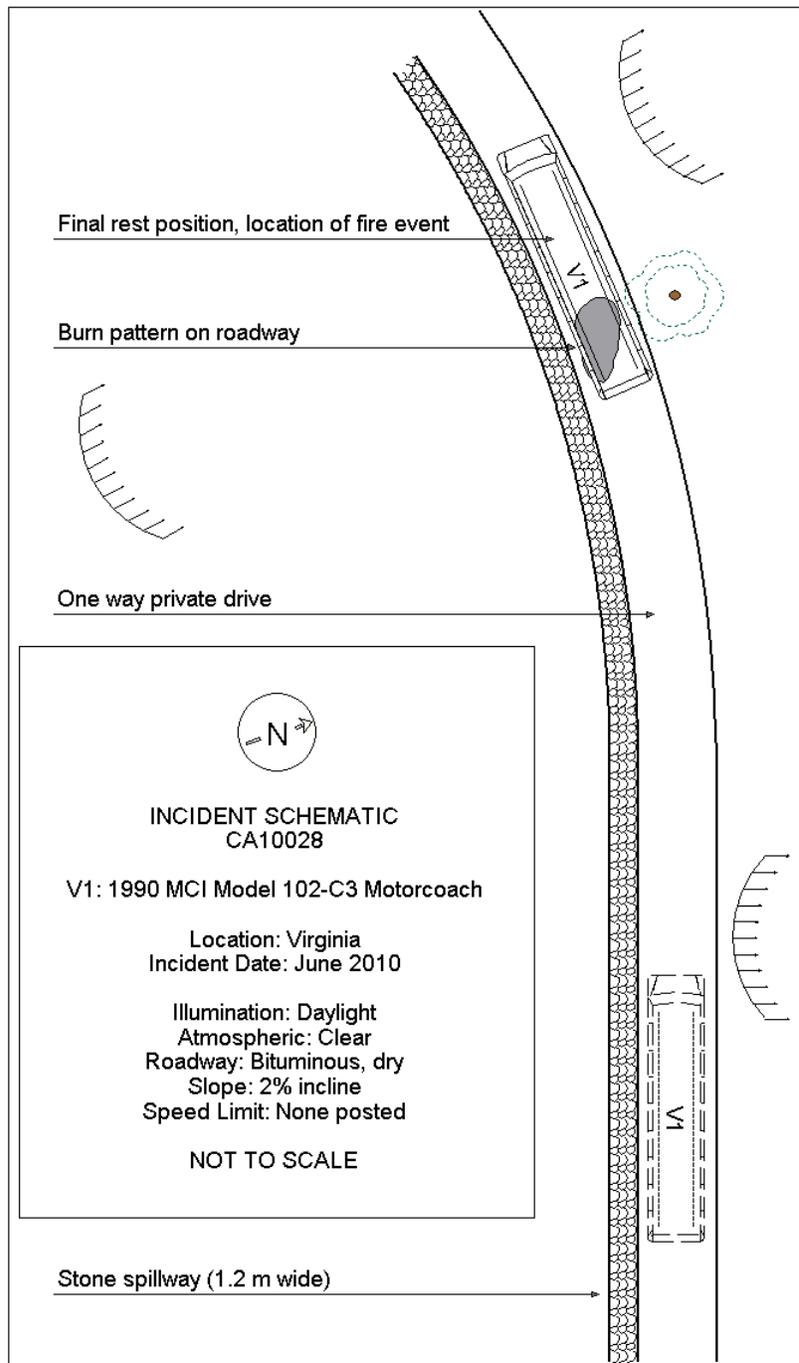
Figure 20. Incident Schematic.

The motorcoach fire occurred on a narrow one-lane, one-way road through a cemetery during daylight hours. At the time of the incident, the weather was cloudy and dry. According to local weather forecasts, the temperature was 31 degrees C (88 degrees F) with relative humidity of 48 percent and easterly winds of 8-13 km/h (5-8 mph). The one-lane road was surfaced with asphalt and was 3.3 m (11.0 ft) in width. On the approach to the incident site, the road was straight and transitioned to a left curve with a two percent positive grade. The left side of the road was bordered by a hand-laid cobble stone shoulder/rain gutter. Located outboard of the stone rain gutter was a steep embankment with a positive slope with stone that transitioned to a grass surface. The right roadside consisted of a negative slope that was grass surfaced. A large diameter hardwood tree was located 1.4 m (4.6 ft) outboard of the pavement edge and was scorched by the fire. **Figure 2** is an overall view of the incident site and the pre-incident trajectory of the motorcoach. A schematic of the incident site is included as **Figure 20**.
