**CALSPAN ON-SITE SIDE IMPACT INFLATABLE OCCUPANT
PROTECTION SYSTEM CRASH INVESTIGATION
SCI CASE NO.: CA10029**

VEHICLE: 2010 HYUNDAI ACCENT GLS

LOCATION: NORTH CAROLINA

CRASH DATE: JUNE 2010

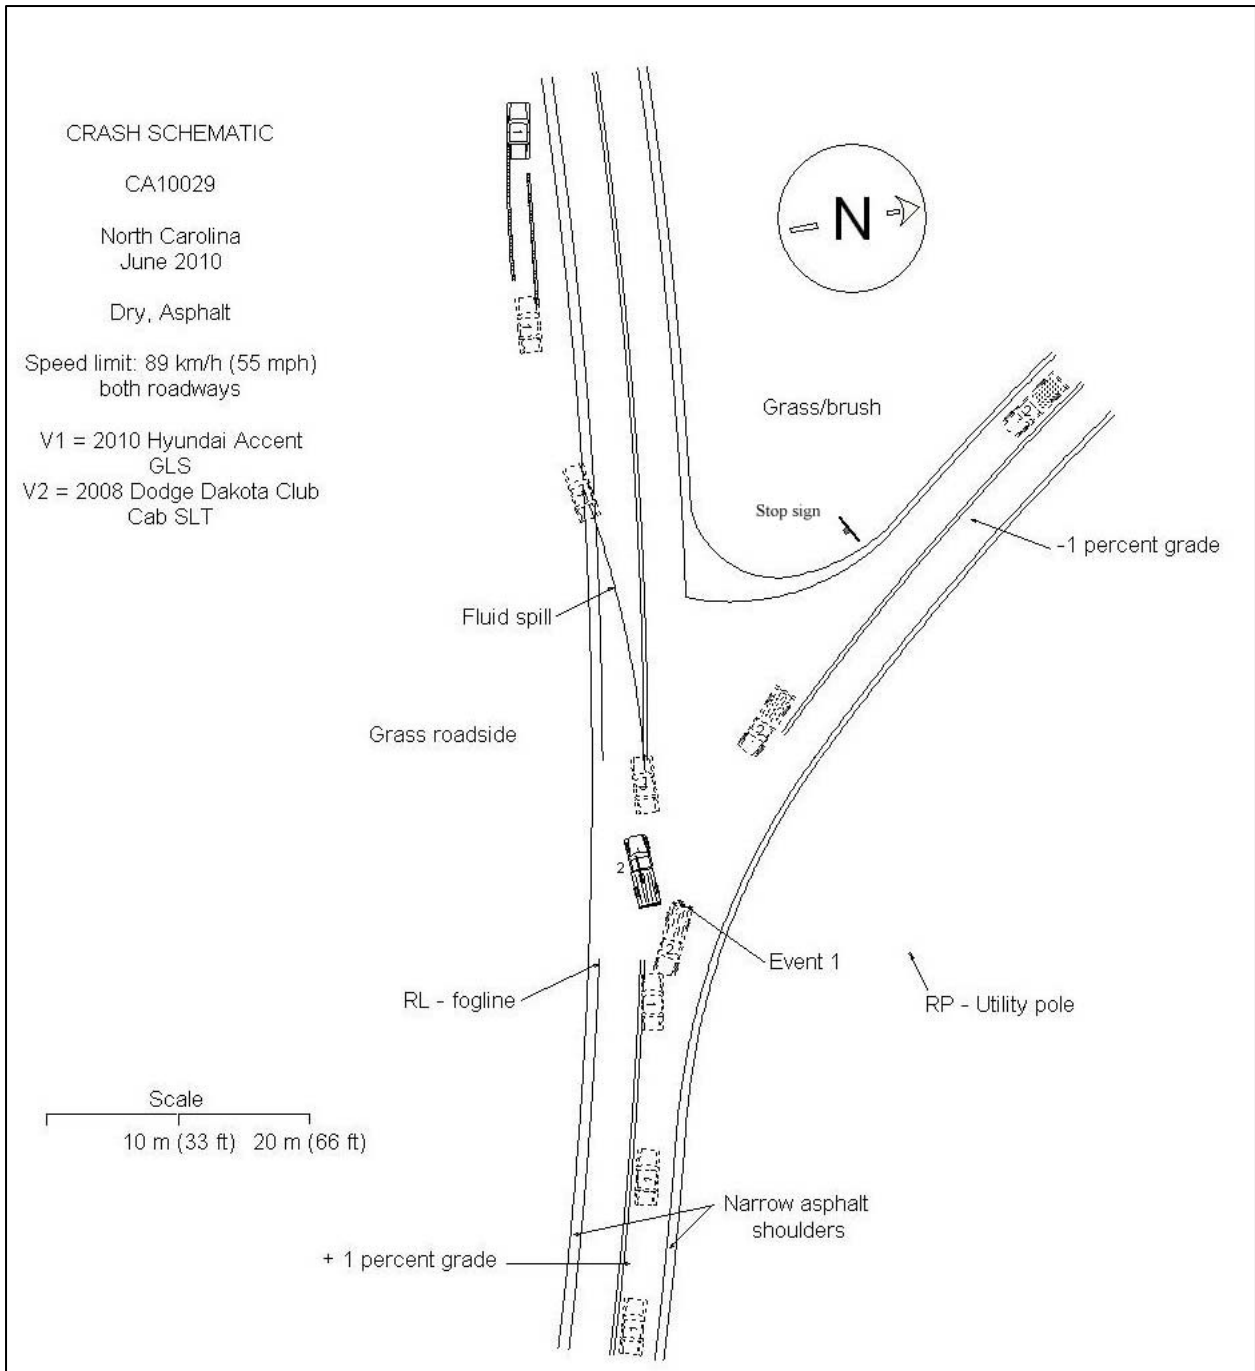
Figure 9: Crash Schematic

asphalt surfaced travel lanes that measured 3 m (9.8 ft) in width and was bordered by asphalt shoulders 40 cm (1.3 ft) in width. From the north, the intersecting roadway included a curve to the left with a radius of curvature of 216 m (709 ft). The intersecting roadway was controlled by a stop sign. The speed limit for both roadways was 89 km/h (55 mph). The Crash Schematic is included as **Figure 9** of this report.

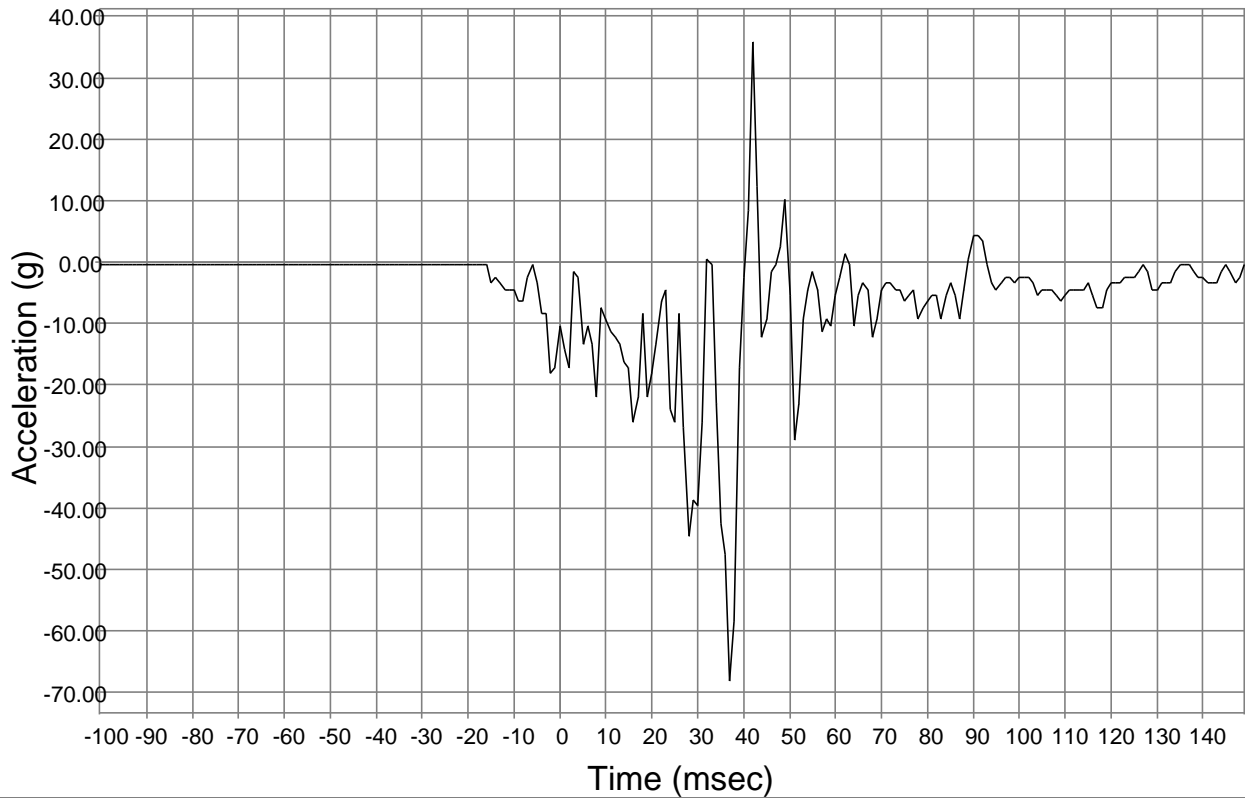
Longitudinal Crash Pulse (Most Recent Event)

The EDR also recorded the bi-directional acceleration pulse of the crash. The crash pulse data was 250 milliseconds in length and was broken into pre-deployment and post-deployment as defined by the time line. The pre-deployment data was 100 milliseconds in length and the post-deployment data was 149 milliseconds in length. Again, T0 (Time zero) was defined as the time of air bag deployment. Independent SCI analysis of the crash pulse determined the maximum longitudinal and lateral delta-V components of the Dodge were -45.5 km/h (-28.3 mph) and +14.0 km/h (+8.7 mph), respectively. A review of the crash pulse data indicated the air bag deployed 15 milliseconds after the time of the initial vehicle-to-vehicle contact.
