**CALSPAN ON-SITE ROLLOVER CRASH INVESTIGATION
SCI CASE NO.: CA10035**

VEHICLE: 2010 NISSAN SENTRA

LOCATION: NORTH CAROLINA

CRASH DATE: AUGUST 2010

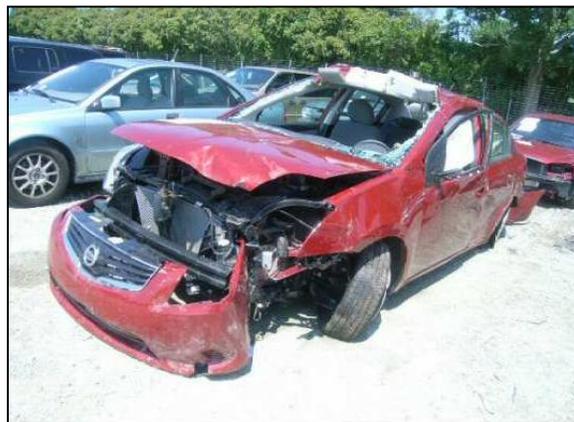
Figure 1: Front left oblique view of the 2010 Nissan Sentra.

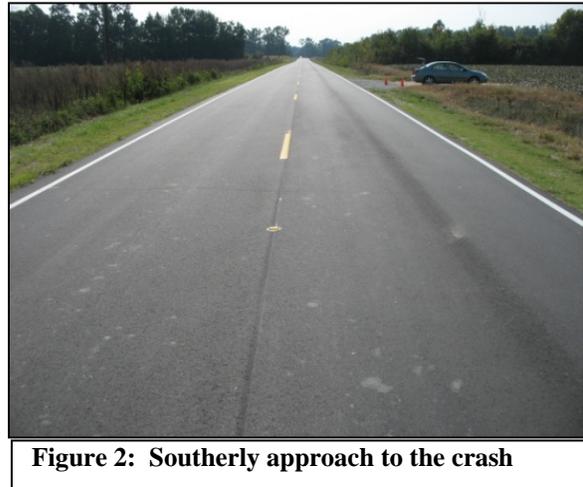
This crash occurred during daylight hours on a two-lane rural roadway. **Figure 2** depicts the southerly approach to the area of the crash site. The roadway extended northwest/southeast, was straight and had a level grade throughout the area in which the crash occurred. The travel lanes measured 3.2 m (10.5 ft) in width and were bordered on the outboard sides by narrow asphalt shoulders 40 cm (15.7 in) in width. Outboard of these shoulders were grass roadsides with a negative grade of 1.5 percent. On the west roadside, the grass shoulder measured 2 m (6.6 ft) in width prior to transitioning to a drainage ditch 2.7 m (8.8 ft) wide and 50 cm (19.7 in) deep. Beyond the drainage ditch was an agricultural field. The speed limit on this section of road was 89 km/h (55 mph). A Crash Schematic is included as **Figure 8** at the end of this report.
