# INDIANA UNIVERSITY

## ON-SITE OFFICE OF DEFECTS INVESTIGATION AIR BAG NON-DEPLOYMENT INVESTIGATION

CASE NUMBER - IN10041  
LOCATION - MARYLAND  
VEHICLE - 2007 FORD ESCAPE XLT  
CRASH DATE - October 2010

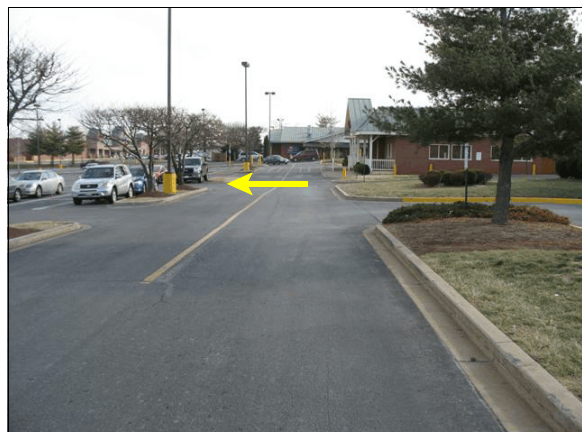
**Figure 2:** View southeast of approach of the Ford on the parking lot access roadway; arrow shows entrance where the Ford entered the parking lot

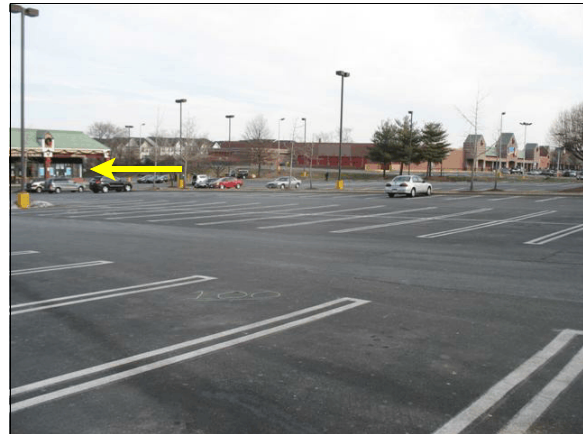
**Figure 3:** Approach through the parking lot to the impact with the building; arrow shows the impacted building (view northeast)

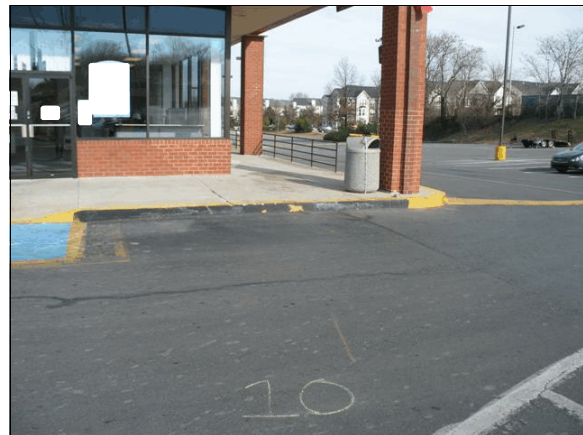
**Figure 4:** Approach northeast to the impacts with the curb, building, trash can, and brick support column
