CALSPAN ON-SITE CHILD RESTRAINT SYSTEM CRASH INVESTIGATION

SCI CASE NO.: CA11001

VEHICLE: 2007 HONDA ODYSSEY EX-L

CRASH DATE: DECEMBER 2010

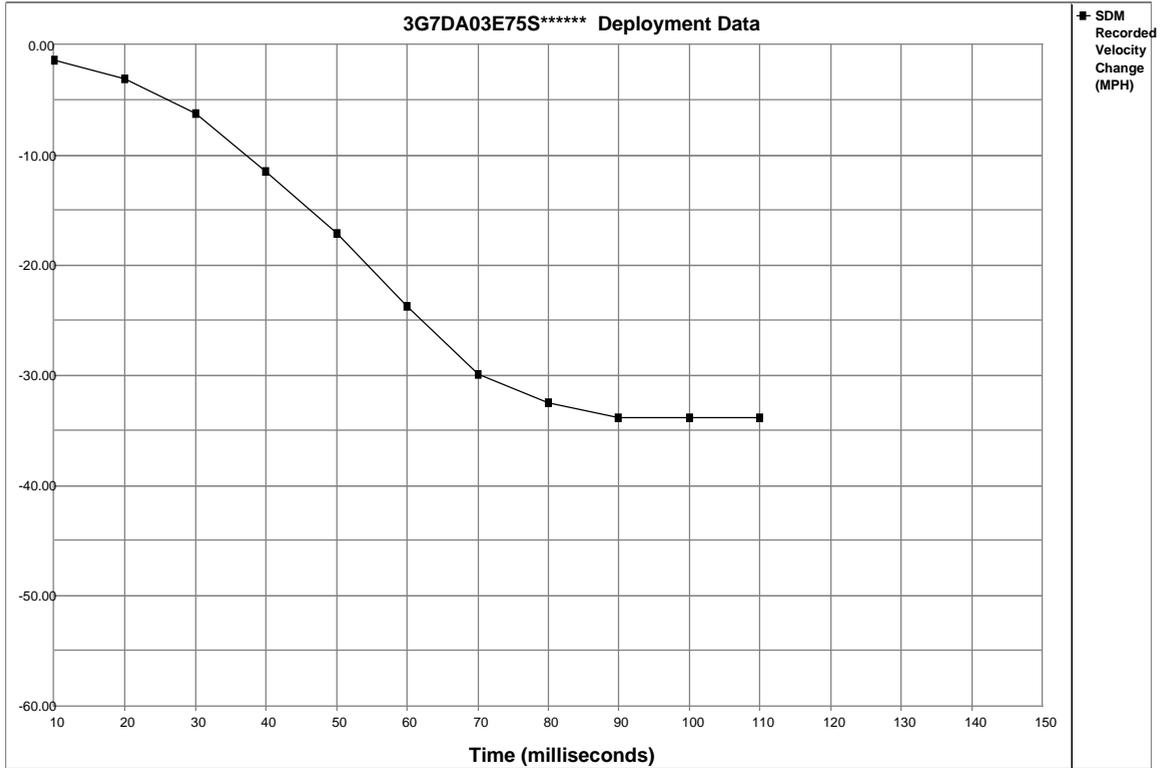
Time (milliseconds)	10	20	30	40	50	60	70	80	90	100	110	120	130	140	150
SDM Recorded Velocity Change	-1.32	-3.07	-6.14	-11.41	-17.11	-23.70	-29.84	-32.47	-33.79	-33.79	-33.79	N/A	N/A	N/A	N/A

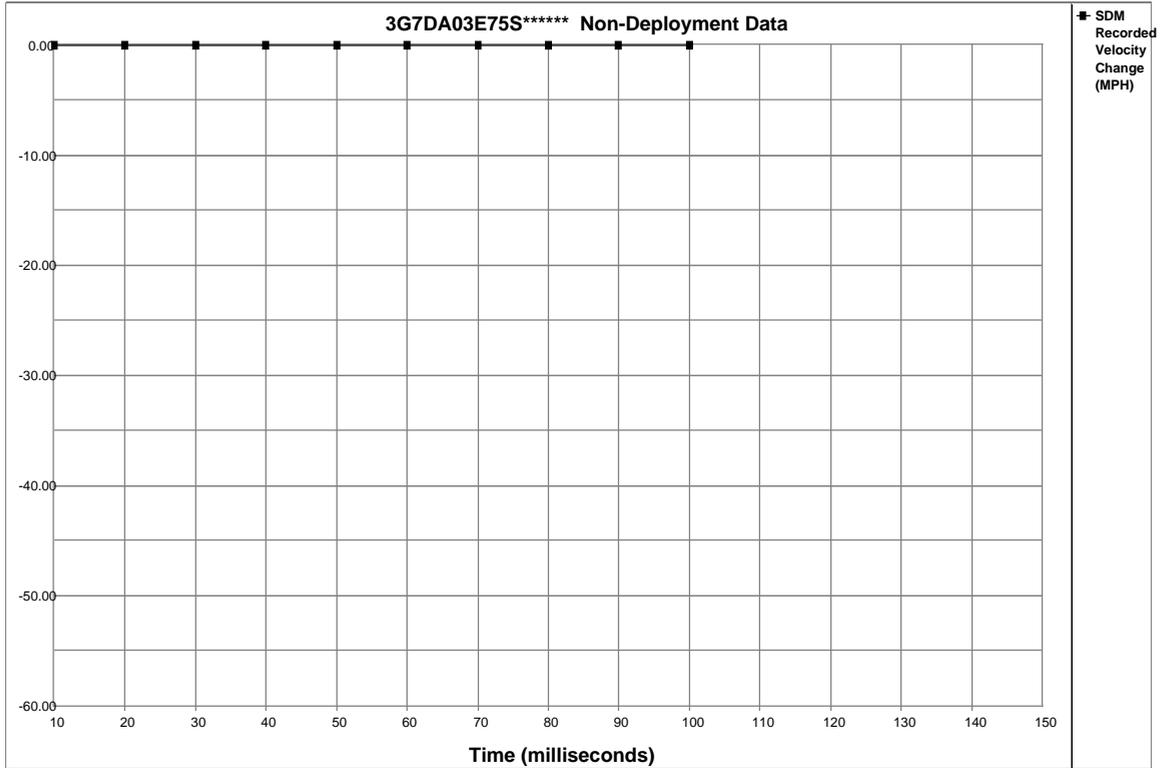
Time (milliseconds)	10	20	30	40	50	60	70	80	90	100	110	120	130	140	150
SDM Recorded Velocity Change	0.00	0.00	0.00	0.00	0.00	0.00	0.00	0.00	0.00	0.00	N/A	N/A	N/A	N/A	N/A
