On-Site Child Restraint System Investigation
Dynamic Science, Inc. (DSI)
Case Number DS11004
2002 Honda Odyssey
Arizona
March 2011

Dynamic Science, Inc.
Crash Investigation
Case Number: DS11004

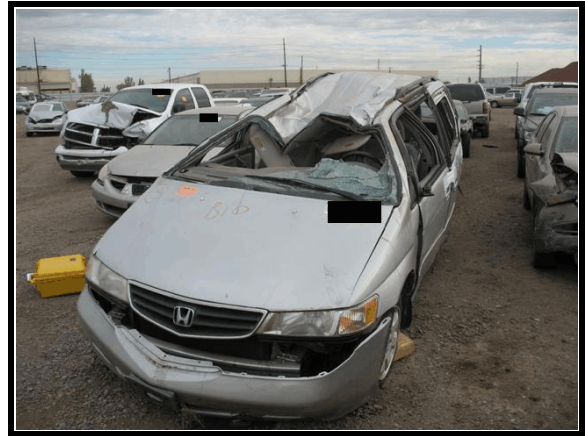
Figure 1. 2002 Honda Odyssey van

This on-site investigation focused on the child occupants and the Child Restraint Systems (CRSs) in a 2002 Honda Odyssey involved in a single vehicle rollover crash (**Figure 1**). This crash occurred in March 2011 on an interstate highway. The vehicle is a 2002 Honda Odyssey van that was being driven eastbound by a restrained 31-year-old male. The second row right seat was occupied by a restrained 27-year-old female. There were three child occupants seated in CRSs (**Figure 2**). A 6-year-old female was seated in the second row left outboard position in a tethered Safeguard CRS. A 4-year-old female was seated in the third row left outboard position in a tethered Safeguard CRS. A 2-year-old female was seated in the third row right outboard position in a rear-facing Brio Zento CRS.

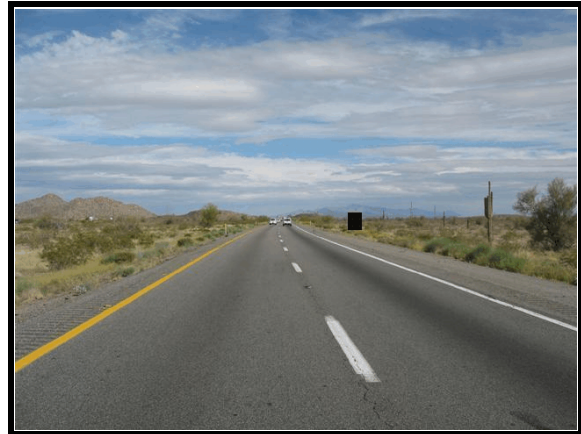
Figure 3. Eastbound approach

This crash took place in the eastbound lanes of a two-lane divided interstate highway (**Figure 3**). At the time of the crash it was dark and clear and the roadway was dry. The temperature at the nearest reporting station was 14.0° C (57.3° F), the wind direction was west northwest at 9.3 km/h (5.8 mph), and the visibility was 16.0 km (10 mi). The highway was configured with two lanes that were separated by dashed white lines. The asphalt roadway was slightly curved to the right and level. The roadway was bordered on both sides by asphalt shoulders with continuous rumble strips near the edge line. Beyond the left shoulder, the roadway was bordered on the north by grass-covered median that terminated at the westbound lanes of the highway. Beyond the right shoulder, the roadway was bordered by a descending embankment, an area of level dirt and brush, and a barbed wire fence that runs parallel to the roadway. The fence was located 22.9 m (75.0 ft) south of the roadway shoulder. The posted speed limit was 121 km/h (75 mph).
