**CALSPAN ON-SITE IMPACT FIRE INVESTIGATION**

**SCI CASE NO.: CA11018**  
**OFFICE OF DEFECTS INVESTIGATION**

**VEHICLE: 2008 DODGE CHARGER POLICE VEHICLE**

**CRASH DATE: APRIL 2011**

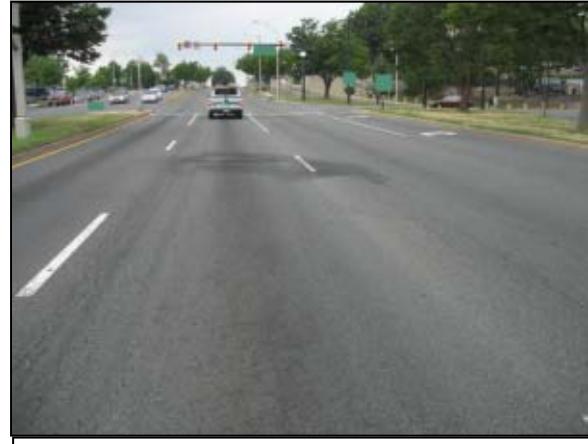
**Figure 2:** Westbound trajectory view of the Dodge approaching the point of impact and final rest position.

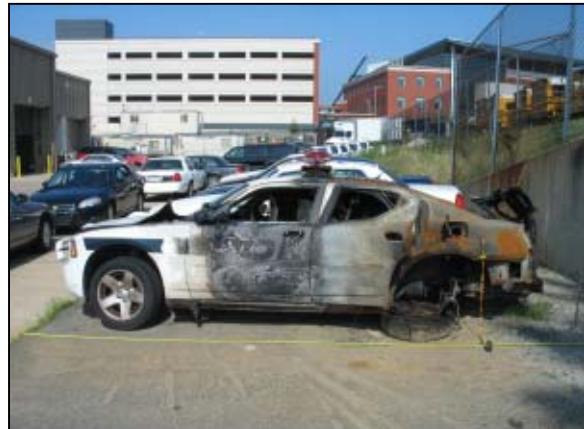
**Figure 3:** Left side view of the Dodge Charger.

Position	Measured Pressure	Measured Tread Depth	Restriction	Damage
LF	241 kPa (35 PSI)	2 mm (3/32 in)	No	None
LR	Tire Flat	Unknown	No	75% Tire burned and debeaded, Rim deformed
RR	Tire Flat	Unknown	No	100% Tire burned
RF	Tire Flat	2 mm (3/32 in)	No	None

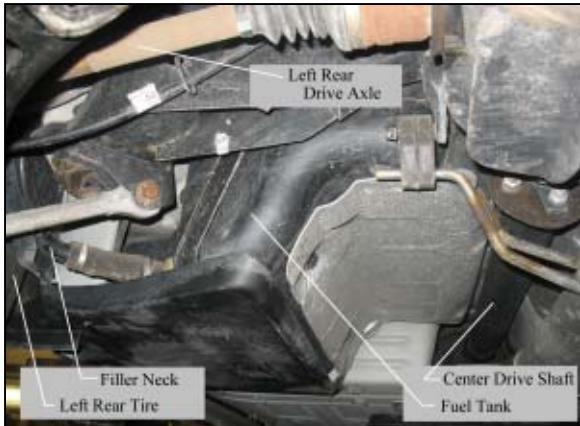
hose that was approximately 13 cm (5 in) in length. This hose was secured to the filler tube and the check valve with two stainless steel hose clamps. **Figure 5** is a view of the undercarriage of an exemplar Dodge taken below the rear axle looking forward depicting the designed orientation of the fuel tank, the tank inlet, and the left rear suspension. **Figure 6** is a closer view of the exemplar depicting the filler neck and its connection at the tank inlet.

**Figure 5:** View depicting the orientation of the undercarriage of an exemplar Dodge Charger.

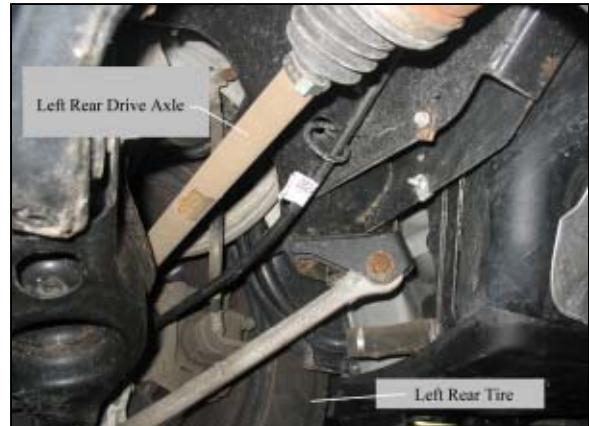
The filler tube was secured within the quarter panel/filler door area with a rubber boot and a retainer clip. The filler tube was formed to follow the contour of the forward aspect of the inner fender and extended to the fuel tank, inboard of the inner fender and the wheel opening. The 3 cm (1 in) diameter filler tube was steel construction and approximately 81 cm (32 in) in length. The filler tube connected to the tank inlet check valve with a 4 cm (1.5 in) diameter neoprene

**Figure 6:** Closer view of the exemplar Dodge depicting the orientation at the left rear wheel/suspension.
