**VERIDIAN ON-SITE AIR BAG RELATED/ADULT PASSENGER  
FATALITY INVESTIGATION**

**VERIDIAN CASE NO. CA97-007  
VEHICLE: 1995 CHRYSLER NEW YORKER  
LOCATION: PENNSYLVANIA  
CRASH DATE: FEBRUARY 1997**

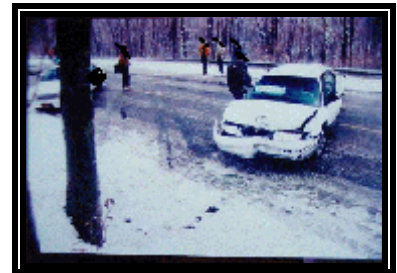
**Figure 1. Lookback view of the New Yorker's frontal air bag deployment crash.**

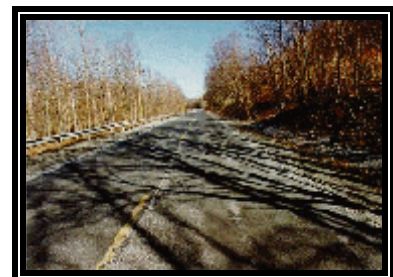
The crash occurred on a rural two-lane state route (**Figure 2**) in February 1997, during daylight hours. The asphalt road surface was slush covered from mixed precipitation. In the vicinity of the crash scene, the roadway was straight with a one-percent positive grade to the east and a posted speed limit of 89 km/h (55 mph). The travel lanes were bordered by stone shoulders with a W-beam guardrail system paralleling the left (north) shoulder. The right shoulder was bordered by an embankment with a mixture of trees.

**Figure 2. Overall view of the crash scene.**

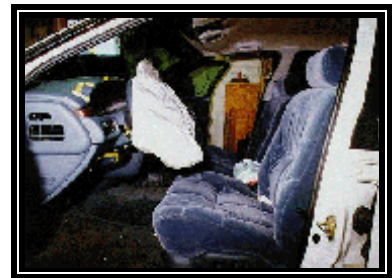
The driver of the Chrysler New Yorker was seated in a presumed upright posture with the power seat track adjusted 2.5 cm (1.0") forward of the full rear position. The seat back support was adjusted to 18 degrees rearward of vertical and the adjusted head restraint was in the full down position. With the seat adjusted to this position, the horizontal distance between the mid point of the driver air bag module and the seat back support was 57.2 cm (22.5"). [This is inclusive of 2.5 cm (1.0") of steering column compression.] **Figure 10** is a profile view of the driver's seated position with respect to the frontal air bag. He was not wearing the 3-point manual lap and shoulder belt system. The belt system was fully retracted against the B-pillar with the D-ring adjusted to a point that was 2.5 cm (1.0") below the top adjustment position. The lack of belt usage was supported by kinematics of the driver and his interior contact points. Additionally, the belt system was in new condition with no evidence of belt loading or routine usage indicators.

**Figure 10. Driver's seated position.**
