INDIANA UNIVERSITY

TRANSPORTATION RESEARCH CENTER

ON-SITE AIR BAG NON-DEPLOYMENT INVESTIGATION

CASE NUMBER - IN97-016
LOCATION - KENTUCKY
VEHICLE - 1995 CHEVROLET ASTRO CS
CRASH DATE - January, 1997

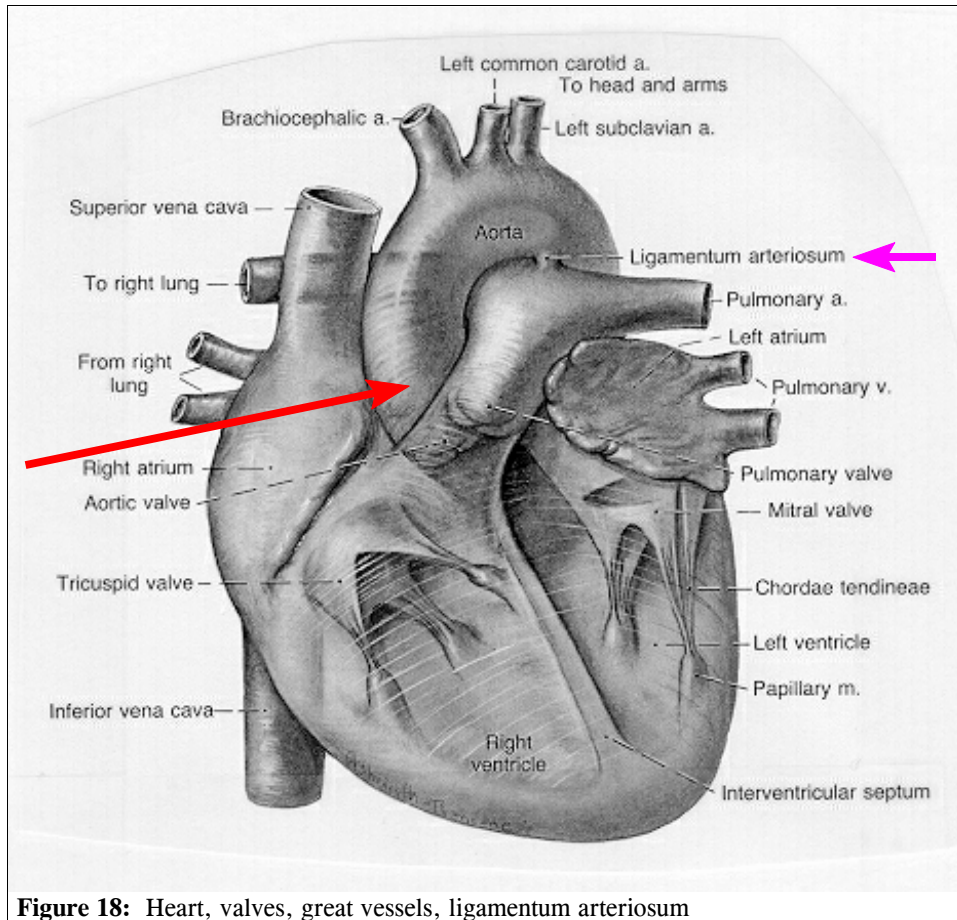
structures causes the heart and great vessels to be jerked away from the posterior chest wall to which the thoracic aorta is attached. This traction on the ligament ductus arteriosus and descending aorta at its point of fixation is sufficient to lacerate the aorta immediately below the origin of the left subclavian artery.

Figure 18: Heart, valves, great vessels, ligamentum arteriosum
