On-scene / Vehicle to Vehicle  
Dynamic Science, Inc. / Case Number: DS97028  
1998 Toyota RAV 4  
California  
December/1997

1. Report No. DS97028		2. Government Accession No.		3. Recipient Catalog No.	
4. Title and Subtitle In-Depth Accident Investigation				5. Report Date	
				6. Performing Organization Report No.

Description: This case was initiated in response to a report of de-powered air bag deployment in a 1998 Toyota RAV4.

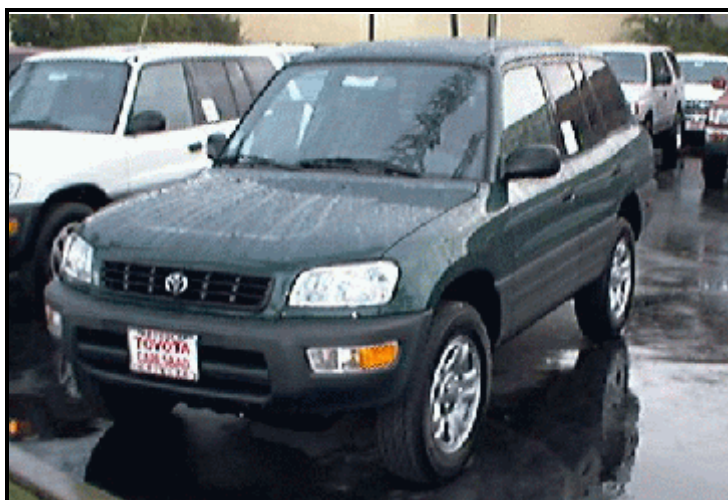
**Figure 3.** Exterior, Vehicle 1

Description:	1998 Toyota RAV 4, four-door, 2 wheel drive	
VIN:	JT3GP10V8WXXXXXXX	
Odometer:	Unknown (Digital)	
Engine:	2.0 liter, 4 cyl.	
Reported Defects:	None	
Cargo:	None	
Damage Description:	Moderate crush to front bumper and grille, left front tire was cut and the rim cracked, rear door buckled.	
CDC:	12FYEW2	
Minimum pre-braking travel speed, using slide to stop as one speed and the delta V as an impact speed: <sup>1</sup>	39.4 km/h (24.5)	
Delta V:	Total	21.6 km/h (13.4 MPH)
	Longitudinal	-21.3 km/h (-13.2 MPH)
	Lateral	-3.8 km/h (-2.3 MPH)
	Energy	39,589 joules (29,221 ft-lbs)

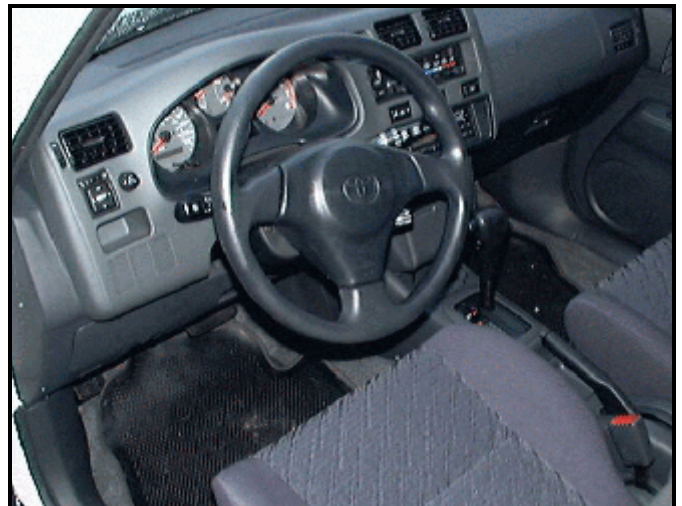
Figure 6. Driver's side air bag

The right front seat was positioned between the forward most and middle track position--11.5 cm (4.5 in.) from the rear most position. The vehicle was equipped with front shoulder belt pretensioners with force limiters, and adjustable front outboard shoulder belt anchors. Both shoulder belts were found in the locked position at the time of the inspection. The three spoke steering wheel was equipped with driver's side air bag. The driver's side air bag is 54 cm (21.2 in.) in diameter with a maximum excursion of 30 cm (11.8 in.). It has two tethers and two vents. There was a blue 20 x 10 cm (7.9 x 3.9 in.) fabric transfer found on this air bag.
