ON-SITE AIR BAG INVESTIGATION

CASE NUMBER - IN97-034

VEHICLE - 1997 HYUNDAI ACCENT L

CRASH DATE - October, 1997

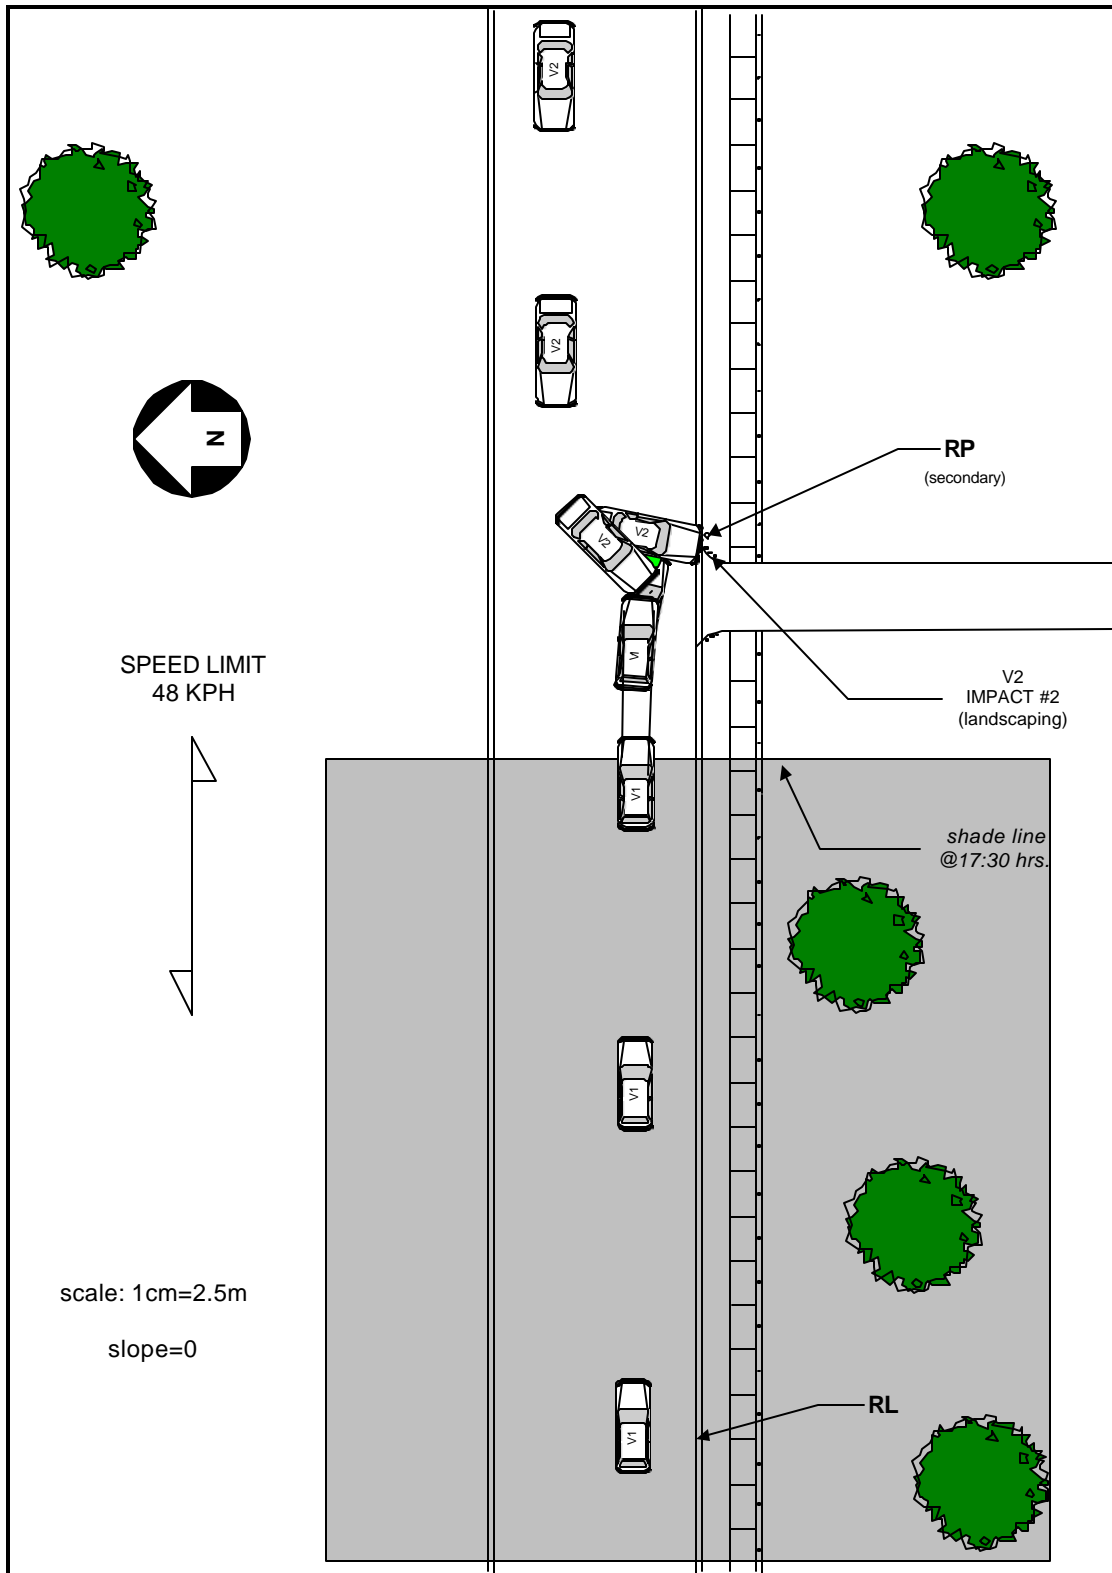
CRASH DIAGRAM

The case vehicle was traveling east in the eastbound lane of a two-lane, undivided, city street (**Figure 1**) and intended to continue traveling eastbound. Vehicle #2 had been traveling west in the westbound lane of the same residential roadway and was making a left-hand turn into a private driveway (see **CRASH DIAGRAM** below). It should be noted that the vision of vehicle #2's driver was obscured due to the setting sun. The case vehicle's driver braked, attempting to avoid the crash. The case vehicle deposited approximately 7.3 meters (24 feet) of faint skid marks prior to impact (**Figure 2**). The crash occurred in the eastbound lane of the roadway, within the three-leg junction of the driveway.
