ON-SITE ASYMMETRICAL AIR BAG DEPLOYMENT INVESTIGATION

CALSPAN CASE NO. CA97-049

VEHICLE - 1993 MERCURY SABLE

CRASH DATE - AUGUST, 1997

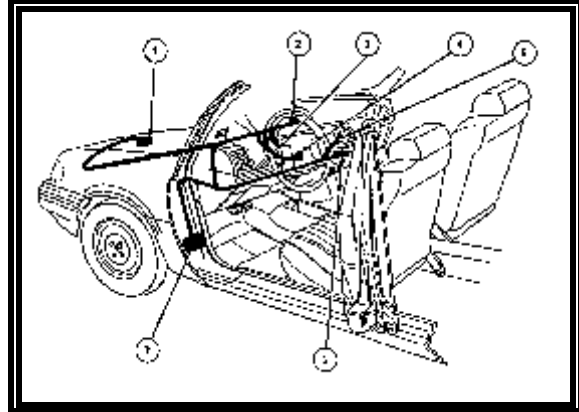
Figure 12: Mercury Sable SRS Components.

The Mercury Sable was equipped with a Supplemental Restraint System (SRS) that consisted of driver and front passenger air bags. The driver air bag module was located in the typical manner in the center hub of the steering wheel. The passenger air bag module was configured as a mid mount on the right side of the instrument panel. **Figure 12** is a layout schematic of the SRS. The components and their respective locations are described in the table below.

The SRS is designed to deploy both the driver and front passenger air bag modules when at least one primary crash sensor and the safing sensor close under vehicle specific parameters related to crash severity. The repair manual for the Mercury indicated the upper bound of the air bag deployment threshold was a barrier equivalent speed of 22.5 km/h (14.0 mph). In the subject crash, the SRS was properly triggered by the sensors, however, only the front passenger air bag deployed in the crash. Technical representatives from the Ford Motor Company were present during the inspection of the Mercury and were asked to participate in the inspection specifically to diagnose the cause of the driver air bag non-deployment. The following procedure was used to diagnose the SRS:
