ON-SITE AIR BAG INVESTIGATION

CASE NUMBER - IN97-051
LOCATION - KENTUCKY
VEHICLE - 1996 BUICK CENTURY SPECIAL
CRASH DATE - December, 1997

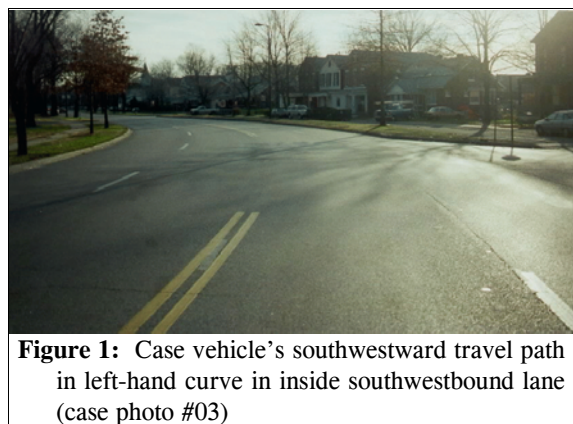
The case vehicle was traveling southwest while traversing a left-hand curve in the inside, southwestbound lane of a four-lane, undivided, state highway and was approaching a "Tee" intersection (**Figure 1**), intending to continue in a southerly travel path after exiting the curve (i.e., there were two through lanes in each direction, but the inside northeastbound lane also served as a left-hand turn lane). The Plymouth had been traveling north in the inside, northbound lane of the same four-lane, undivided, state road. The Plymouth entered and began traversing the right-hand curve, intending to continue in a northeasterly travel path (**Figure 2** below). When the Plymouth drifted left-of-center, near the apex of the curve, the case vehicle's driver steered to the right, attempting to avoid the crash. The

crash occurred within the “Tee” intersection, in the southerly lane of the state roadway; see **CRASH DIAGRAM** below.
