## TRANSPORTATION RESEARCH CENTER

### ON-SITE AIR BAG NON- DEPLOYMENT INVESTIGATION

CASE NUMBER - IN97-052  
LOCATION - TEXAS  
VEHICLE - 1995 CHEVROLET C-1500 PICKUP  
CRASH DATE - June, 1997

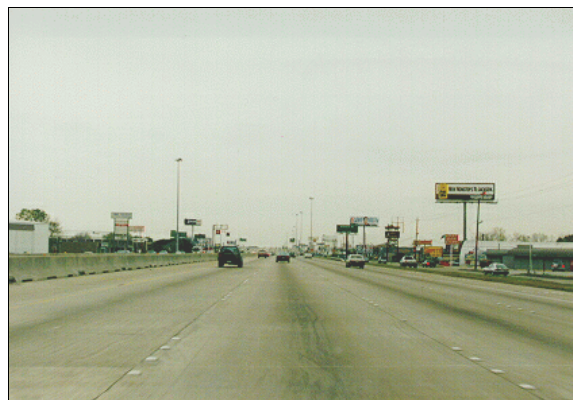
**Figure 1:** Case vehicle's northwestward travel path in inside center (3<sup>rd</sup>) lane of northwestbound roadway (case photo #01)

The state highway was straight and level (**Figure 1**) with a heading of 321 degrees at the area of impact. The pavement was concrete, but sharp, and the width of each of the four travel lanes was measured at 3.7 meters (12 feet). The shoulders were improved (i.e., concrete) and the northwestbound roadway had 3.7 meter (12 foot) wide shoulders on both the northeast and southwest sides of the roadway. The northwest and southeastbound roadways were divided by a median with concrete barriers. Pavement markings consisted of single broken white lane lines with intermittent raised pavement markers separating each lane. In addition the roadway was bordered by a solid white edge line on the outside lane and a solid yellow "no passing" line along the inside lane at the median. The estimated coefficient of friction was 0.70, when dry. There were guide signs and regulatory signs posted along the side of the roadway. The legal posted speed limit was 89 km.p.h. (55 m.p.h.). At the time of the crash the light condition was daylight, the atmospheric condition was overcast but without precipitation, and the road pavement was extremely wet from a torrential rain storm that had just hit the area moments prior to the crash. Traffic density was moderate, and the site of the crash was urban commercial.

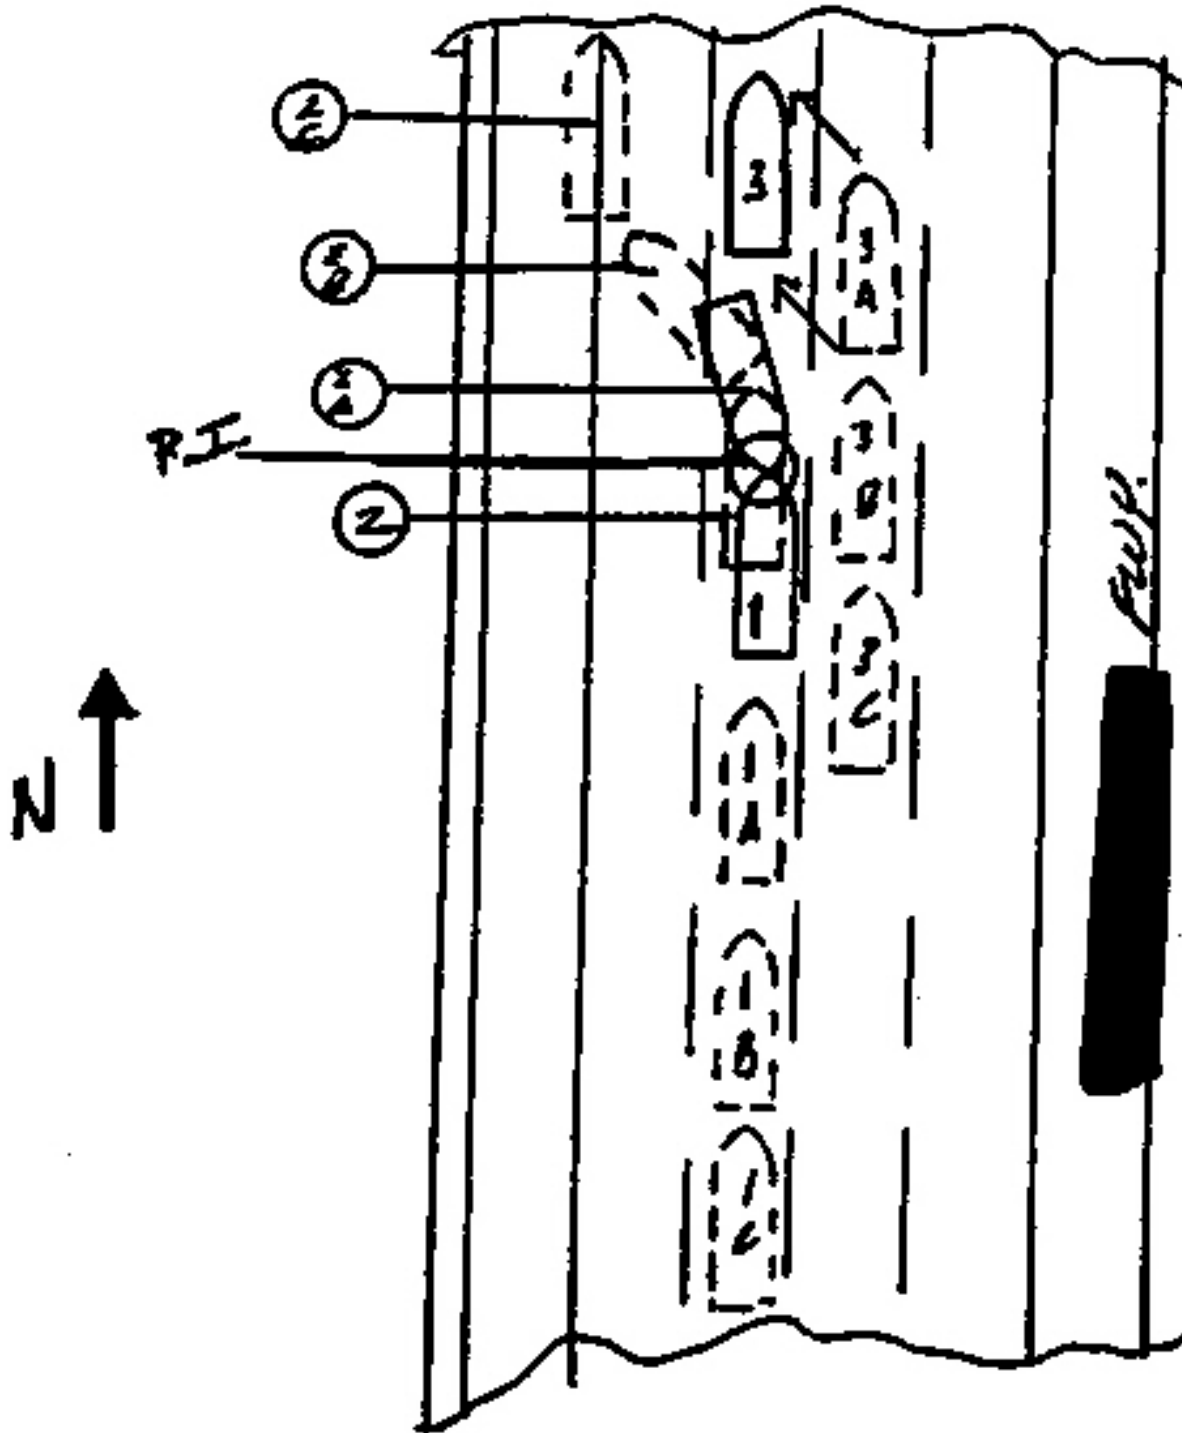
**Sketch from Police Crash Report:** Note: movement of the case vehicle is labeled 1C, 1B, 1A, and 1, respectively. Movement of the other vehicle is labeled 2, 2A, 2B, and 2C. Movement of the noncontact vehicle is labeled 3C, 3B, 3A, and 3. In this sketch, the initial impact occurred at positions 1 and 2A. Finally, the north arrow is not correct. The heading angle for the roadway was approximately 320 degrees.
