TRANSPORTATION RESEARCH CENTER

DEPOWERED AIR BAG REPORT

CASE NUMBER - IN97-056
LOCATION - ALABAMA
VEHICLE - 1998 CADILLAC DEVILLE CONCOURS
CRASH DATE - December 1997

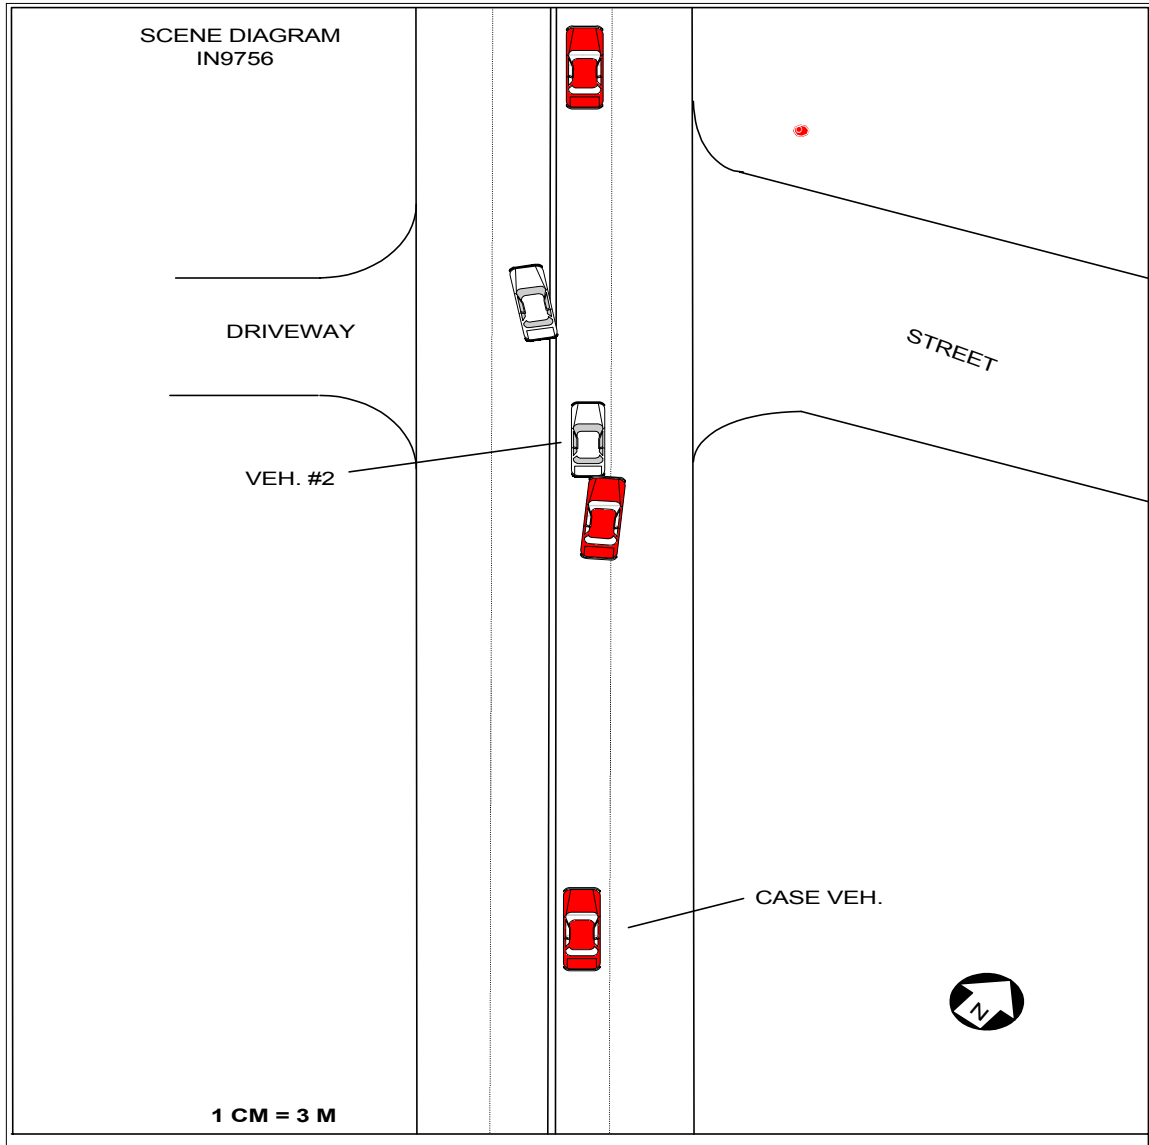
Vehicle #2 was a rear wheel drive 1979 Oldsmobile Cutlass Supreme two-door sedan (VIN: 3M47H9D-----). The damage was located at the back right corner, with direct contact to the bumper, tail light area, trunk lid and right rear quarter panel. The wheelbase was shortened by 8 centimeters [3 inches] on the right and maximum crush was 59 centimeters [23 inches] at the back right corner (see **Figures 10 - 12**). The CDC for vehicle #2 is **06-BZEW-3**. The ROLDMIS reconstruction algorithm was used to compute delta v because the case vehicle was dis-assembled and a crush profile could not be measured. The calculations for vehicle #2 indicate total delta v of 25 km.p.h. [15 m.p.h.], with +25 km.p.h. [+15 m.p.h.] longitudinal and +2 km.p.h. [+1 m.p.h.] lateral. There were three occupants in vehicle #2, none of whom sustained any police reported injury.

Figure 11: Right side of vehicle #2 (case photo #40)
