**VERIDIAN REMOTE REDESIGNED AIR BAG INJURY
INVESTIGATION
SCI TECHNICAL SUMMARY REPORT**

NASS CDS CASE NO. 1998-09-053A

VEHICLE - 1998 SATURN SL

LOCATION - STATE OF MARYLAND

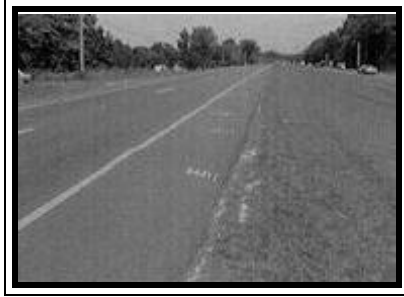
The Saturn approached the crash site traveling in an easterly direction in the second eastbound travel lane at an estimated travel speed of 89-97 km/h (55-60 mph). The Saturn driver was grossly intoxicated (BAC=0.28) and may have either fallen asleep or passed out, relinquishing steering control. The Saturn exited the left edge of the eastbound travel lanes at a shallow departure angle, crossed the depressed grass median, and then entered the westbound travel lanes, the Saturn began arcing to the left, crossing the outboard westbound lane and entered the inboard or first westbound lane (**Figure 1**).

Figure 1. Eastbound approach for the 1998 Saturn SL.

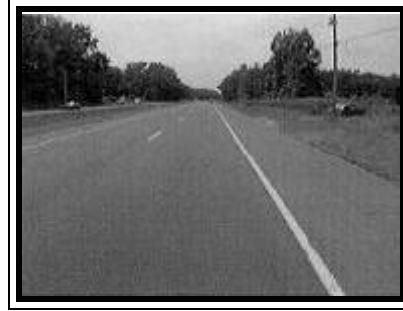
The GMC Jimmy approached the crash site traveling in the first westbound travel lane (**Figure 2**) at an estimated travel speed of 81-89 km/h (50-55 mph). When the Jimmy driver saw the Saturn entering the

Figure 2. Westbound approach for the 1998 GMC Jimmy Typhoon.

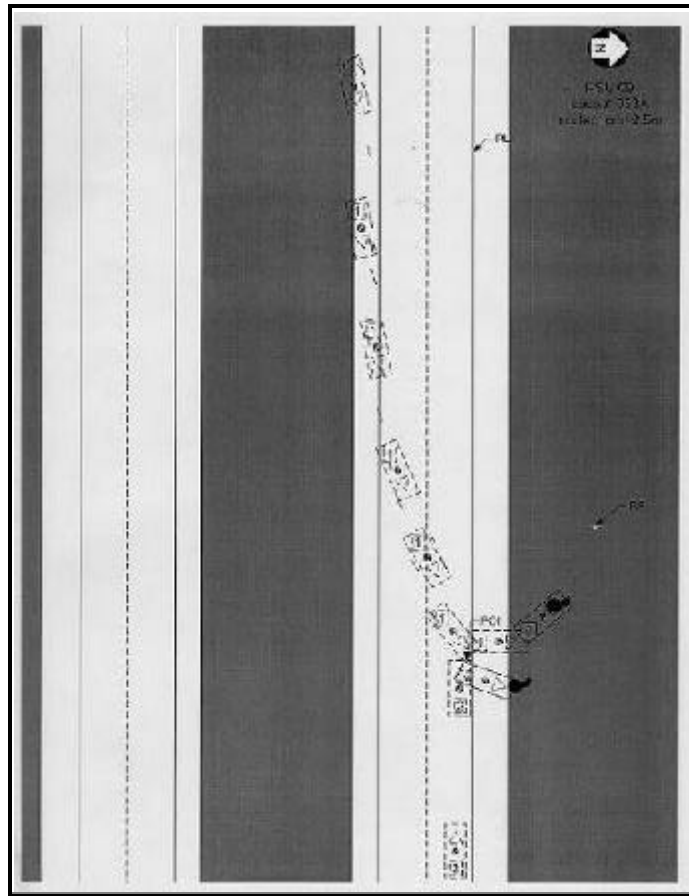
In the immediate vicinity of the crash site the eastbound lanes of the state roadway were asphalt surfaced, straight, and level. The east and westbound travel lanes were delineated by a broken white centerline and solid white edge lines (see **Figure 8 - page 7**). Both edges of the east and westbound travel lanes were bounded by wide paved shoulders and the travel lanes were separated by an 11.0 m (38.7') wide depressed grass median. At the time of the crash it was dark, the roadway was not lighted, the weather was clear, and all environmental surfaces were dry. Both travel directions were posted with a 80 km/h (50 mph) speed limit.

Figure 8. NASS Scene Diagram.
