**VERIDIAN REMOTE REDESIGNED AIR BAG INJURY
INVESTIGATION
SCI TECHNICAL SUMMARY REPORT**

NASS CDS CASE NO. 1998-11-102G

VEHICLE - 1998 FORD EXPLORER

CRASH DATE - JUNE, 1998

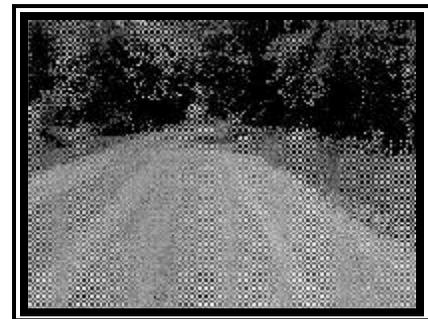
Prior to the crash, the Explorer was traveling in a northerly direction (**Figure 1**) at an estimated speed of 80-89 km/h (50-55 mph). As the vehicle crested a hill, the driver noted an animal entering the roadway forward of his position. The animal's trajectory was from the driver's left to his right. The driver reported that he initially steered sharply to the right to avoid the animal and then steered sharply back to the left to remain on the roadway. As the Explorer regained the center of the roadway, the driver overcorrected back to the right. The Explorer subsequently exited the right edge of the roadway traveling in a northeasterly direction while in a clockwise yaw.

Figure 1. Northbound approach for the 1998 Ford Explorer.

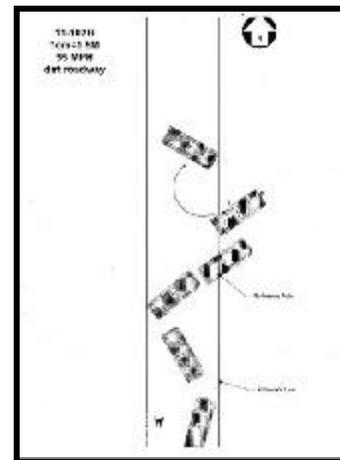
Figure 5. NASS Scene Diagram.

The Explorer approached the crash site traveling in a northerly direction on a two lane, dirt and gravel-surfaced, rural roadway (see **Figure 5 - page 4**). In the immediate vicinity of the crash site the roadway was straight with a slight downgrade to the north. Both edges of the roadway were bounded by tall grass berms with trees located outboard of the grassy areas. At the time of the crash, it was daylight and all environmental surfaces were dry. The area speed limit was 89 km/h (55 mph).
